# Environmental Quality Commission

## SPECIAL MEETING AGENDA

## STAFF REPORT

Staff recommends the Environmental Quality Commission (EQC) deny the appeal and uphold staff's decision to deny the Heritage Tree removal permit application at 262 Yale Rd.

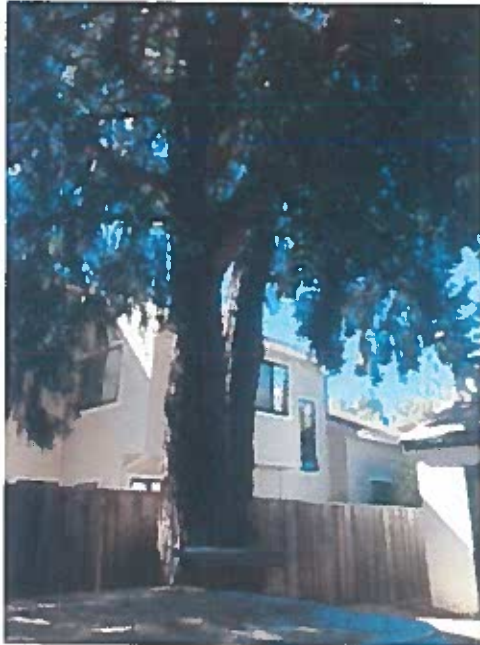
**Large incense cedar near southeastern property line. The poor crotch of the tree is a safety concern.**

The tree in question is an incense cedar (*Calocedrus deccurans*) with a diameter at breast height of 53.9 inches. The tree is located in the rear of the property on the southeastern property line. The estimated height of the cedar is 55 feet with a total crown spread of 50 feet. The vigor of the cedar is good with normal shoot growth for the species. The form of the cedar is poor with codominant leaders at 5 feet with a very poor crotch formation. The tree receives an overall condition rating of 40 on a 1-100 scale.

Remove and replace the large poorly formed cedar as trimming within ANSI standards will not improve the form of the tree or lessen the chances of failure, making the tree an immediate hazard. Removal and replacement of this tree is the only method that will eliminate all hazards and liabilities associated with the tree. The neighbor whose house is the likely target should be informed of the possible risks associated with this tree.

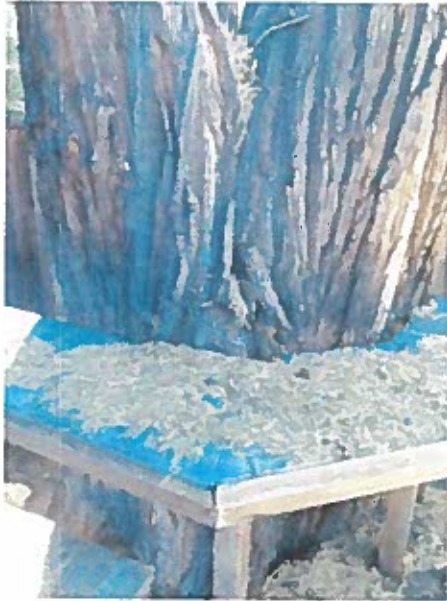
The crotch formation has a very narrow attachment with included bark and a large swollen seam extending from the top of the crotch to the ground. The swollen seam is evidence of a past splitting of the crotch. Two cables were installed in the past to help support the poor split crotch.

**The poor narrow crotch formation shows evidence of a past splitting. Cables installed to help support the crotch will do little to insure the safety of the tree.**

The size of the part that is most likely to fail is a large codominant leader. The likelihood of failure is great do to the past split crotch. The target is the neighbor's home.

A rating of 12 points is the highest point score a tree can receive making the tree an immediate hazard. Removal should strongly be considered for the tree.
