Environmental Quality Commission

REGULAR MEETING AGENDA

**STAFF REPORT****Environmental Quality Commission****Meeting Date:** 1/25/2017**Staff Report Number:** 17-002-EQC**Regular Business:****Issue: Determination on appeal of staff's denial of one Heritage Tree removal permit at 318 Pope St.****Recommendation**

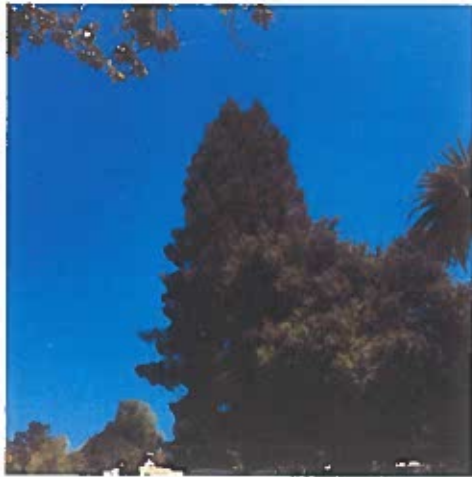
As requested on Tuesday, May 17, 2016, and again on Wednesday August 3, 2016 I visited the above site to inspect and comment on a large redwood tree proposed for removal. The large redwood tree has some form flaws that give the tree a high risk of failure. The owner would like to remove and replace the tree per the city of Menlo Park's replacement tree requirements.

Showing tree in question from the street

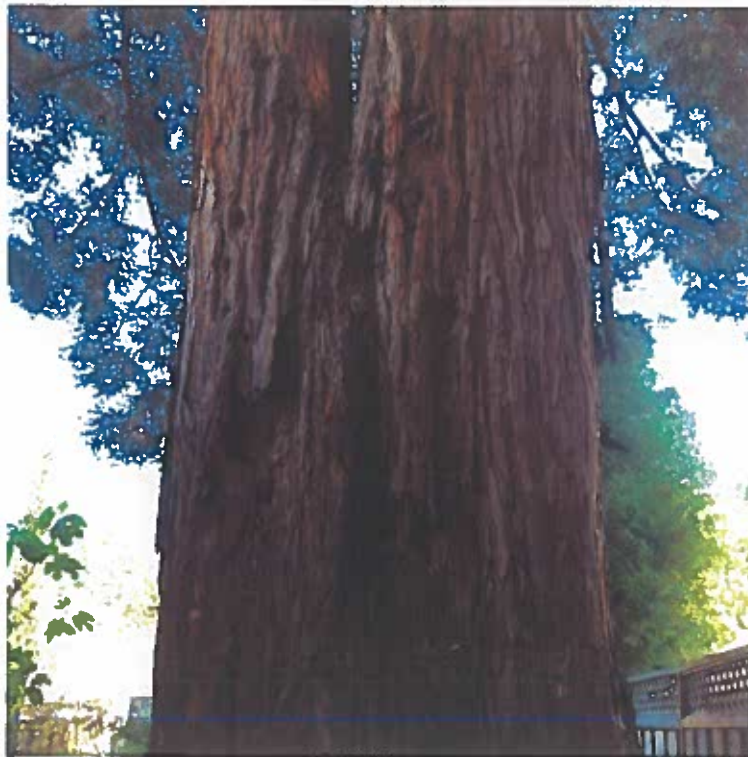
Showing poor union with included bark

The large redwood tree has a diameter of 95.7 inches. The tree has fair vigor, and poor form. The tree is located on the south side of the property near the property line. The tree is only 3.5 feet away from the existing home. This tree is a codominant tree consisting of 3 separate leaders starting at a height of 15 feet. These 3 leaders all have poor unions. In particular the union formation on the west side of the tree has a large seam that runs down to the base of the tree, and a bulging area can be seen below the poor formed union. These bulging areas often indicate included bark. Included bark forms in the junctions of codominant stems where there is a narrow angle union, meaning the junction looks like a "V" rather than a "U." As the tree grows the narrow union will essentially fill with bark and create a growing area of structural weakness in the tree. Even in young trees, when you notice a very narrow angle (creating a "V" at the junction of branches) it is likely that stress put on the either of the codominant stems can cause splitting, or even cause the stem to break off at the junction. As the 3 leaders grow they have the potential to push against each other often until the point of failure. In the poor union I observed

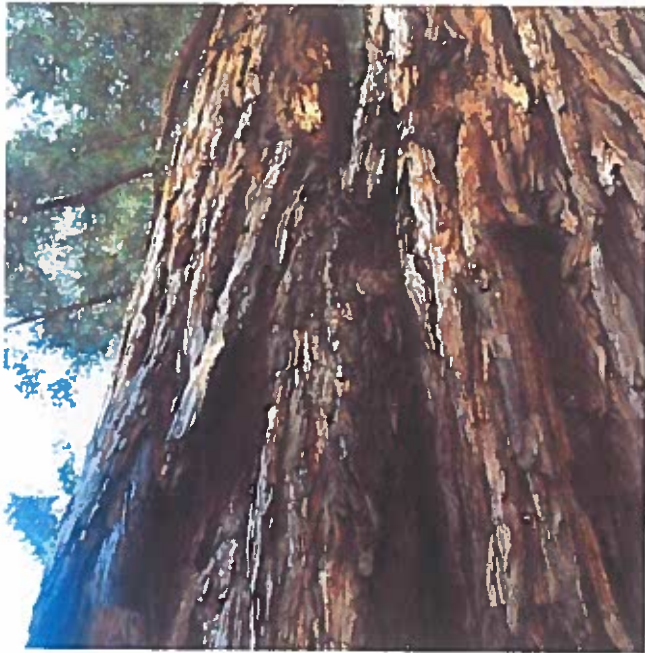
a good amount of callus tissue indicating that the tree is under a considerable amount of stress that may have caused the union to slightly split open. Also each leader is heavy to the direction away from the trunks and creates more stress to the poor formed union area. In the past a cable has been installed in the trees canopy in order to offer extra support to the poor union. This indicates past mitigations in place to reduce the risk of failure. The installed cables are not strong enough to hold such a large amount of weight and would likely snap if the tree were to fail. The leader of most concern leans slightly towards the neighbors property on the south side of the tree.

Showing close up of union with callus tissue

A basic tree risk assessment was performed on this tree. The leader to the south has a high risk even after possible mitigations were explored. The target of impact for this leader would be the neighbors home. Consequences of failure would be severe. The remaining leaders had a moderate risk level. Because of the large seam in combination with included bark on the leader to the south, its risk rating did not change from high, even after mitigations were explored. The high risk rating for the leader to the south is unacceptable by the owners standards and is the reason this tree is being recommended for removal. Removing this tree will alleviate all risk associated with this tree. The owners have plans to replant per Menlo Park replacement tree procedures.

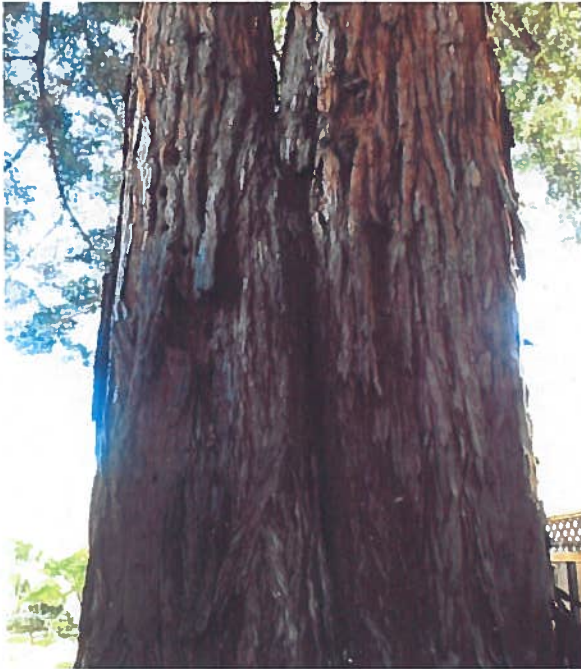
Showing poor crotch formation with included bark.

Mature redwood #5 has poor form and is the reason for its poor condition rating. This tree has a large trunk with a diameter of 95.7. The tree is codominant with 3 leaders starting at 15 feet. These 3 leaders all share apical dominance and have created poor crotches with included bark at 15 feet. Included bark forms in the junctions of codominant stems where there is a narrow angle union, meaning the junction looks like a "V" rather than a "U." As the tree grows the narrow union will essentially fill with bark and create a growing area of structural weakness in the tree. Even in young trees, when you notice a very narrow angle (creating a "V" at the junction of branches) it is likely that stress put on the either of the codominant stems can cause splitting, or even cause the stem to break off at the junction. As the 3 leaders grow they have the potential to push against each other often until the point of failure. Bulging is visible in these areas of included bark and often indicate a structural weakness. Also each leader is heavy to the direction away from the trunks and creates more stress to the poor crotch area at 15 feet. Because of this trees poor growth form and the trees target at a failure being the home or neighbors home, I am recommending this tree to be removed as it is a hazard to the property. The owner of the property would like to save the tree. Recommended mitigation measures are as followed:

- Install cables in upper 2/3 of canopy in order to offer extra support. Cables have been installed in the past at the wrong height.
- During the dry season irrigate the tree with soaker hoses, especially during construction.
- Have a licensed tree care provider selectively prune branches to lighten the load on each leader, while still allowing for an aesthetically pleasing tree. Pruning shall not exceed 25% of the total foliage, following ANSI standards and Palo Alto standards. The leader that is heavy towards the neighbors home should be heavily pruned as this leader already has a lean.
- Continue to monitor the crotches and overall health of the tree.
- It is advised that a certified arborist inspect the tree every 2 years, or if any noticeable cracking, or bulging near the base of the tree is seen, that a certified arborist be called out right away.

Even with these mitigation measures in place this tree would still pose as a liability if a leader failure were to occur and is the reason removal is recommended.

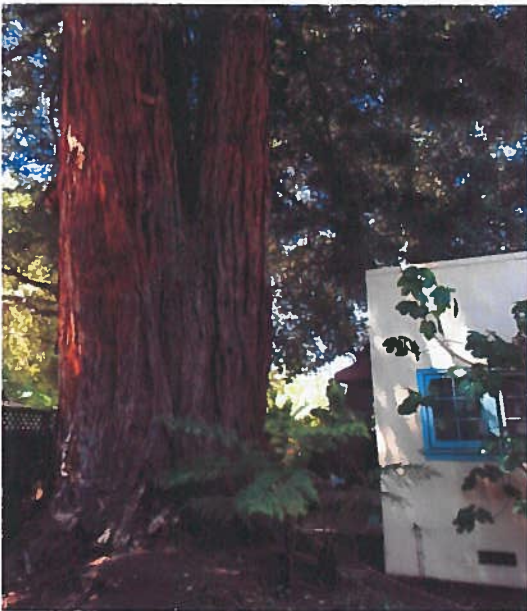
Showing proximity to home

The existing home near redwood tree #5 is only 3.5 feet away from this tree. If this tree is to be retained, during demolition of the existing home the tree protection fencing must be placed as close to the existing home as possible. The whole south side of the home where trees #3-5 are located should be fenced off. All heavy equipment must work away from these trees in order to not compact the soil around these trees. Tree protection fencing for redwood #5, past the foundation area, should be extend as far out as possible. The proposed home will be set slightly farther back from this large tree. The existing foundation near this home likely acted as a root barrier. When designing the new foundation near this tree a pier and grade beam should be used with the least amount of excavation depth as possible for the grade beam, in order to bridge over what large roots may exist in these areas. After demolition has taken place, a trench must be dug by hand in combination with an air spade in the area of the proposed foundation in order to explore potential impacts to the tree and to strategically place piers in order to miss areas of heavy rooting.

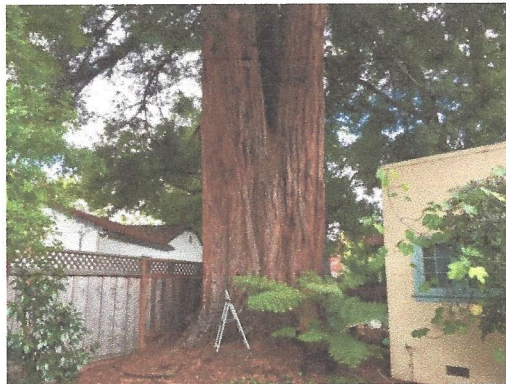
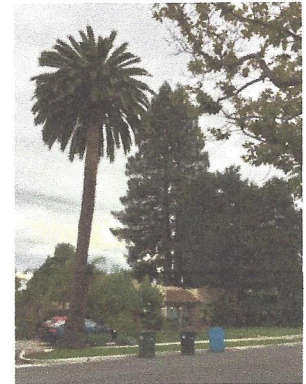
This Redwood (see images to right) is enormous. Quite simply this is a very large peg in a very small hole. All of that would be a non-issue except this tree has a serious structural flaw that could cause it to split in three different directions. When failure occurs the tree will cause enormous

structural damages and loss of life is highly likely. The likelihood of tree failure in this instance is high. Rather than living with this enormous threat I recommend removing this tree ASAP.

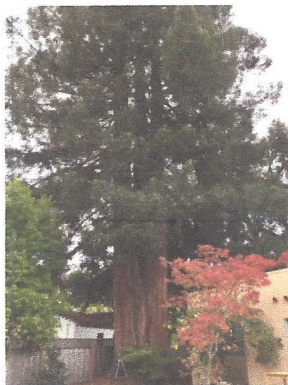
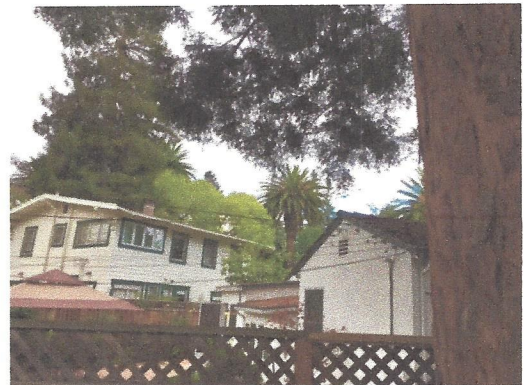
This Redwood has a trunk diameter (DBH) of 95.7". It stands approximately 120' tall and 45' wide. This tree is in Good Health but the Structure is Fair/Poor – Poor due to the three codominant limbs that make up the tree's main structure.

The tree is located 3.5' from the right rear corner of the home at 318 Pope, and right along the right side fence line (see images to right).

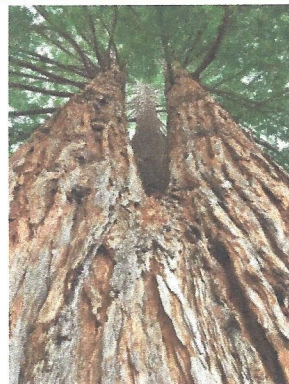
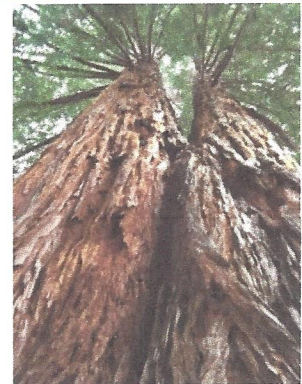
The main problem with this tree is the three main codominant leaders starting 15' above grade (see images to lower right). Codominant leaders, especially when they have included bark, are prone to splitting apart because they are not attached where they appear to be growing together (http://www.umass.edu/urbantree/factsheets/35codominantstems_rev1.html).

This tree has three main co-dominant leaders with included bark and the three leaders are not well attached to each other. In fact, each year the three main stems of this tree grow apart more and more. The union between these tree main stems is weak and highly prone to splitting apart. This is a well-known fact among trained Arborists. There is no disputing it. This isn't a matter of IF this tree will fail; it's a matter of WHEN.

The level of risk presented by this tree falling apart is extremely high. The combination of the height of this tree, the weight of the wood and the proximity of this house and the neighbors within striking distance – there are *at least* two – mandates that the risk be mitigated.

Mitigating the risk of a tree this large can only be done by removing the risk factor (ie. whole tree removal). If the tree were smaller a series of cables could be used to try to cable the three leaders together, in an attempt to have them not split apart in a high wind event. This tree currently has cables, but it is my opinion that they are non-functional. While there are Industry Best Practices for cabling trees – this tree is too large to be able to say that proper cabling would truly mitigate the risk of a large limb failure. Trees have not been engineered and the mitigation would not be engineered, thus the reliability of the cables would be a “best guess” at best. Due to the size of this tree and the threat of loss of life; a best guess is not acceptable.
