Environmental Quality Commission

SPECIAL MEETING AGENDA

Date:7/26/2017Time:6:30 p.m.City Hall/Administration Building701 Laurel St., Menlo Park, CA 94025

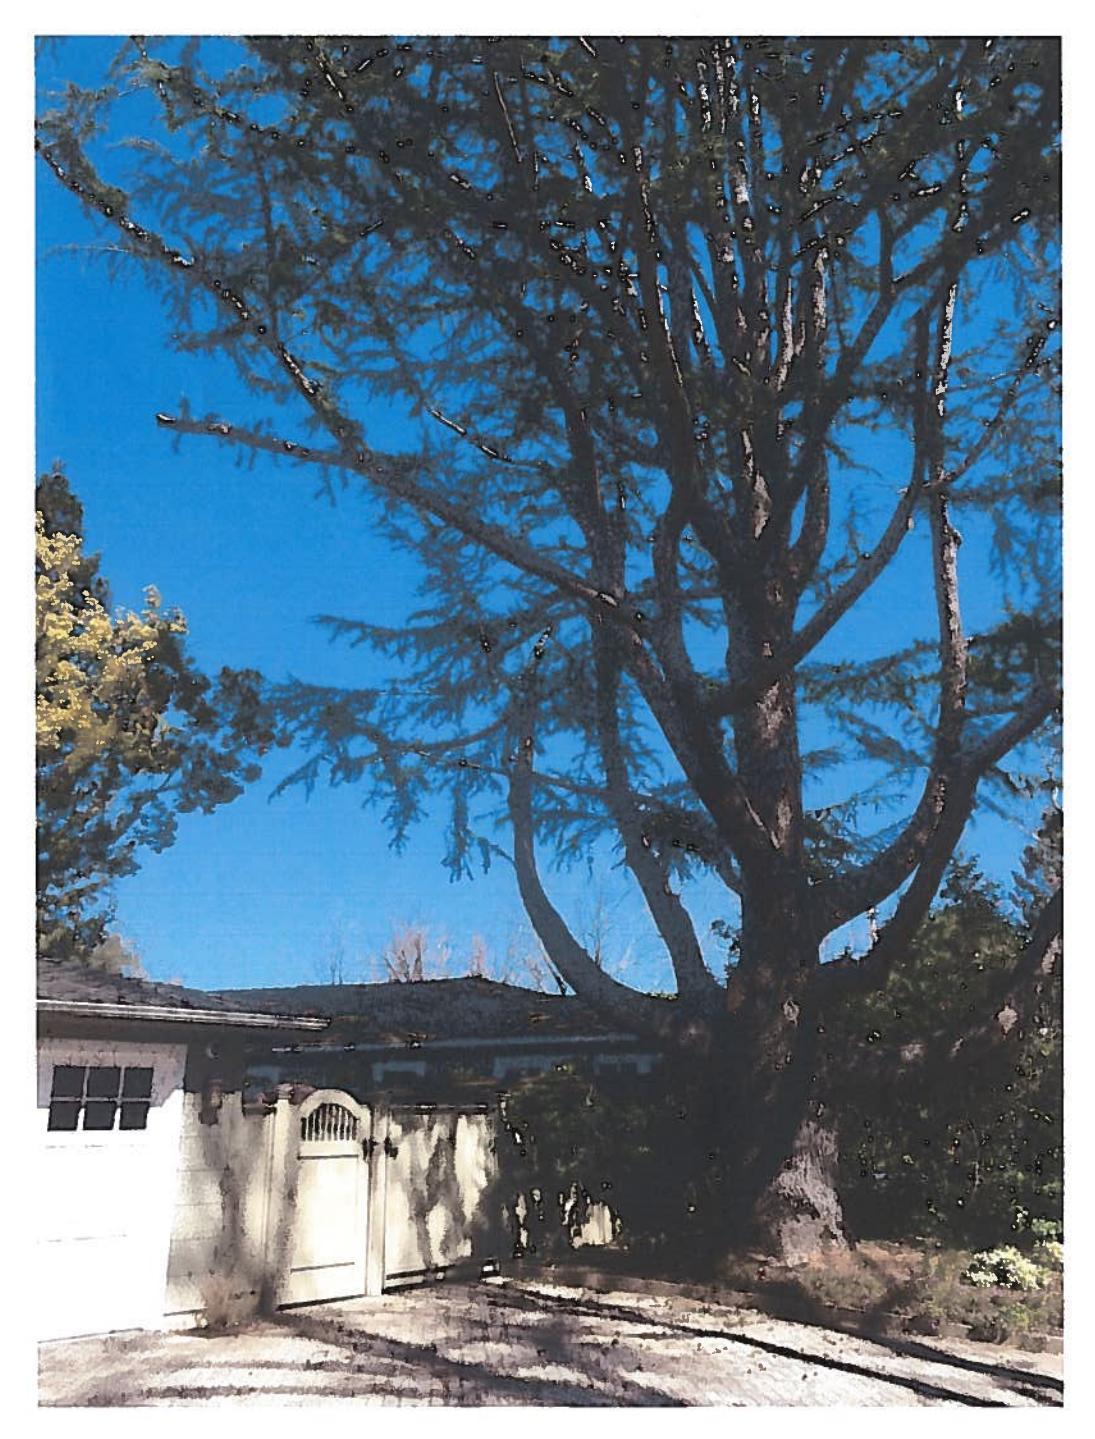
The tree is in fair health and condition. It has been well maintained but despite maintenance, branches continue to fall from the tree. Photo 2. The canopy is healthy and there are no signs of disease or insect infestation. The tree has poor structure with many co-dominant trunks and long heavy branches.

Photo 1: Deodar cedar at the front of the house

The tree has been well maintained, however branches have continued to fall from the tree. The tree is located on a busy school street where there is a lot of pedestrian traffic as well as parked cars under the tree during school periods. Since recent maintenance has failed to prevent the tree from dropping limbs and a falling limb may land on a car or pedestrian, I recommend that this tree be removed.

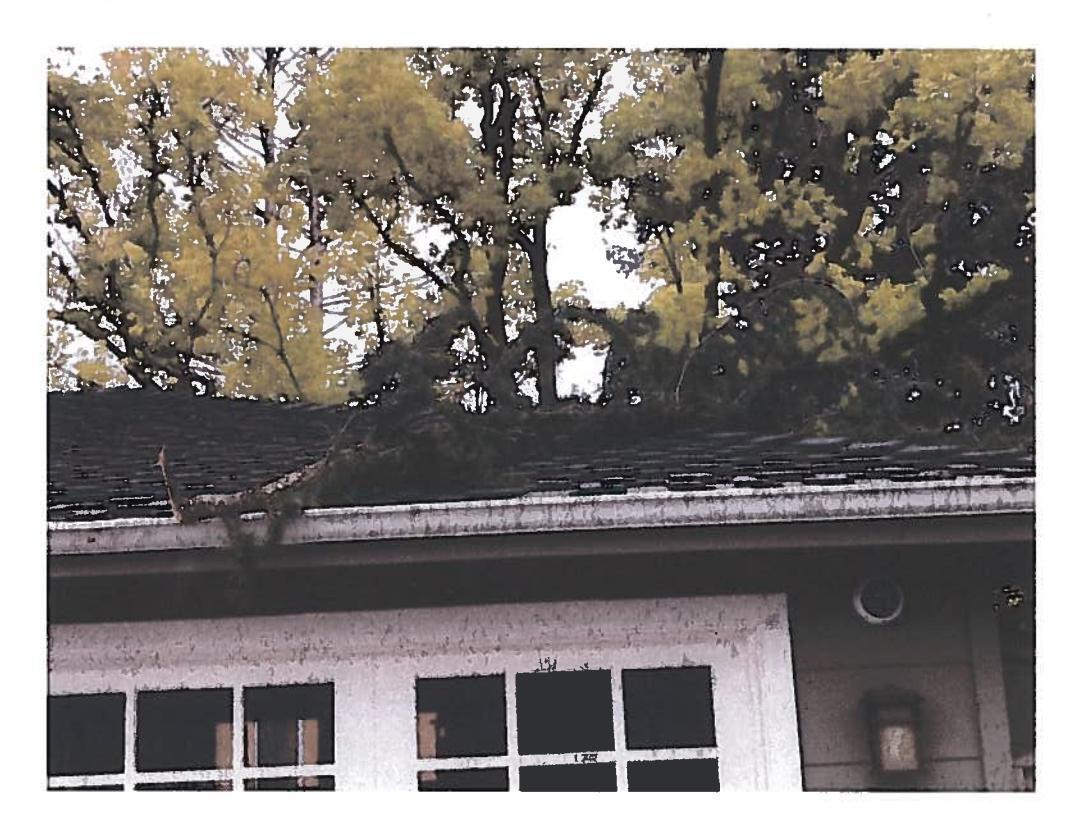
- There was no visible evidence of damage to adjacent structures at time of inspection. An image of a previously fallen limb on the roof of subject address was submitted with the removal application. No documentation of damage was submitted before action being taken on the permit application.

Photo 2: Recent fallen limb on house

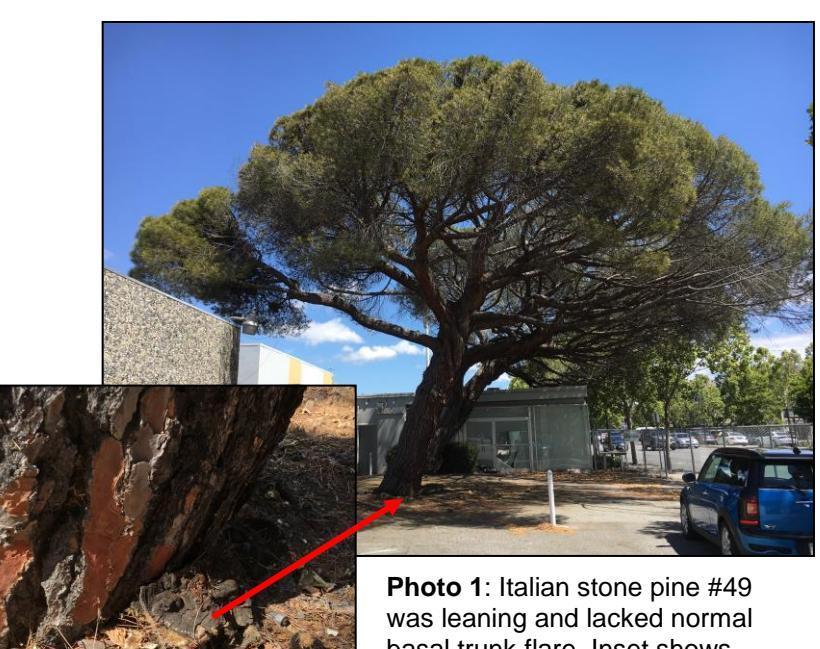
and roots had cracked and uplifted the pavement. There was a velvet top fungus (Phaeolus schweinitzii) conk at the base of the trunk on the southwest. This is a fungus that causes extensive root and basal trunk decay in conifers. making the tree more prone to windthrow and lower stem breakage. There are no treatments to halt or repair decay progression in infected trees.

basal trunk flare. Inset shows velvet fungus conk on trunk.

Based on my testing and analysis I rate the likelihood for this tree to fail within the next five years as **probable**.

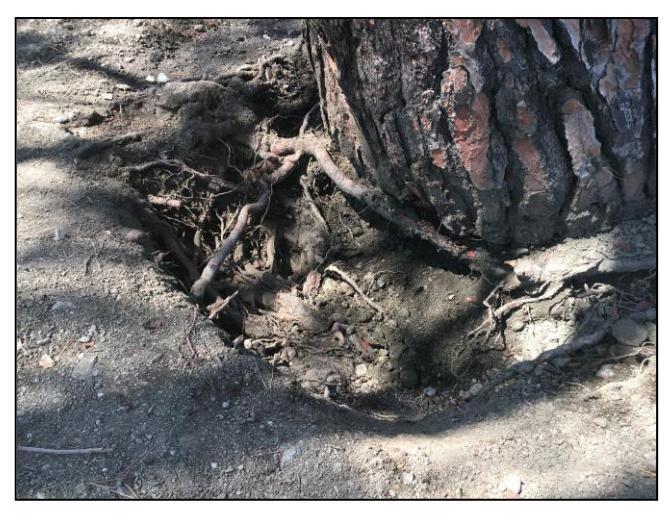
Photo 2: The root collar excavation at tree #49 revealed approximately 20" of fill over the root collar and a dense network of circling adventitious roots.

Fig. 1: Resistograph trace into the basal trunk area below the fungal conk.

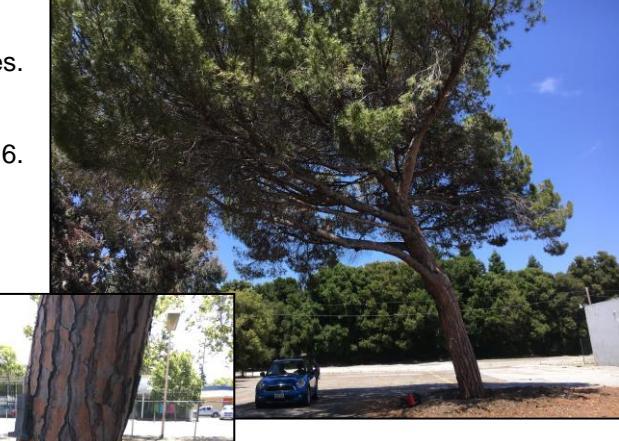
This tree also lacked basal trunk flare. Excavation revealed 24" of fill soil had been placed over the root collar in years past.

The primary visual clues indicating condiitons of concern for this tree were signs of localized wood failure from tension and compression forces acting acting on the lower trunk. On the west side where the trunk was under compression, the bark was indented (photo 4). One the east side where the trunk was under tension, the

Photo 3: Pine #59 was leaning to the west and lacked basal trunk flare. There was 24" of fill soil over the original root collar.

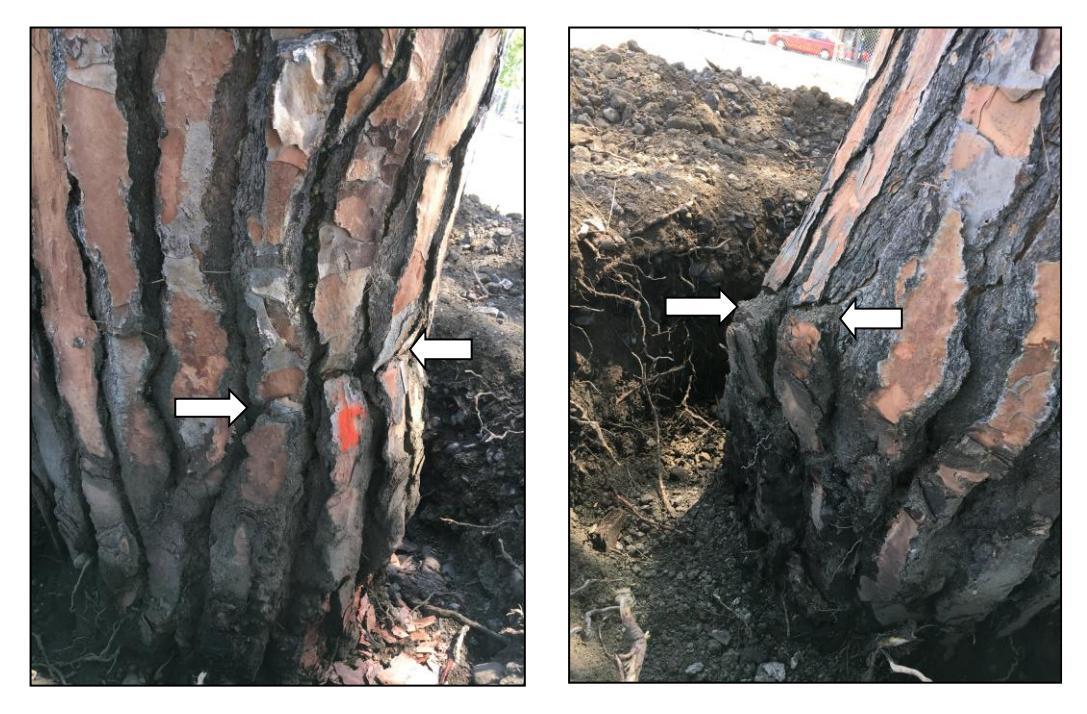
bark was fractured and protruding outward (photo 5).

Photo 4 (left): Localized failure of the west side of the trunk under compression forces.

Photo 5 (right): Localized failure of the east side of the trunk under tension forces.

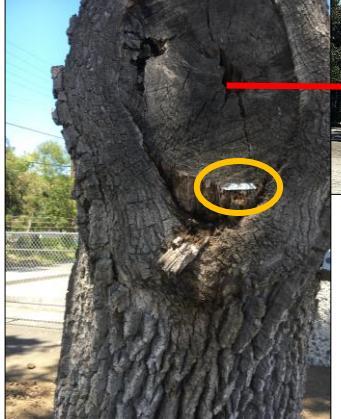
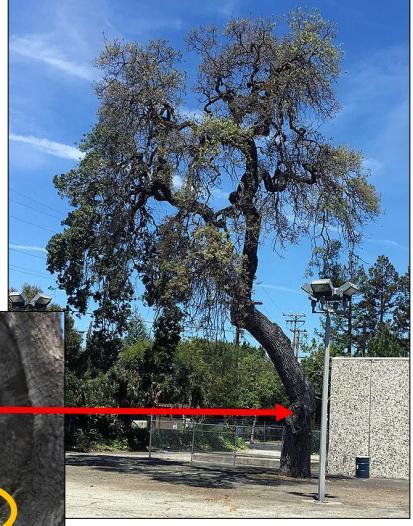
gilbertsonii) on the large wound faces. This decay organism causes and cubical brown rot that reduces structural strength and makes the tree prone to failure.

Photo 6: Valley oak #69 had large wounds with remnants of the decay conk sulfur fungus.

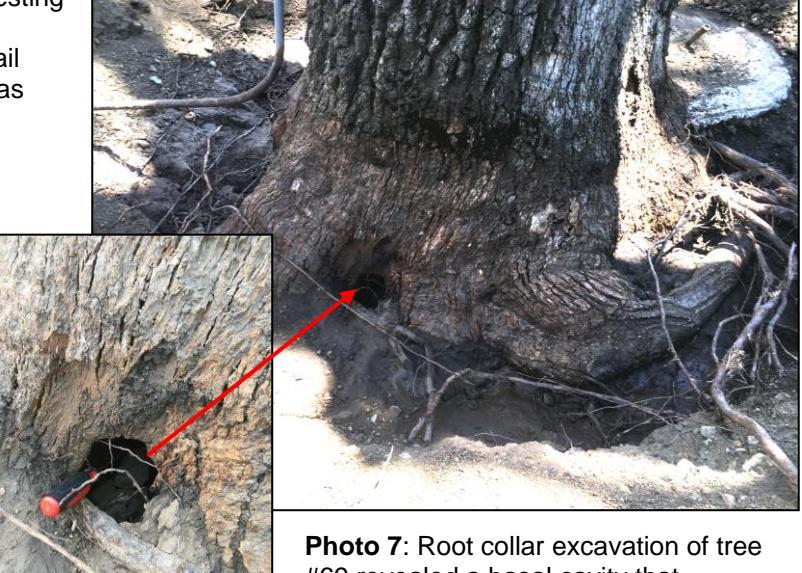
The root collar excavation removed 24" of soil and revealed the presence of a cavity on the north side (photo 7). I was able to insert a 24"-long probe into the cavity. I do not know how much deeper the cavity extended below

the trunk. Based on my testing and analysis I rate the likelihood for this tree to fail within the next five years as **probable**.

Photo 7: Root collar excavation of tree #69 revealed a basal cavity that extended at least 24" below the trunk.

In summary, I inspected Heritage trees #49, 59, and 69 following root collar excavations of each. Based on the degree of decay and defects present in each tree I rate the likelihood for each tree to fail in the next five years as **probable**. I recommend removing and replacing them. all three trees.
