Environmental Quality Commission

REGULAR MEETING AGENDA

STAFF REPORT - AMENDED

On November 8, 2017 a permit application was started to remove seven coast redwood trees at 1000 El Camino Real to address water damage in the underground parking garage (Attachment A.) The below grade parking garage and podium structurally supports the entire office building.

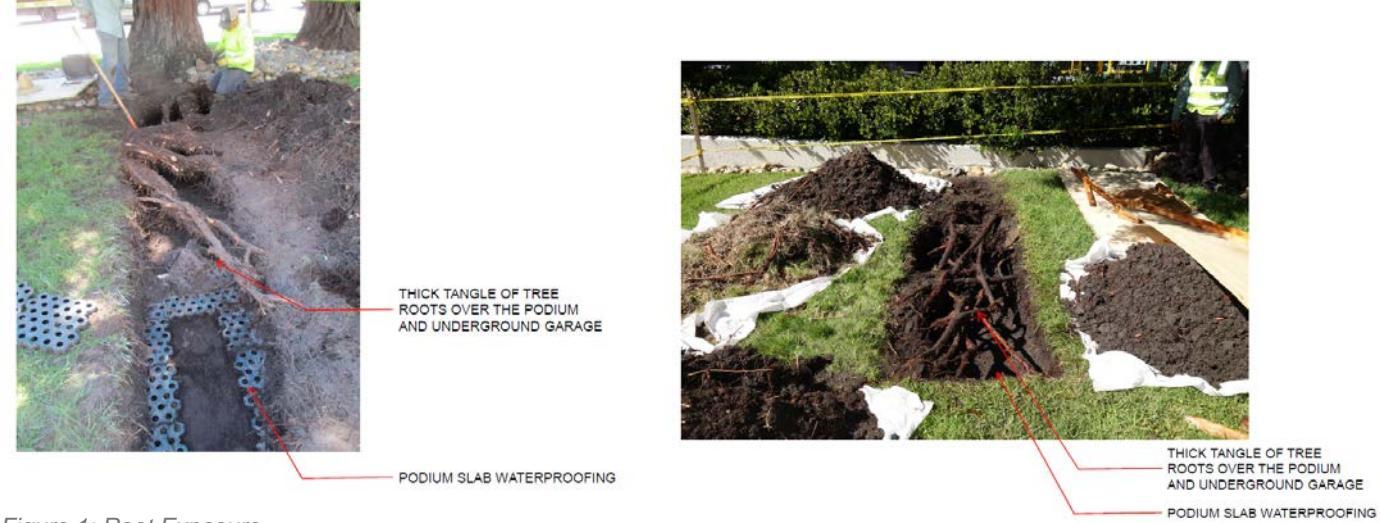
Figure 1: Root Exposure

Figure 2: Additional Root Exposure

The excavation required to install the waterproofing and perform structural repairs would be within the majority of each tree's root zone. This is beyond the recommended arboricultural industry practice for removing roots, and would impact tree stability.

In order to make the repairs and apply a water-proof barrier, these heritage trees and the landscaping above the parking garage would need to be removed and replaced. The approved landscaping plan specifies landscaping with drought tolerant plantings and heritage replacement trees. The replacement trees will be planted on a two to one ratio, meeting the City heritage tree replacement procedures, and selected to have less invasive roots. Replacement trees would be located in relatively the same location as the trees proposed for removal while allowing adequate distance from the parking garage to limit the potential for future root conflicts.

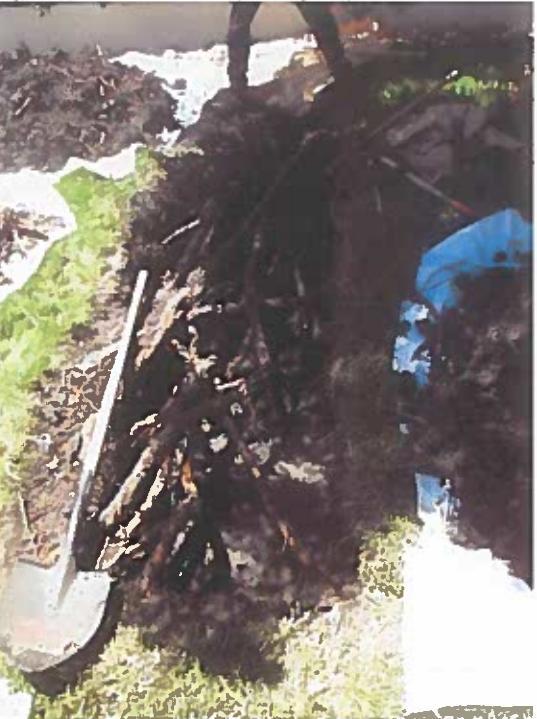
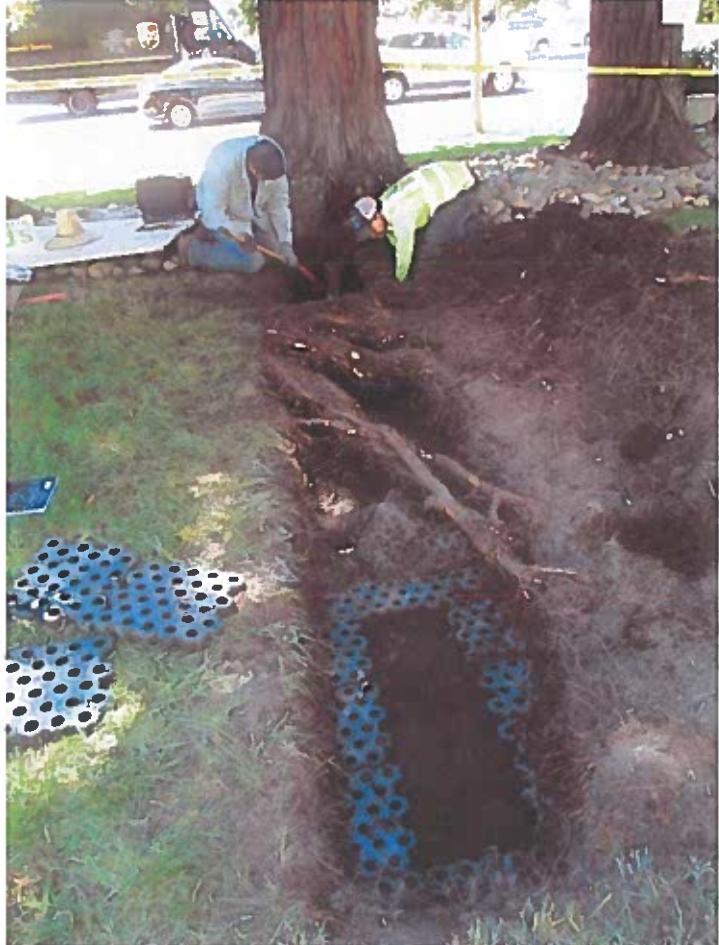
Photo 3. Photo to the right shows the massive amount of roots found in the turf area. All of these roots would need to be removed to accommodate the waterproofing.

Photo 4. Photo to the left shows the old water proofing and protection open for inspection. Significant root cutting was needed to gain access to the surface of the garage roof. People doing the excavation are working at the edge of the outer wall of the below ground garage. Cutting large roots so close to the tree will compromise the root anchoring and tree stability. Most likely "target" would be El Camino Real in the background.

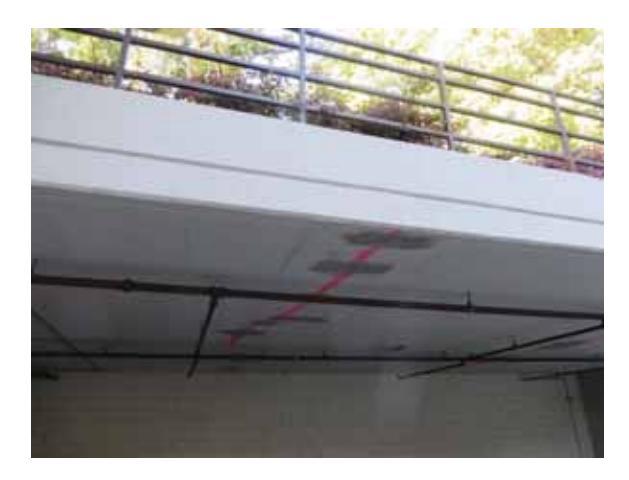
DAMAGE TO POST-TENSION CABLE STRUCTURE - REQUIRES REPAIR

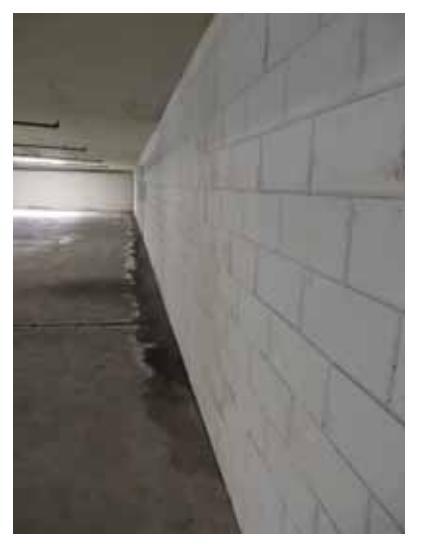
DAMAGE TO PODIUM WATER-PROOFING AT LOCATIONS ADJACENT TO REDWOOD TREE PLANTING

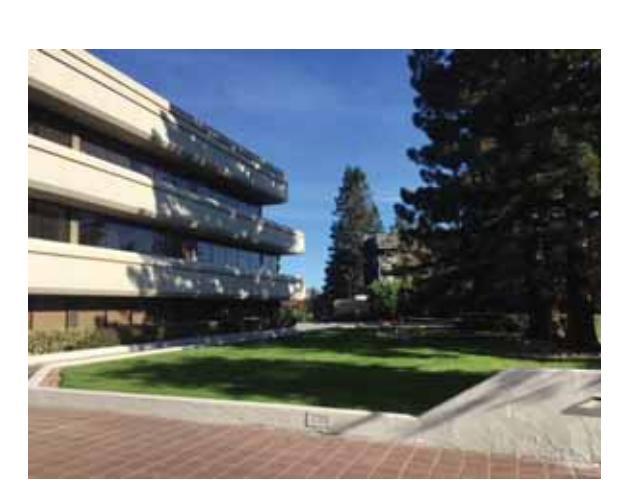
EXISTING LANDSCAPE CONDITIONS AT FRONT OF BUILDING (SOUTH SIDE). EXTENSIVE TURF LAWN PLANTING WITH REDWOODS INTRUDING UPON PO-DIUM STRUCTURE

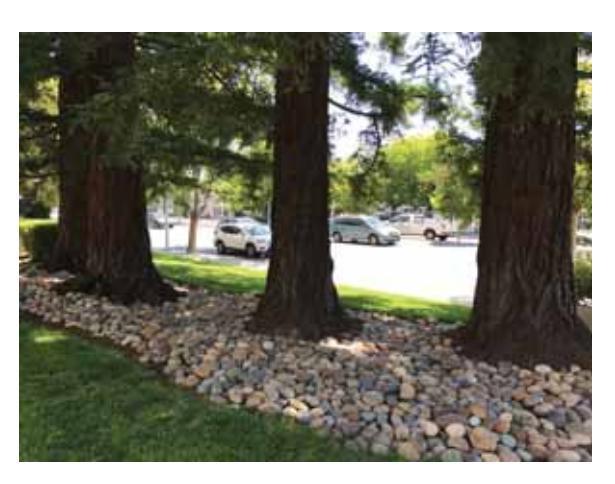
REDWOOD TREE GROVE PLANTED ADJACENT TO PODIUM - PROPOSED FOR REMOVAL TO ALLOW REPAIR

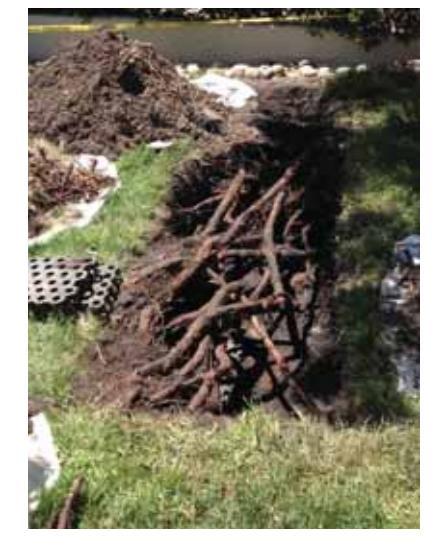
EXPOSED ROOTS OF REDWOODS INTRUDING ON PODIUM INTEGRITY

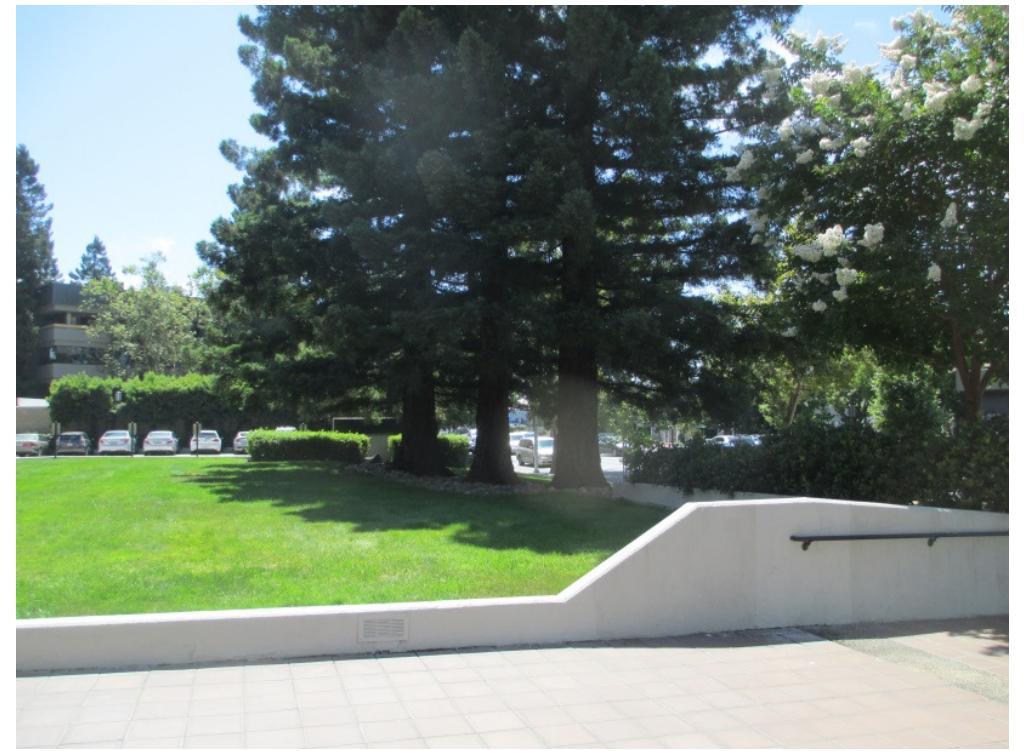
Photo 1. Photo shows the four redwood trees located at the south end of the row.

None of the trees can be retained due to the safety concerns resulting from the level of root loss that will occur.

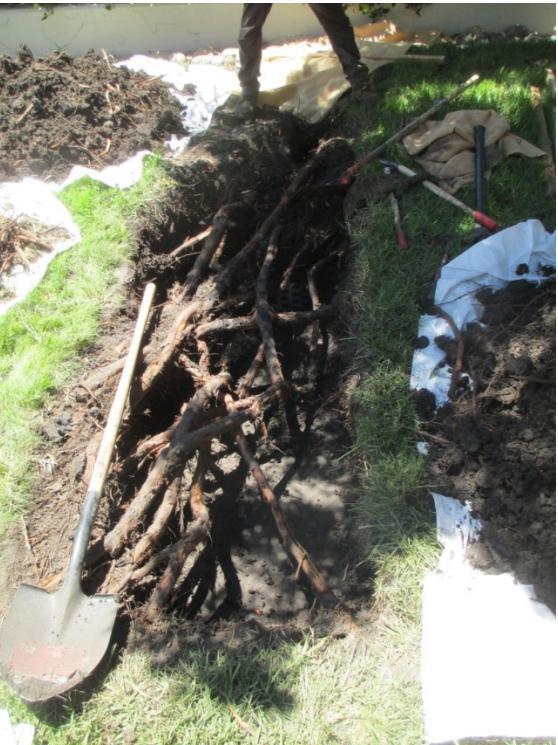
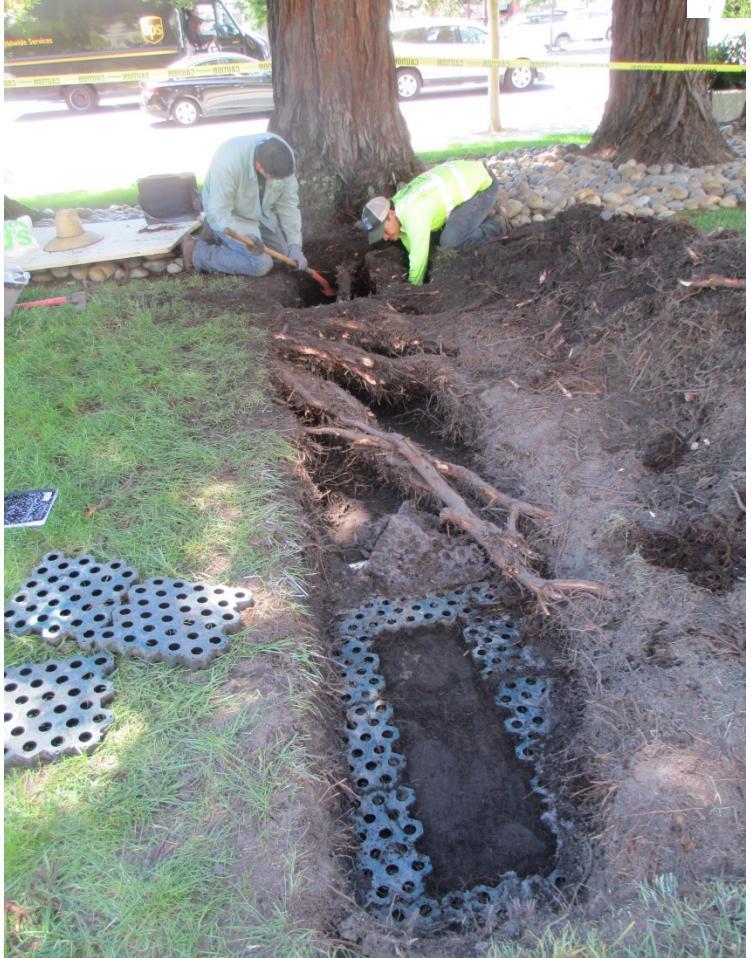
Photo 3. Photo to the right shows the massive amount of roots found in the turf area. All of these roots would need to be removed to accommodate the waterproofing.

Photo 4. Photo to the left shows the old water proofing and protection open for inspection. Significant root cutting was needed to gain access to the surface of the garage roof. People doing the excavation are working at the edge of the outer wall of the below ground garage. Cutting large roots so close to the tree will compromise the root anchoring and tree stability. Most likely "target" would be El Camino Real in the background.

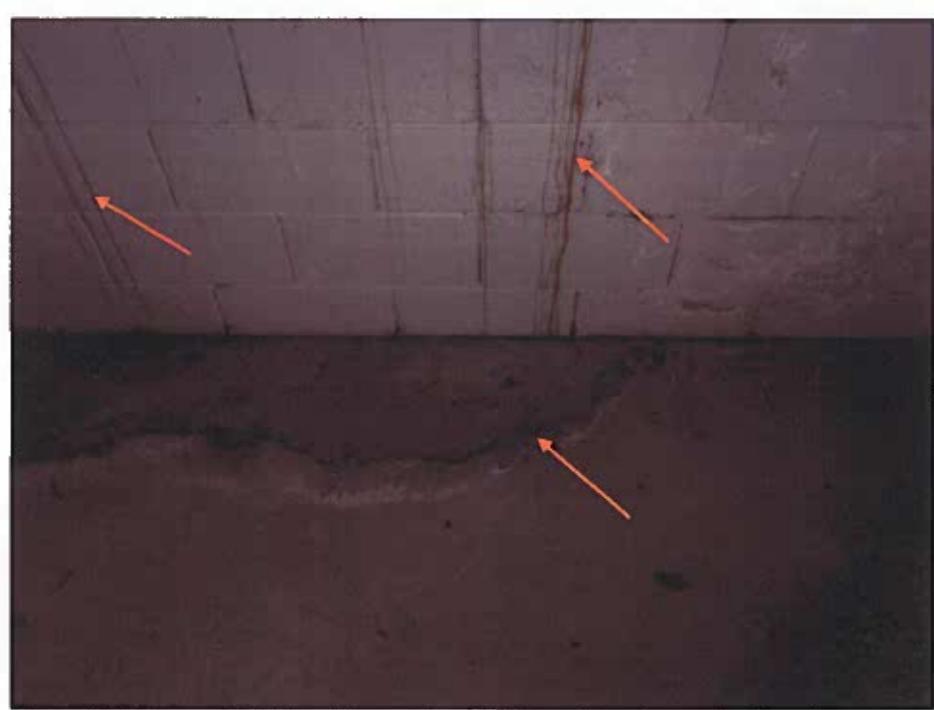
Figure 2 Staining on CMU foundation walls; staining on floor; from water intrusion.

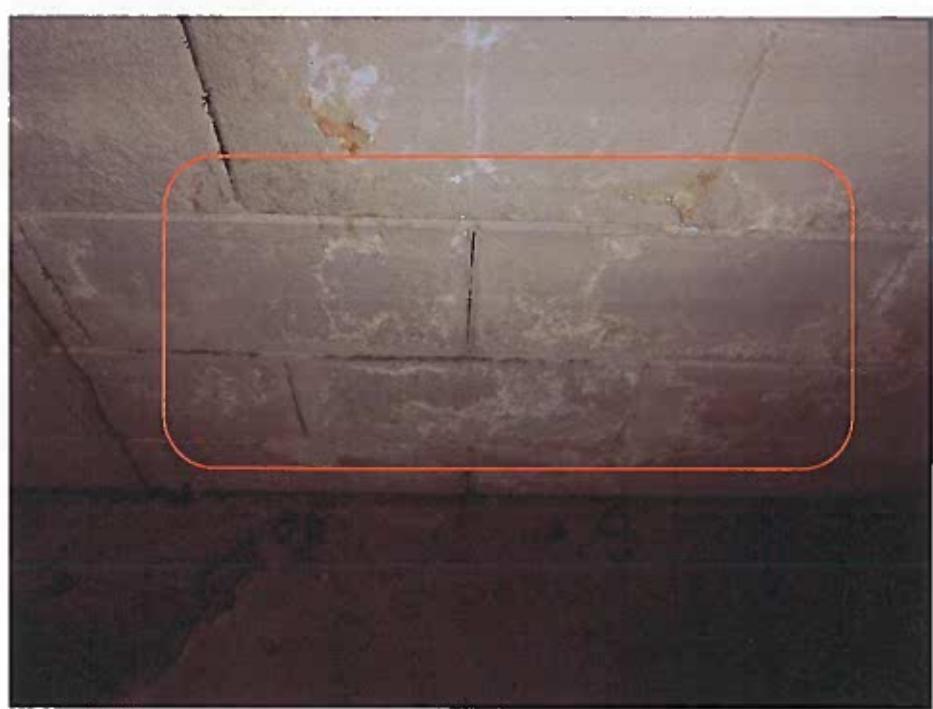
Figure 3 Efflorescence bloom on the CMU foundation wall along El Camino Real.

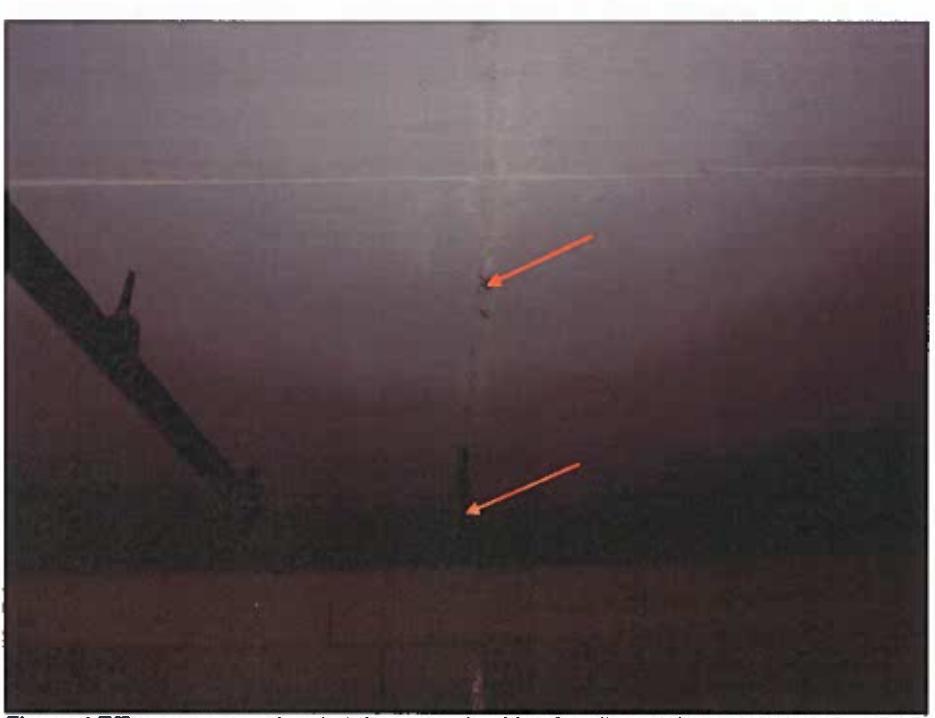
Figure 4 Efflorescence and rust stains on underside of podium slab; see photo below for floor staining at this location.

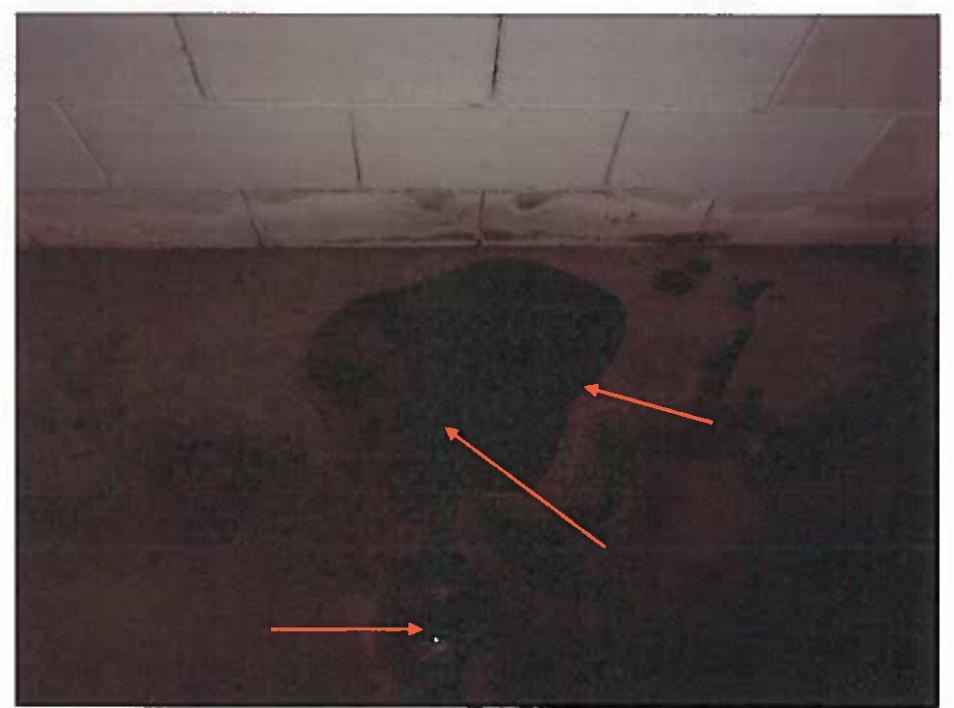
Figure 5 Water with rust staining from podium slab leak above.

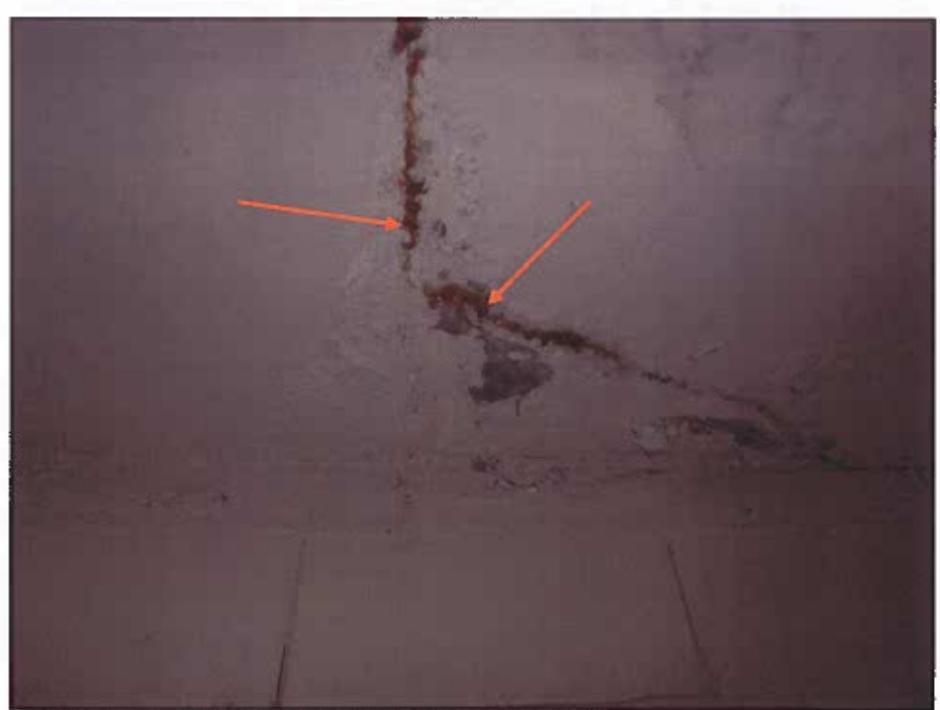
Figure 6 Active dripping from underside of podium slab.

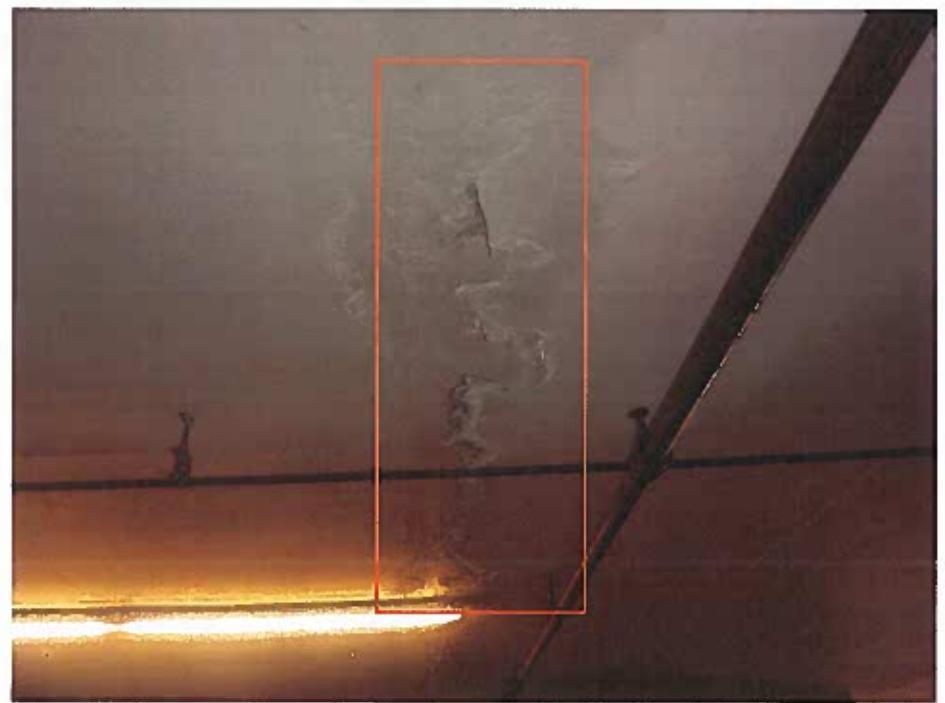
Figure 7 Efflorescence bloom along crack in underside of podium slab.

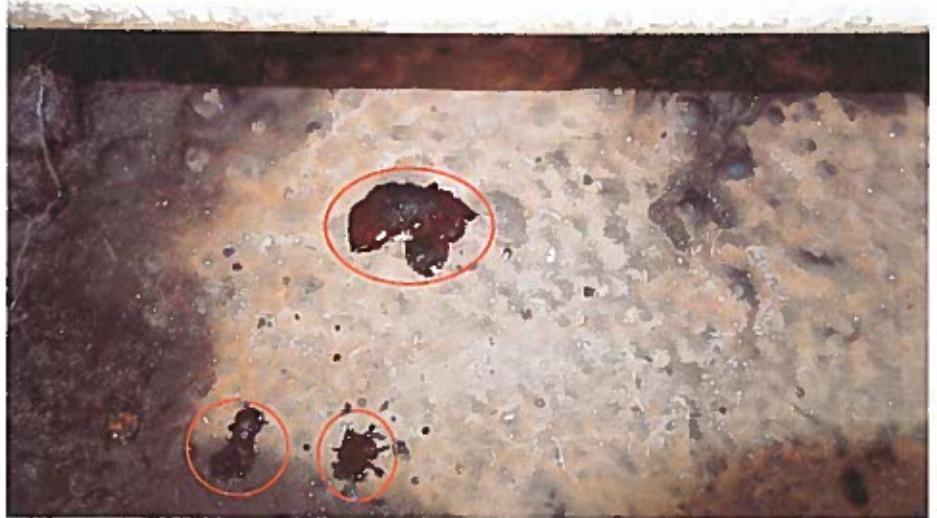
Figure 16 Sliced blisters seeping trapped water that was below the waterproofing – indicating that moisture is moving through the waterproofing membrane.

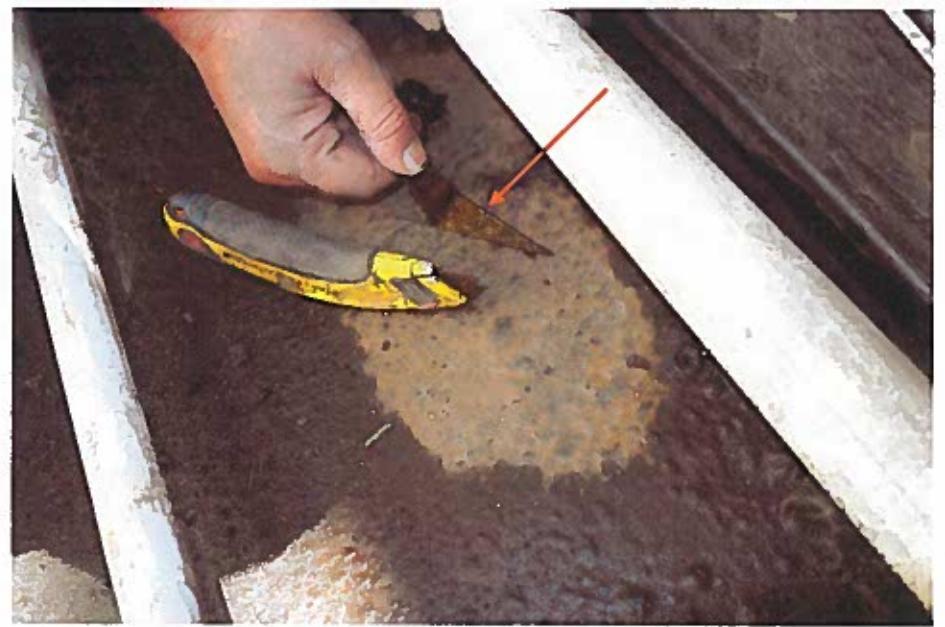
Figure 17 Adhesion pull test was performed on the waterproofing membrane. Adhesion was poor.

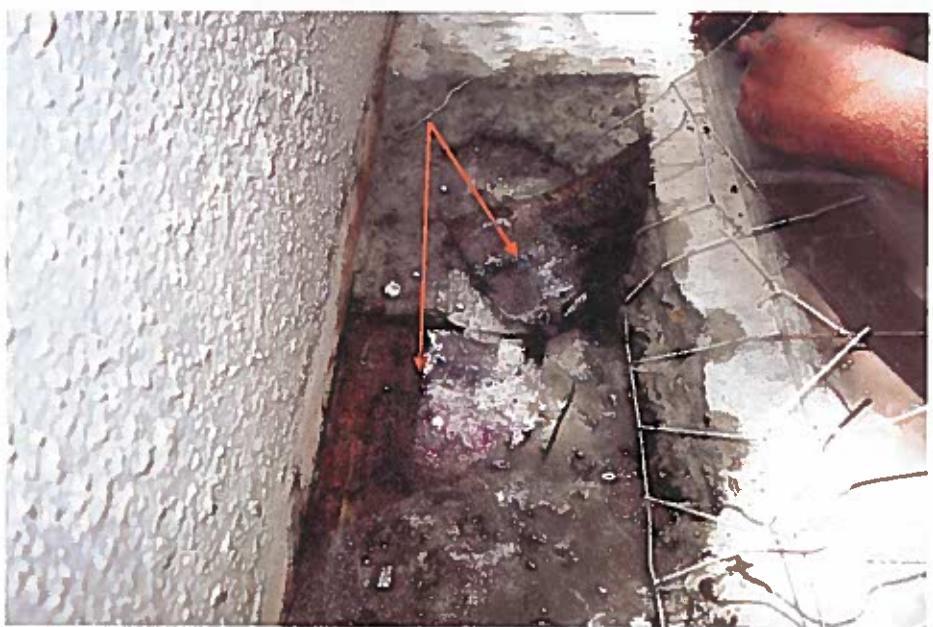
Figure 22 Note moisture below membrane, indicating water intrusion is occurring. Water below the waterproofing membrane can travel through voids and unadhered portions of the membrane.

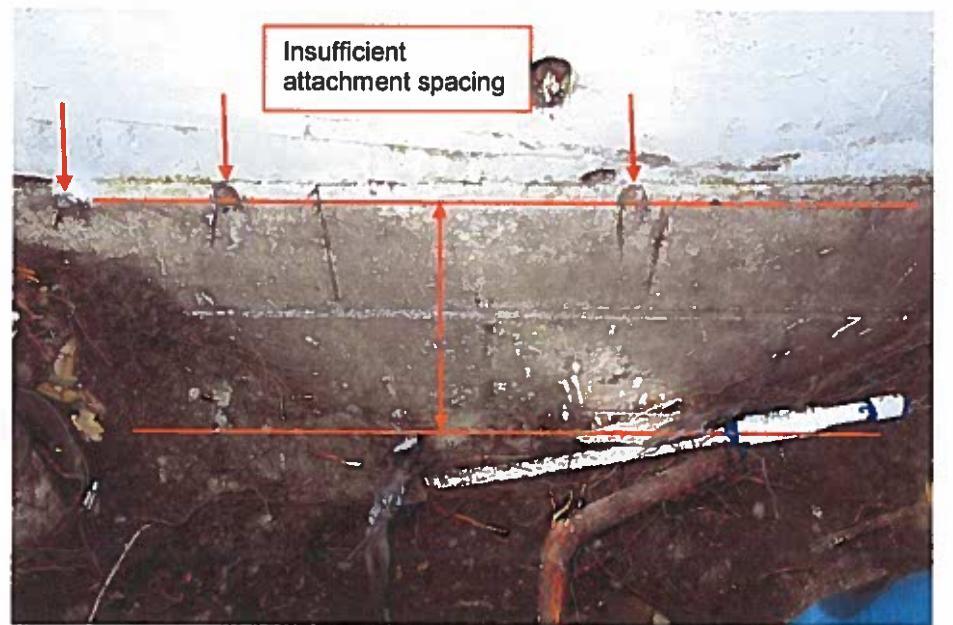
Figure 23 DT location at the CMU foundation wall at the rear of the garage. Note that the wall waterproofing has slipped down - leaving a portion of the wall unprotected. Additionally, note the insufficient attachment spacing.

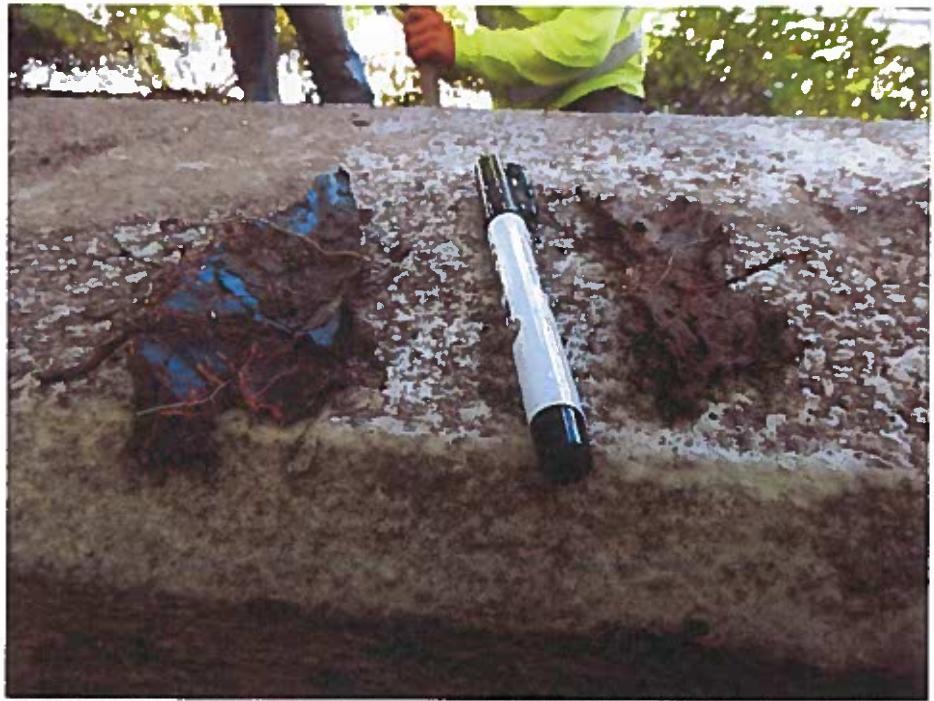
Figure 25 Samples of self-adhering membrane taken from location. Note the extent of root damage caused by the roots penetrating the membrane.

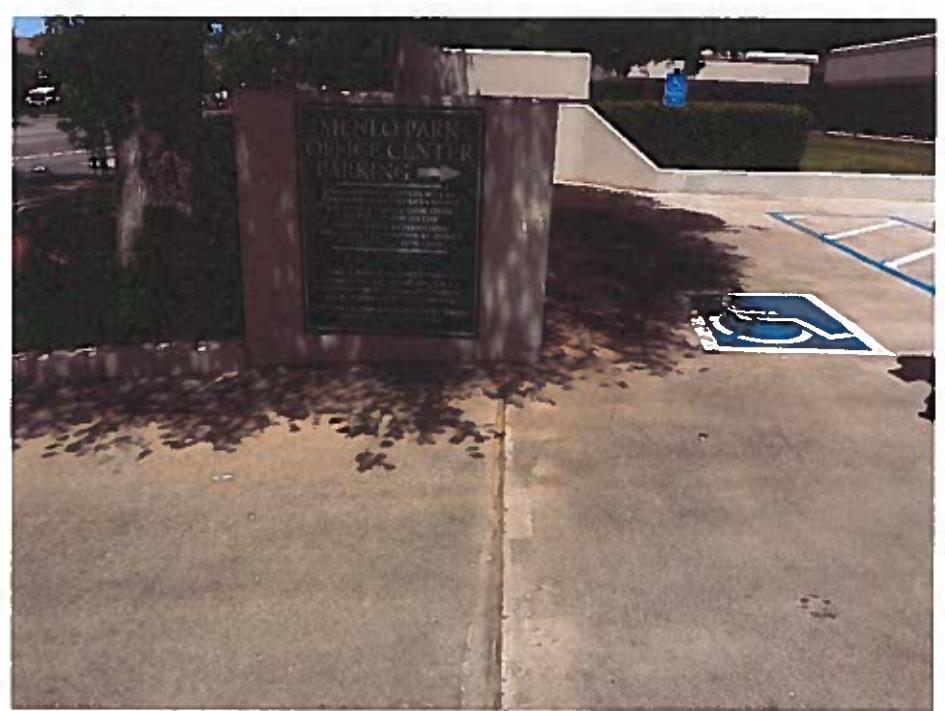
Figure 26 Topcoat of existing parking deck is aged and maintenance is recommended.

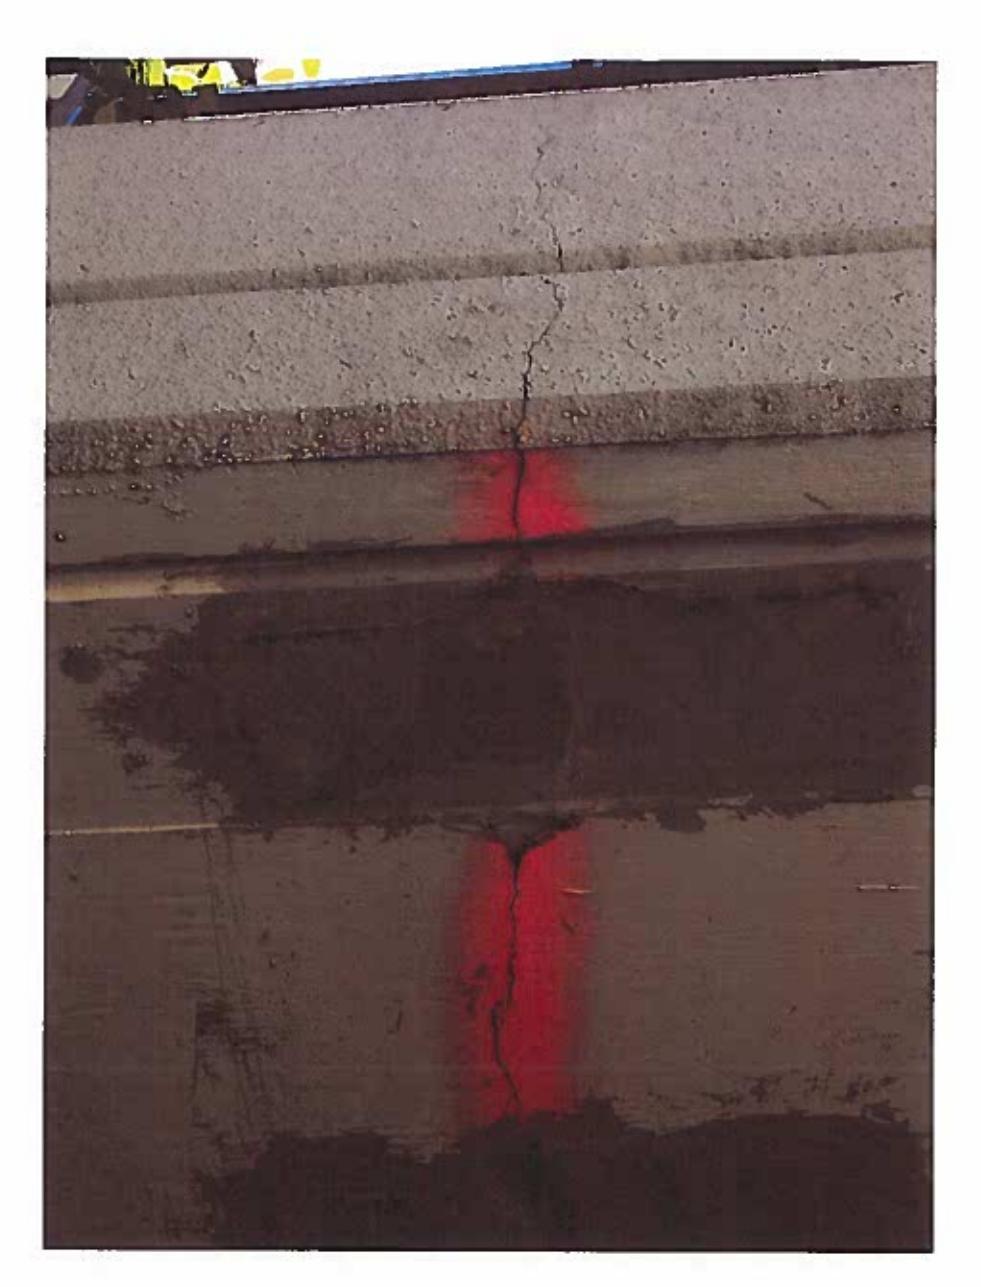
Photo 1 – Podium slab cracks along with chip and patch regions at gridlines 2.5/H1

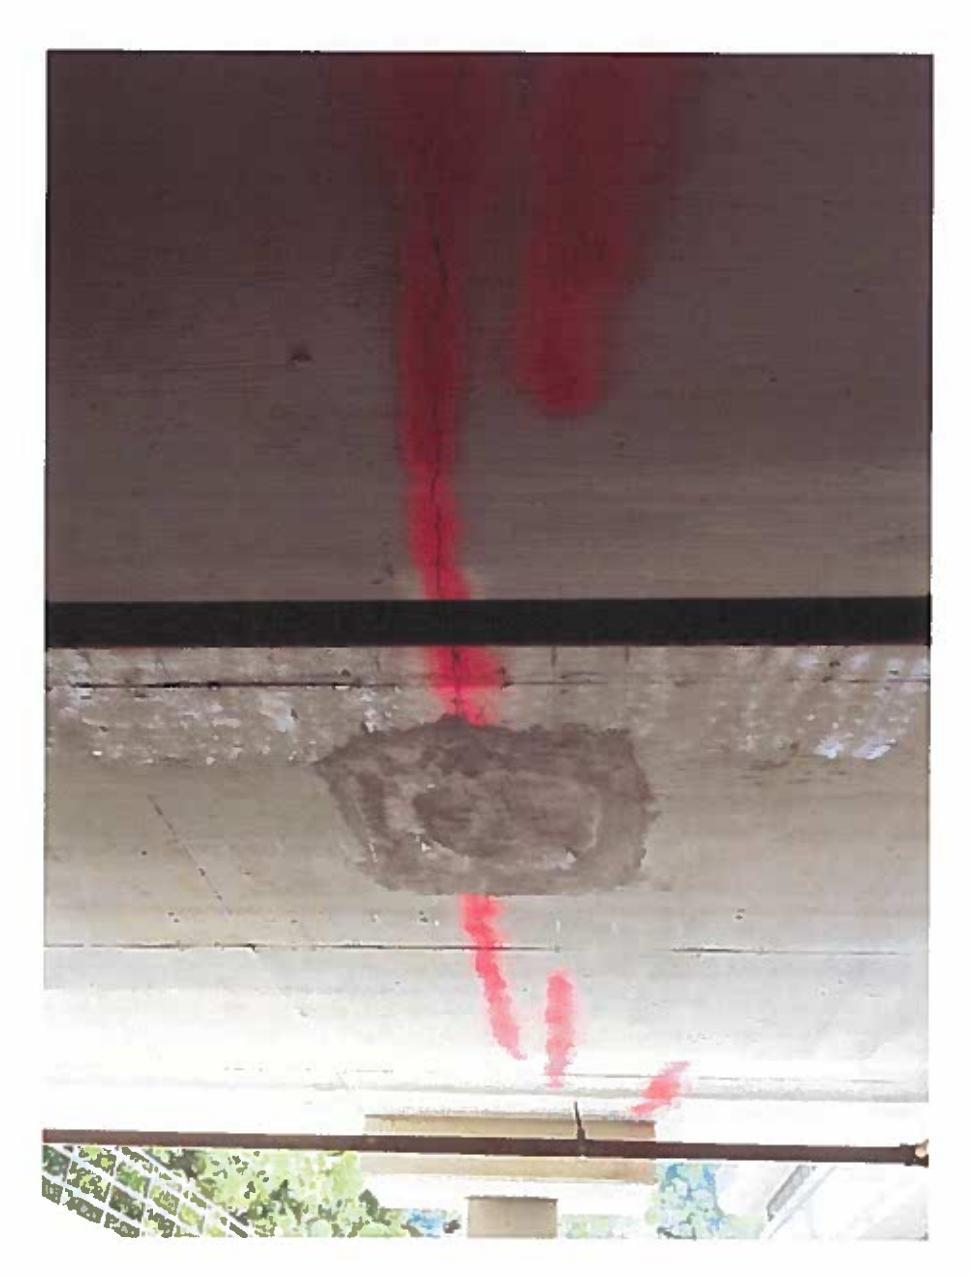
Photo 2 - Podium slab cracks along with chip and patch regions at gridline 2

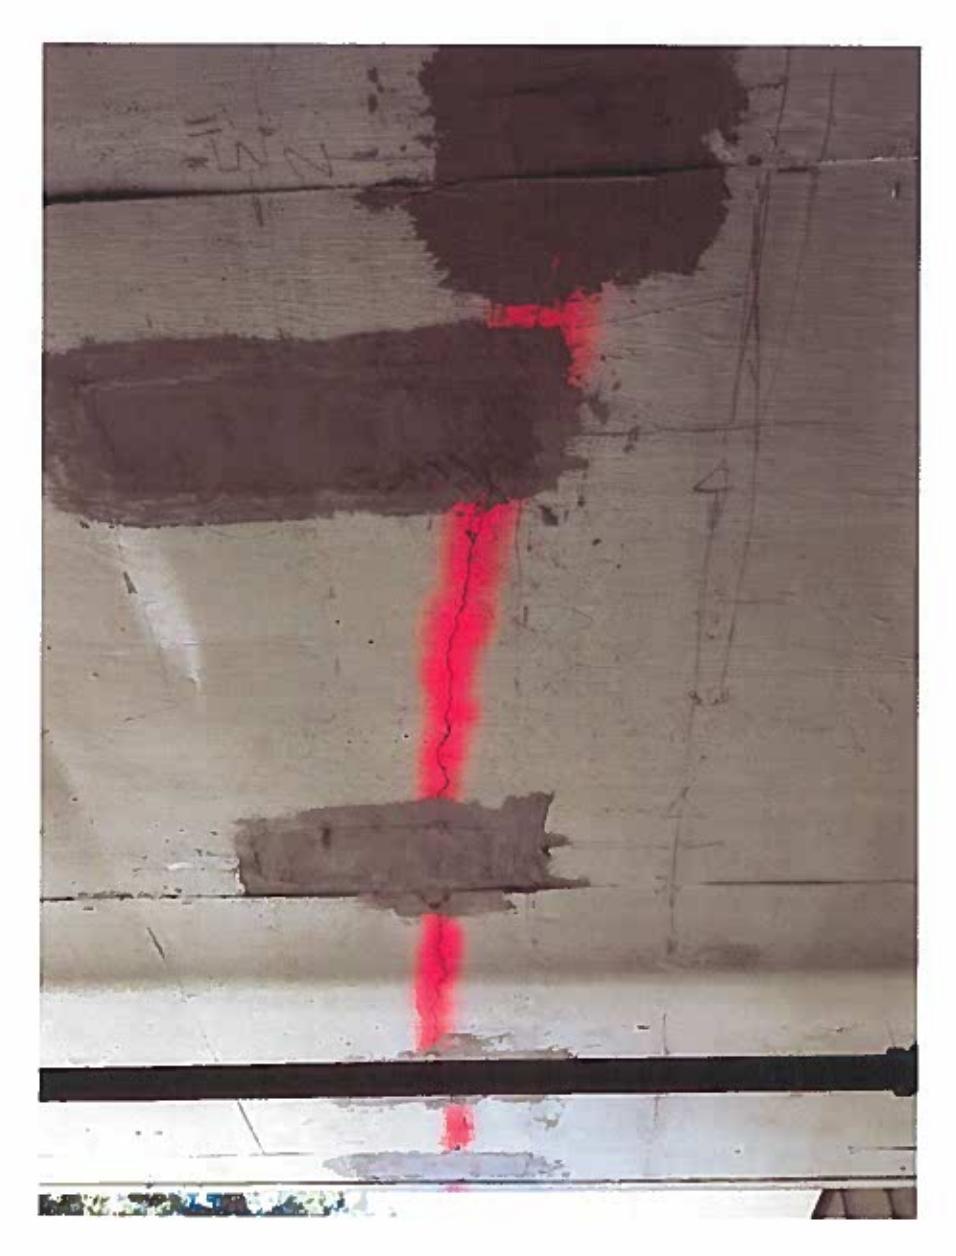
Photo 3 - Podium slab cracks along with chip and patch regions at gridline 2.5

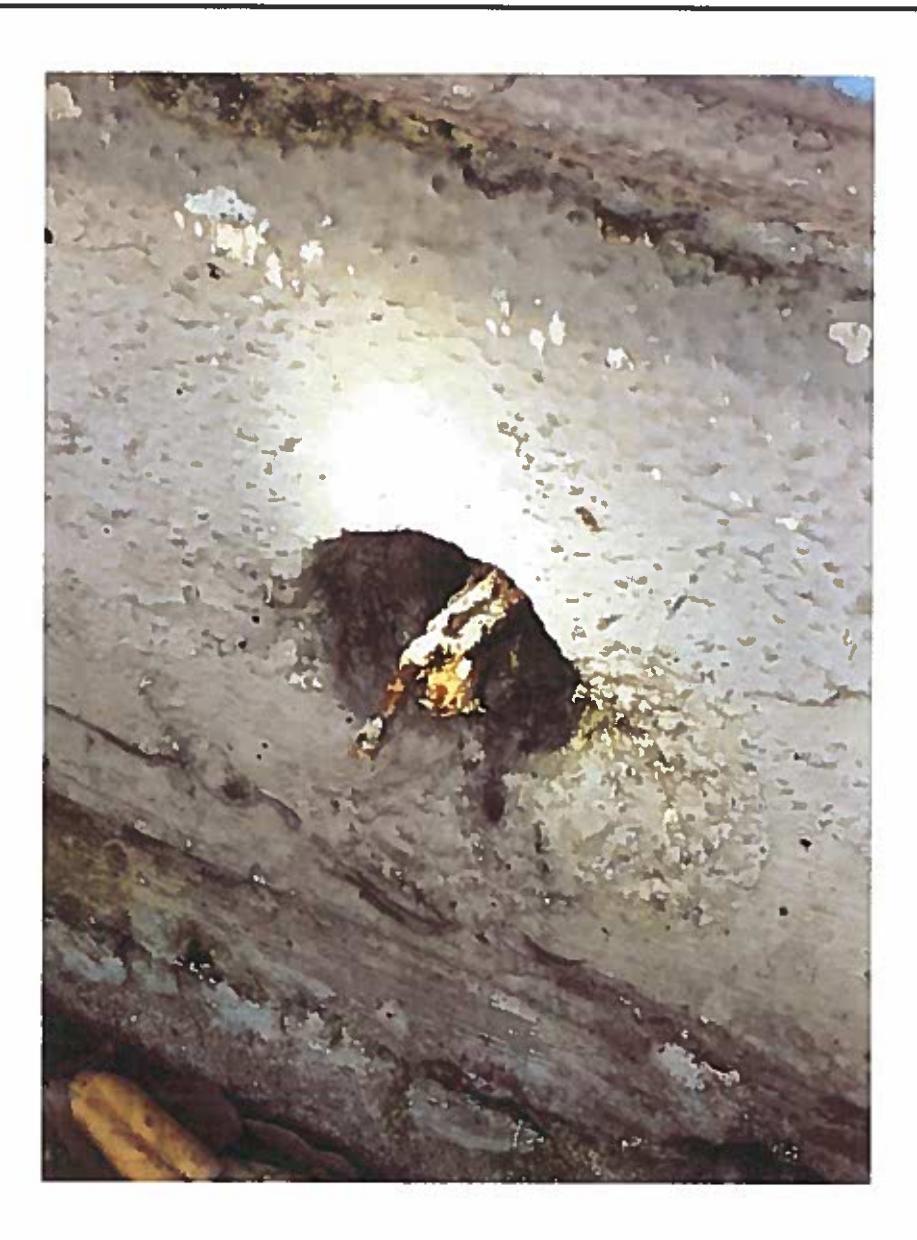
Photo 6 - Exposed P/T tendon showing signs of corrosion

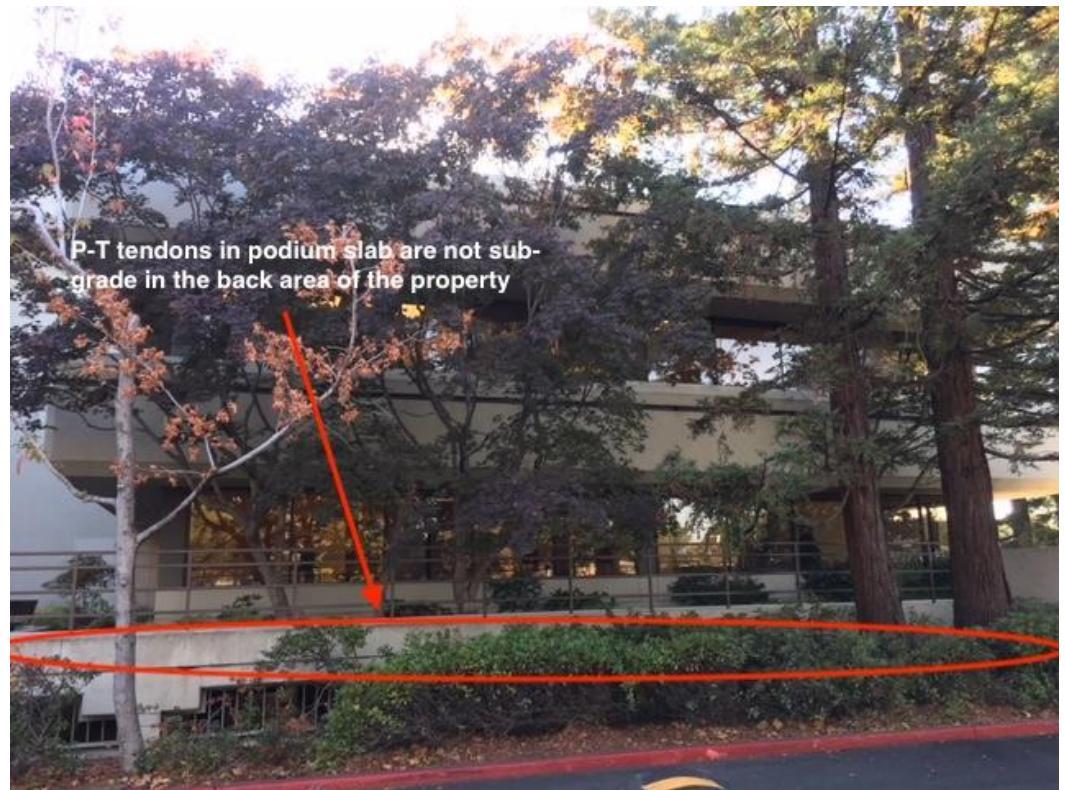
A-1.9 – View on the north side of the 1000 El Camino Real building showing that the Post tension (P-T) tendons are above grade, which is a different condition than in the front.

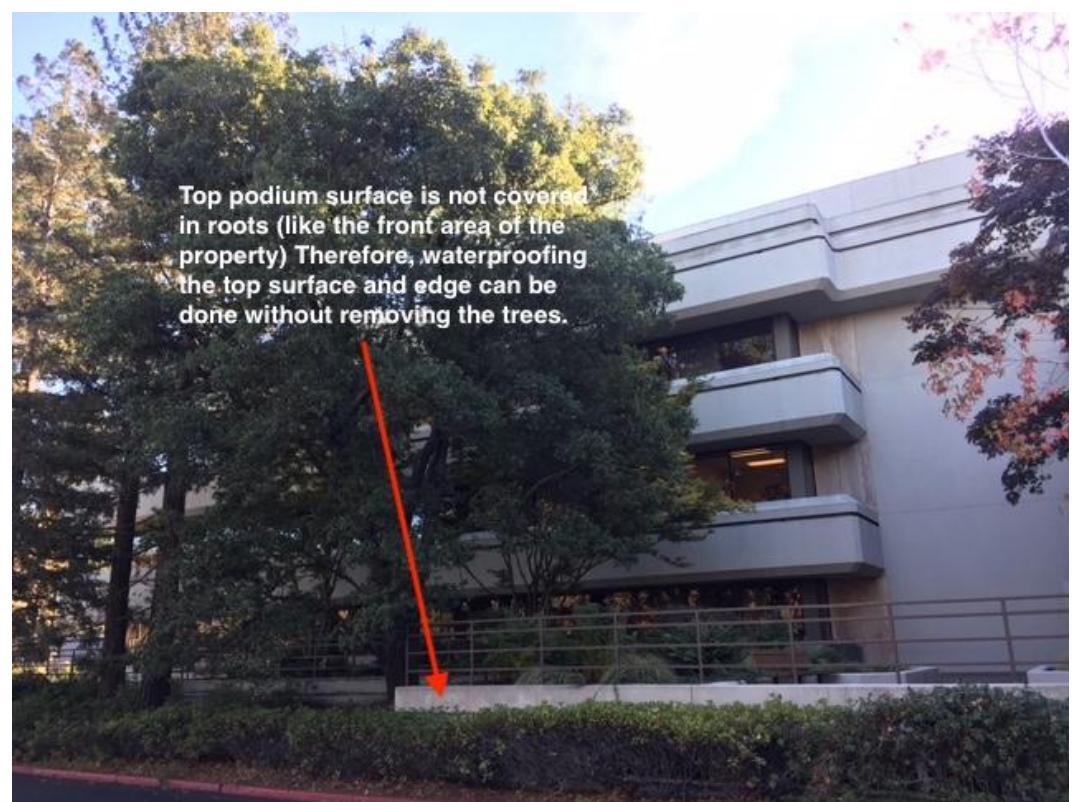
A-1.10 – View on the north side of the 1000 EI Camino Real building showing that the Post tension (P-T) tendons are above grade, which is a different condition than in the front.

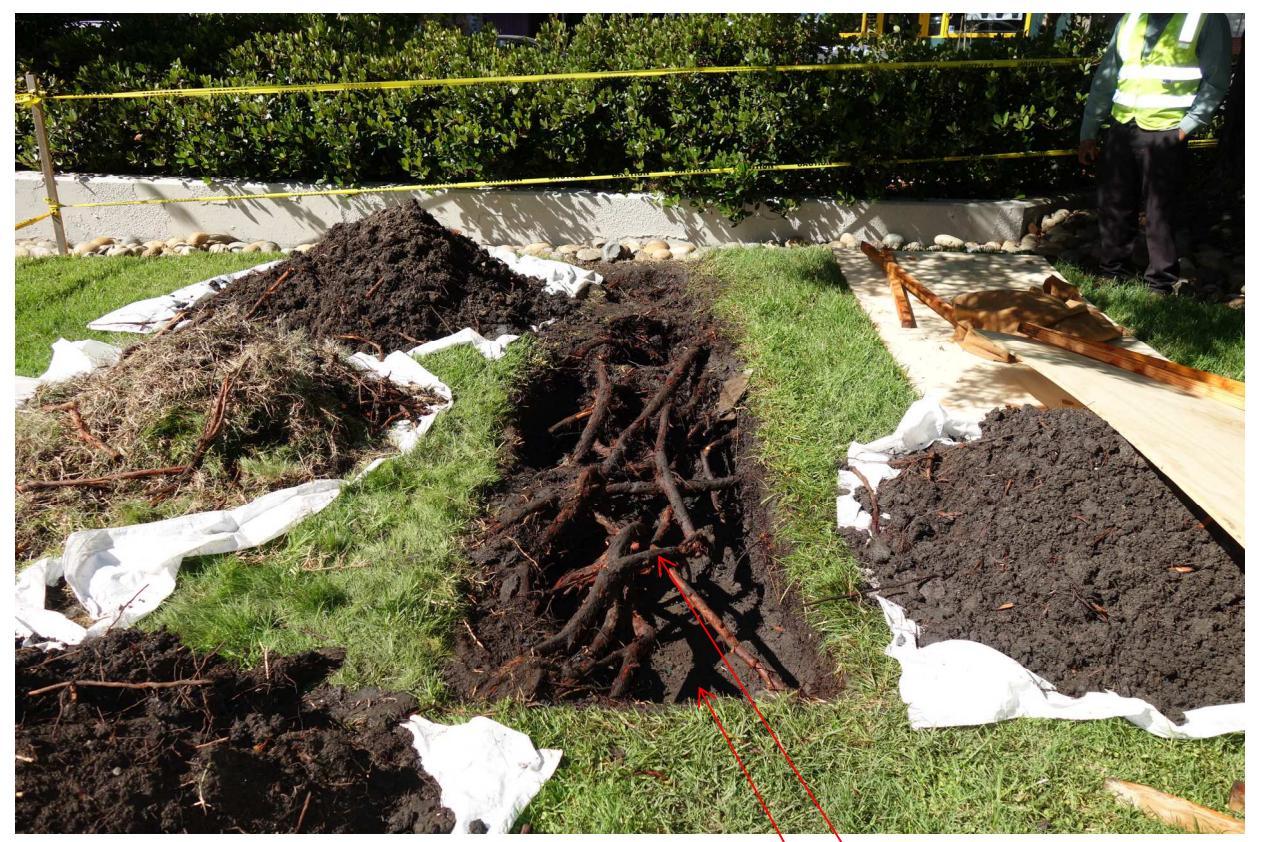
THICK TANGLE OF TREE - ROOTS OVER THE PODIUM AND UNDERGROUND GARAGE

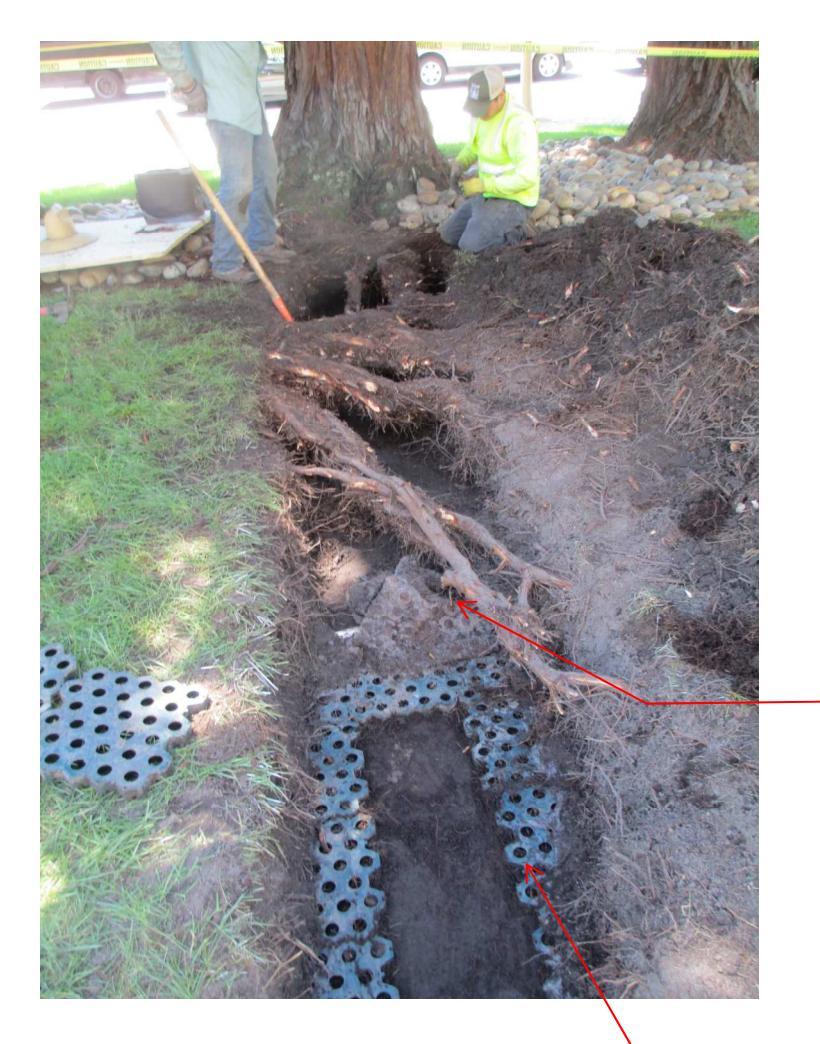
THICK TANGLE OF TREE ROOTS OVER THE PODIUM AND UNDERGROUND GARAGE
