PROJECT AND PURPOSE

- 1) To preserve and/or enhance the natural character of San Francisquito Creek by increasing the presence of native vegetation. This will improve habitat value, water quality, and bank stability – while protecting or improving creek conditions for state and federally listed species.
- 2) To stabilize banks in an environmentally sensitive manner that protects property and infrastructure, without significantly changing the conveyance of the creek.
- 3) To enhance the value of the creek as a community amenity by improving access to public areas, enhancing interpretive and education opportunities, and improving visual connections.
- 4) To develop a unified approach to implementation of the Plan that promotes consistency across jurisdictional boundaries and streamlines the permitting process for participating landowners.

This project is a multi-jurisdictional effort, intended to assist agencies and landowners' consultants in the planning, conceptual design and permitting of San Francisquito Creek stabilization and revegetation projects. The recommendations herein are based on analyses of site conditions by a multidisciplinary team that has considered the entire cr

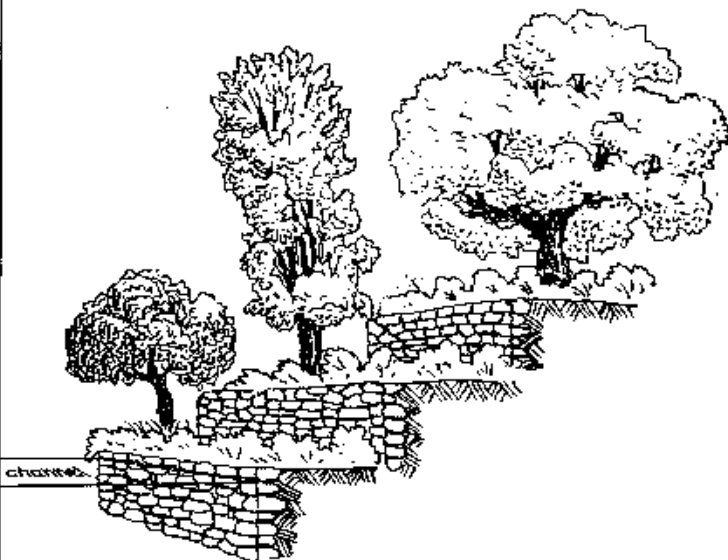
Multiple retaining walls
