**SPECIAL MEETING MINUTES**

# HERITAGE TREE APPEAL-1000 EL CAMINO REAL

# 1000 El Camino Real Podium Slab Rehabilitation

# 1000 El Camino Real

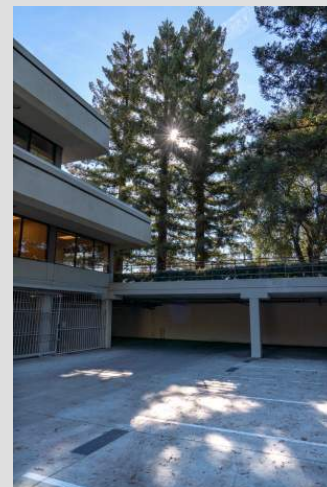
Photo 6 - Exposed P/T tendon showing signs of corrosion

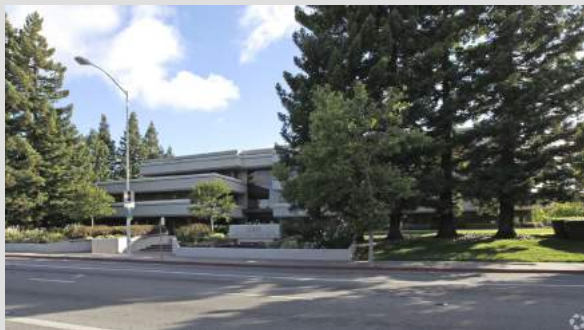
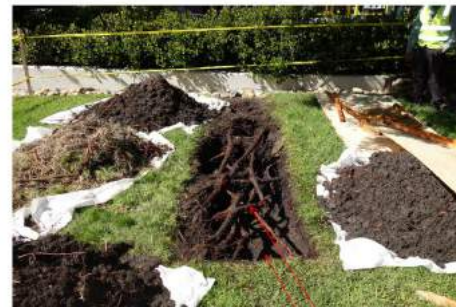
- Repair work and installation of waterproof barrier would occur within major root zone of seven coast redwood trees
- Root removal within three times the diameter of a tree impacts stability/safety and is not recommended by standard arboricultural practices

THICK TANGLE OF TREE  
ROOTS OVER THE PODIUM  
AND UNDERGROUND GARAGE  
PODIUM SLAB WATERPROOFING

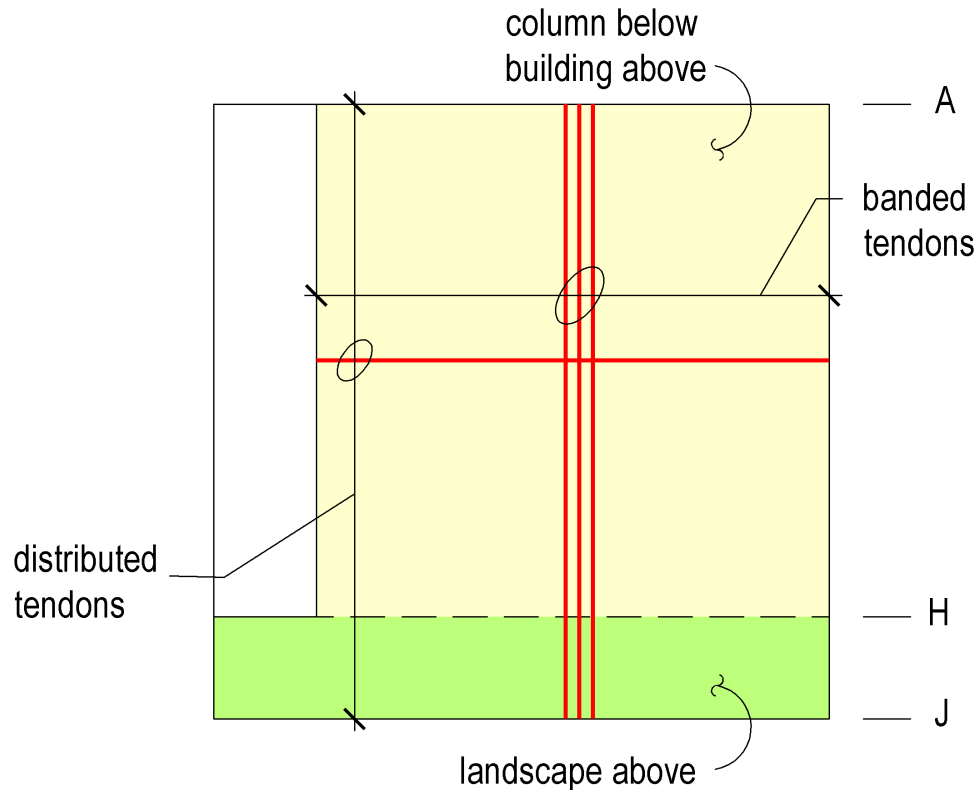
simplified schematic of the podium slab

Podium slab is post-tensioned  
The same podium slab  
**supports both** the  
**building and landscaped**  
area

- ❖ The slab strength is provided by tendons that run **through the entire length** of the slab; up-down and left-right;
- ❖ Tendons used act like stretched **ropes**; once severed at one point, the rope becomes ineffective;
- ❖ The tendons used were **not meant for corrosive environment**;
- ❖ Breach of water proofing below the landscaping has **damaged several tendons in landscaping region**. This results to the reduction/loss of force over the entire tendon length.
- ❖ The cursory observation of the podium slab leads to the conclusion that the **region below the building is in reasonably good and serviceable condition**.

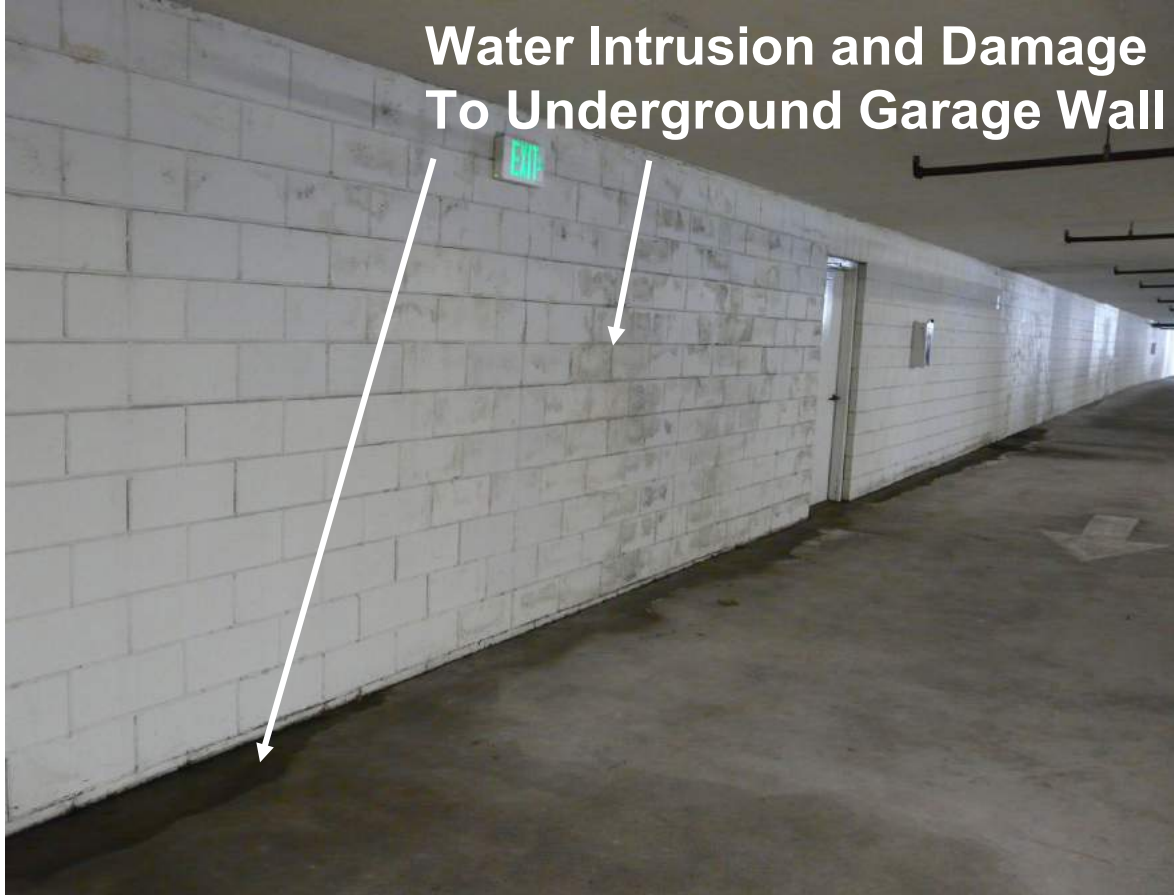
**Water Intrusion and Damage  
To Underground Garage Wall**

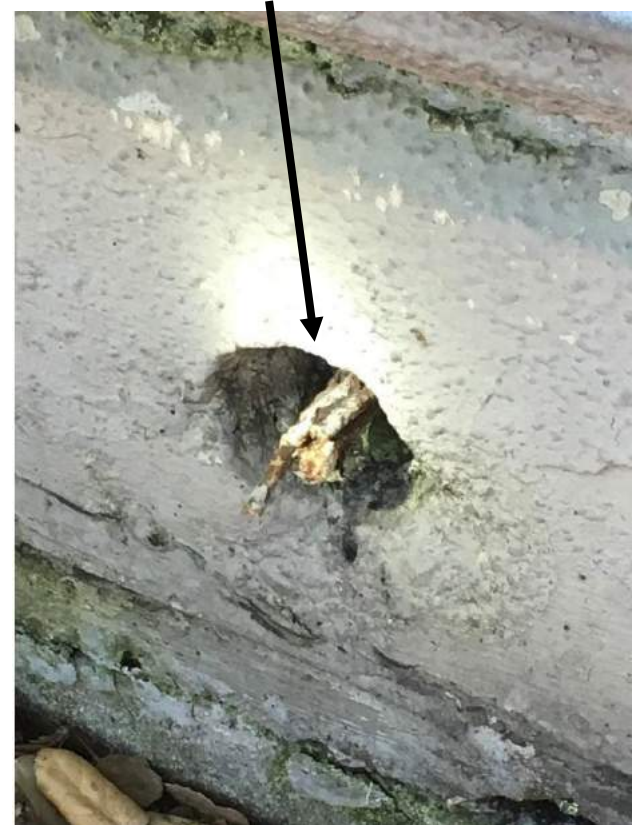
**Post-tensioned  
cable corroded**

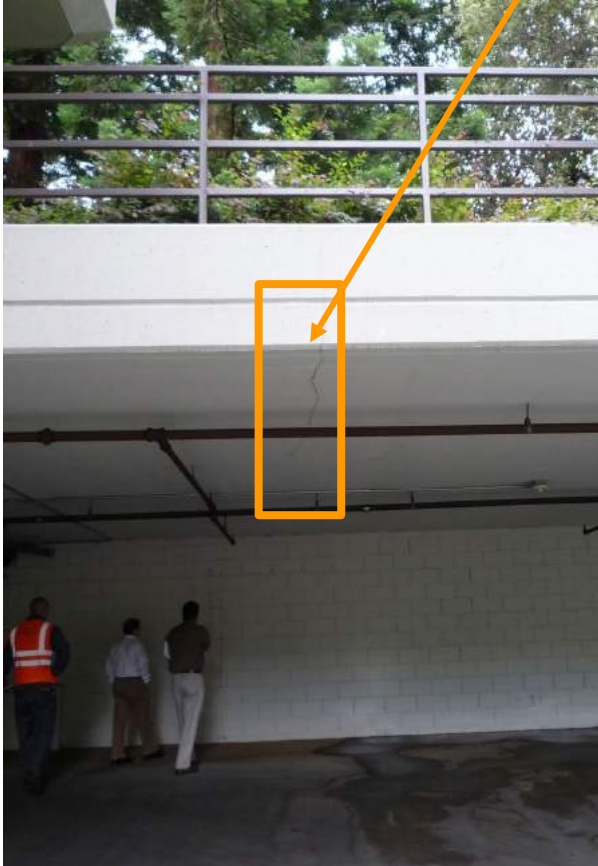
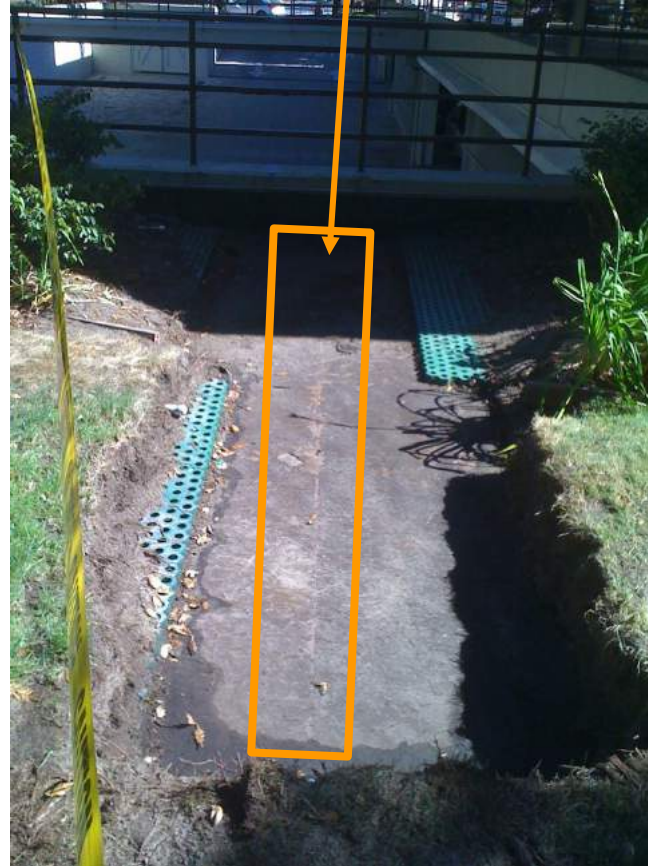
# CRACKS VISIBLE IN WATERPROOFING AND CONCRETE PODIUM SLAB

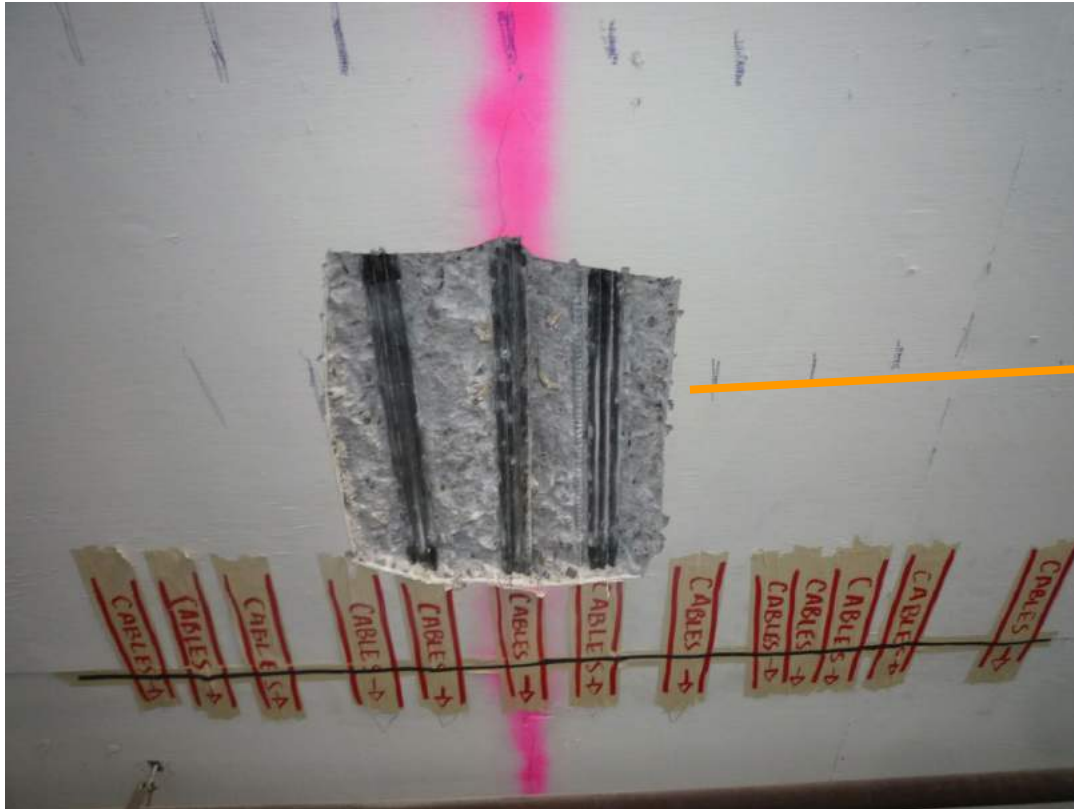
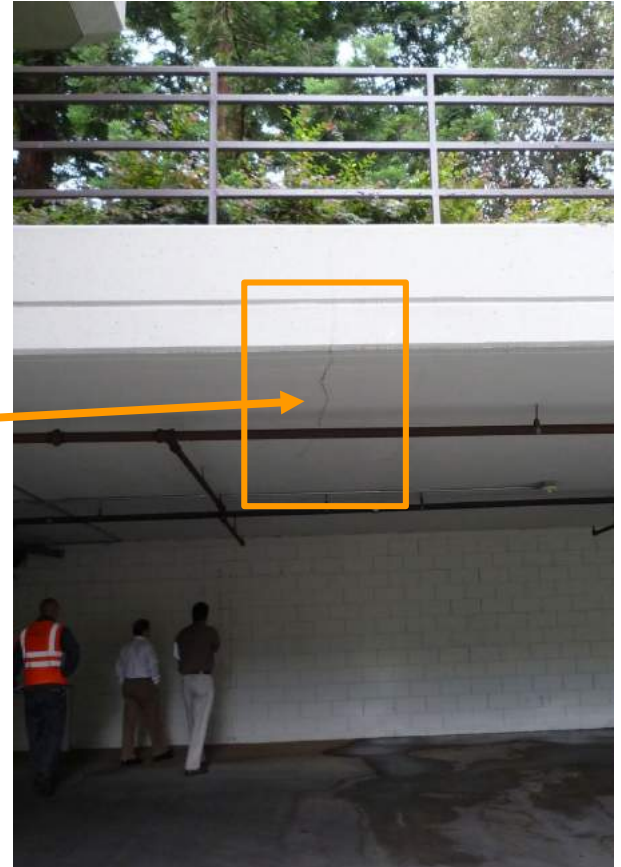
# Area with failed tendons

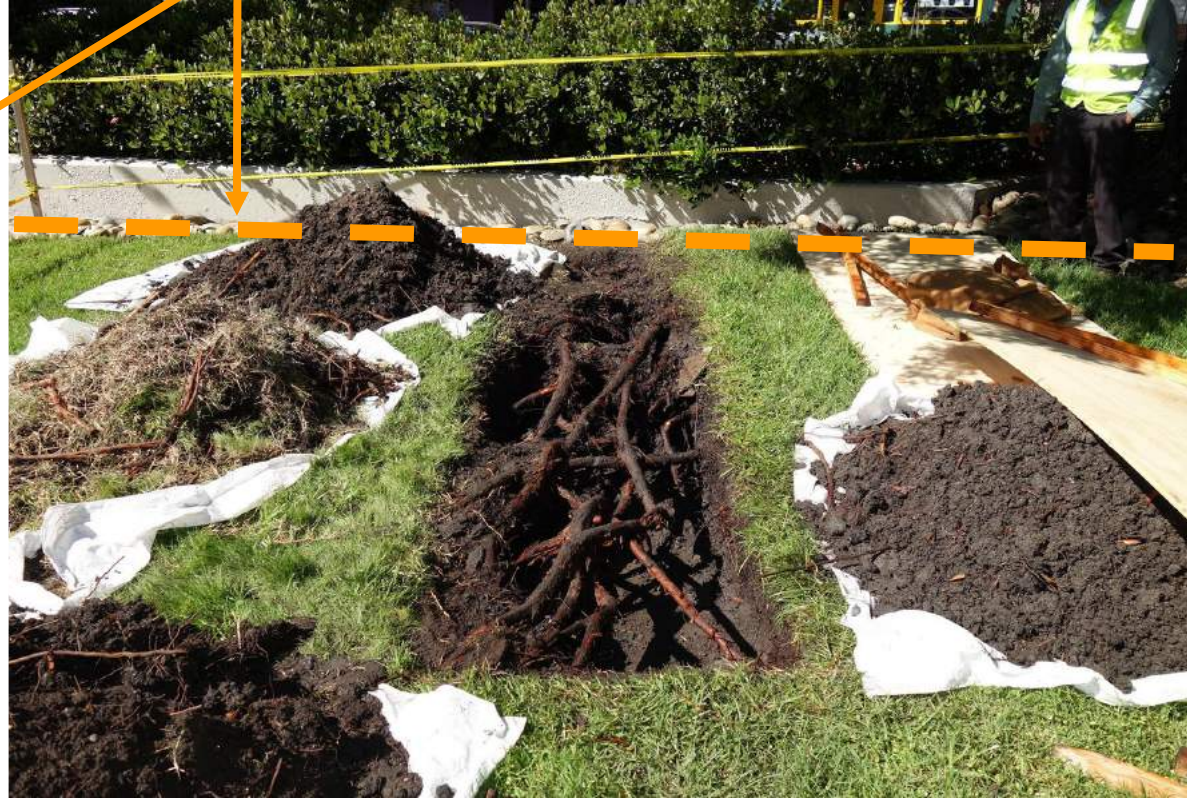
# Underground Garage Edge

**Waterproofing Failed**

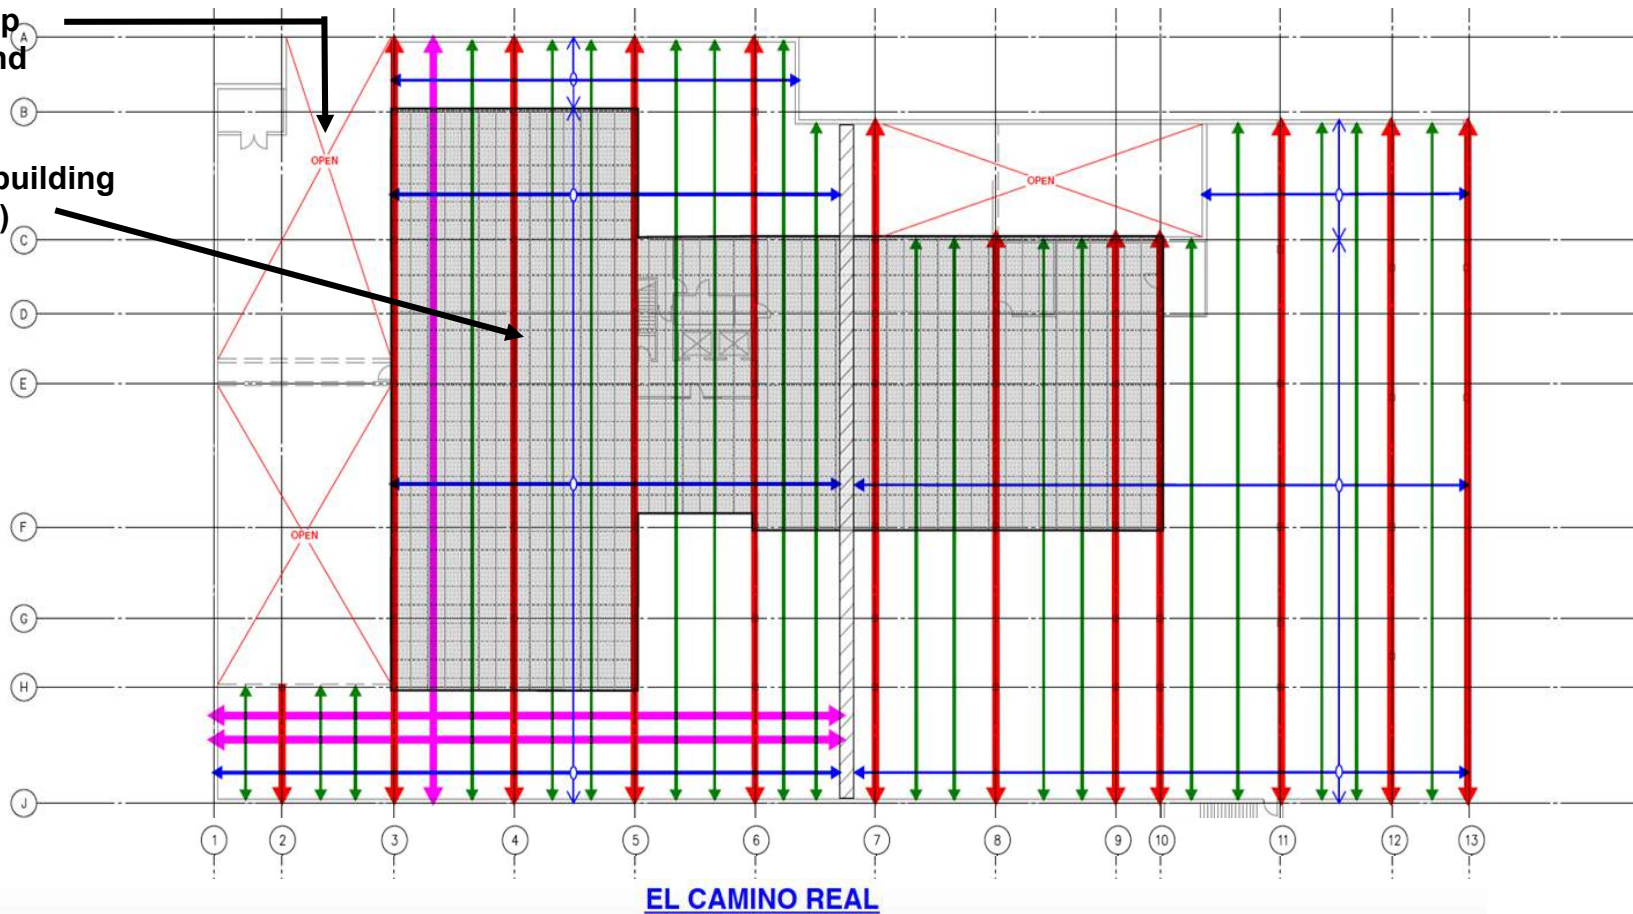
# Post-Tensioned Cable Podium Slab

Known Broken Post-tension Cables
-

Other Existing Post-tension Cables

Entrance Ramp  
to Underground  
Garage

Footprint of building  
(shaded area)

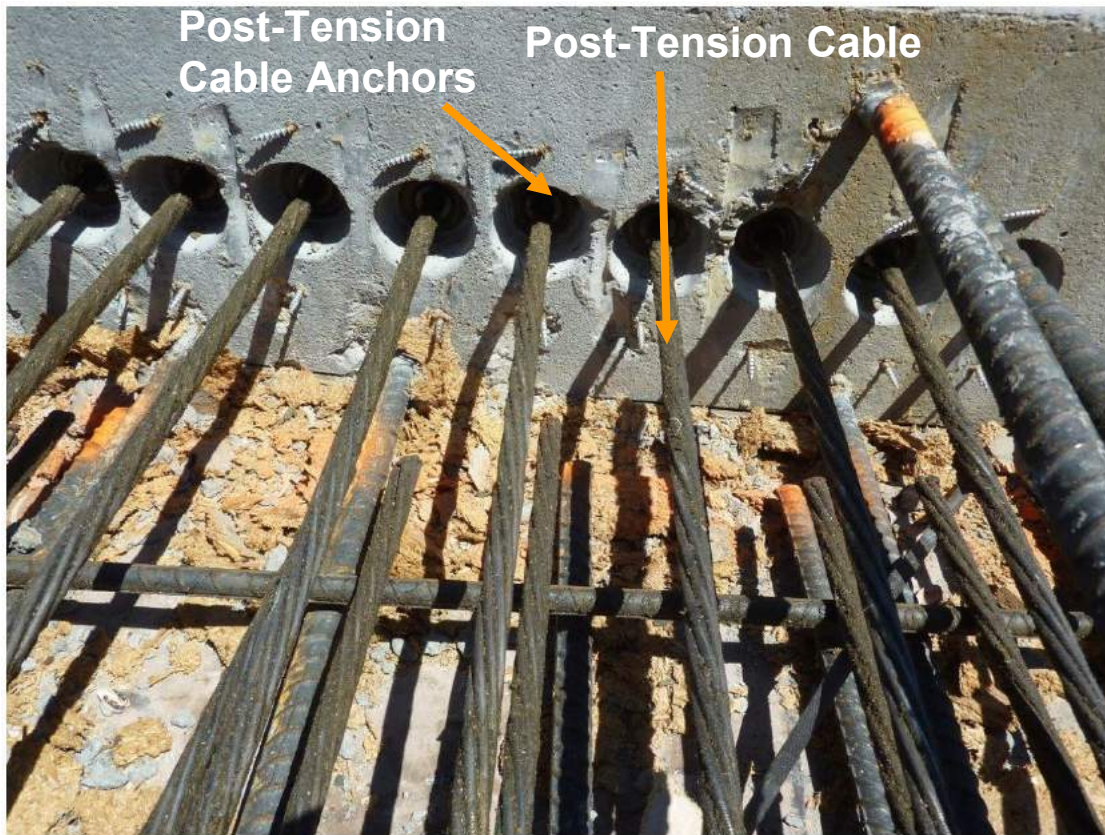
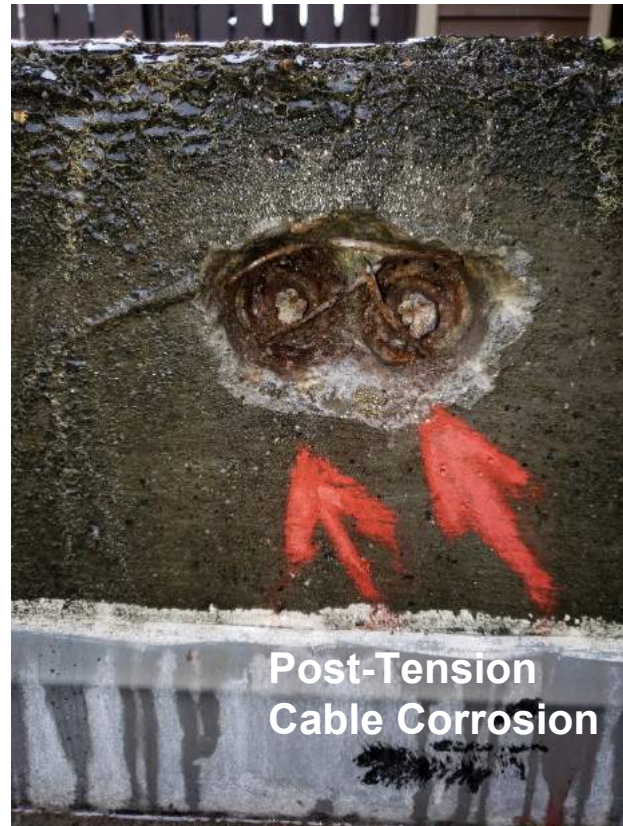
# Post-Tensioned Cables and Corrosion Examples

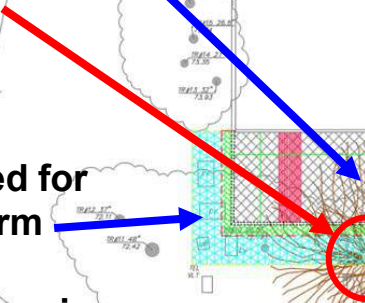
Tree Roots

Primary Root Zones needs to be protected

Trenches needed for access to perform structural and waterproofing repairs

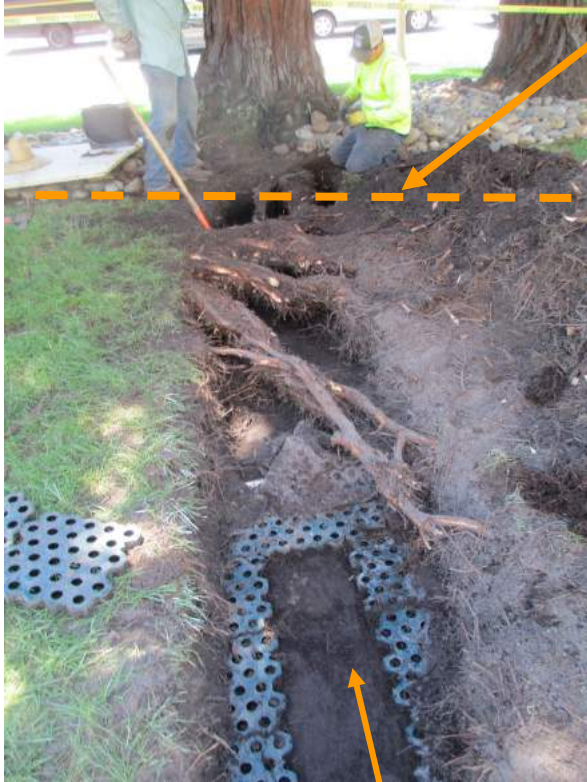
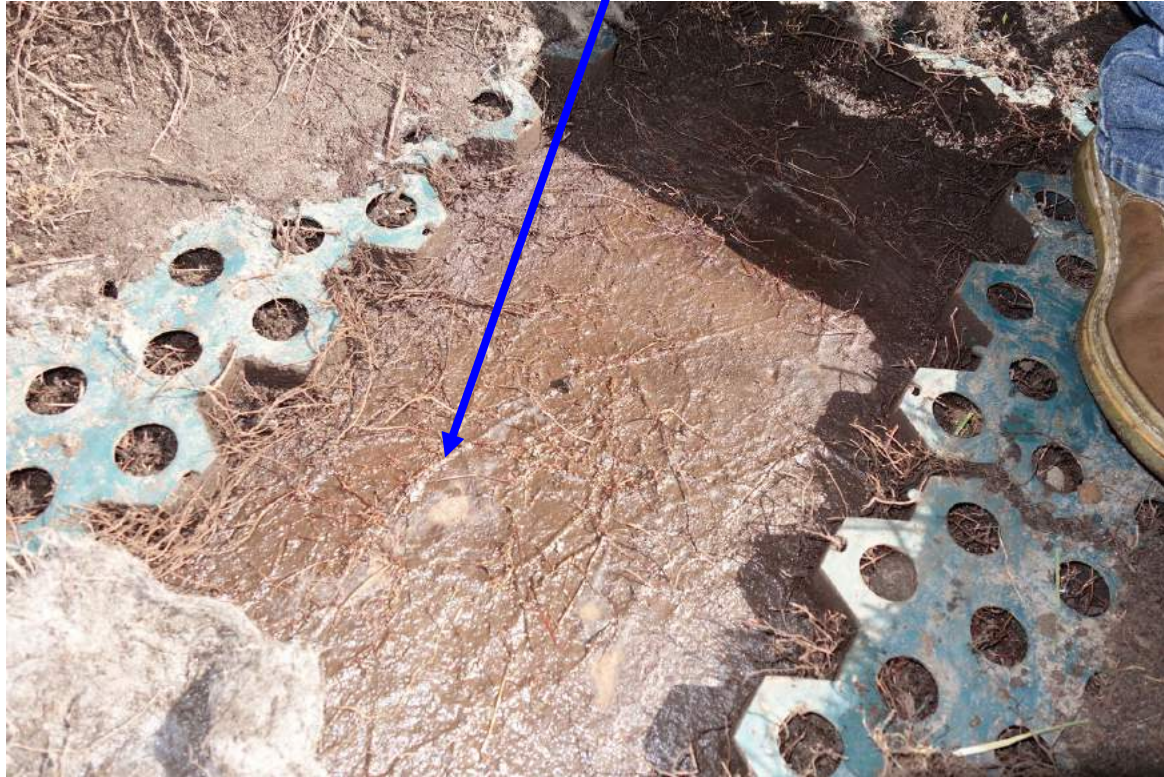
**Underground  
Garage Edge**

**Roots Under Damaged  
Waterproofing**

**WATERPROOFING  
FAILED**

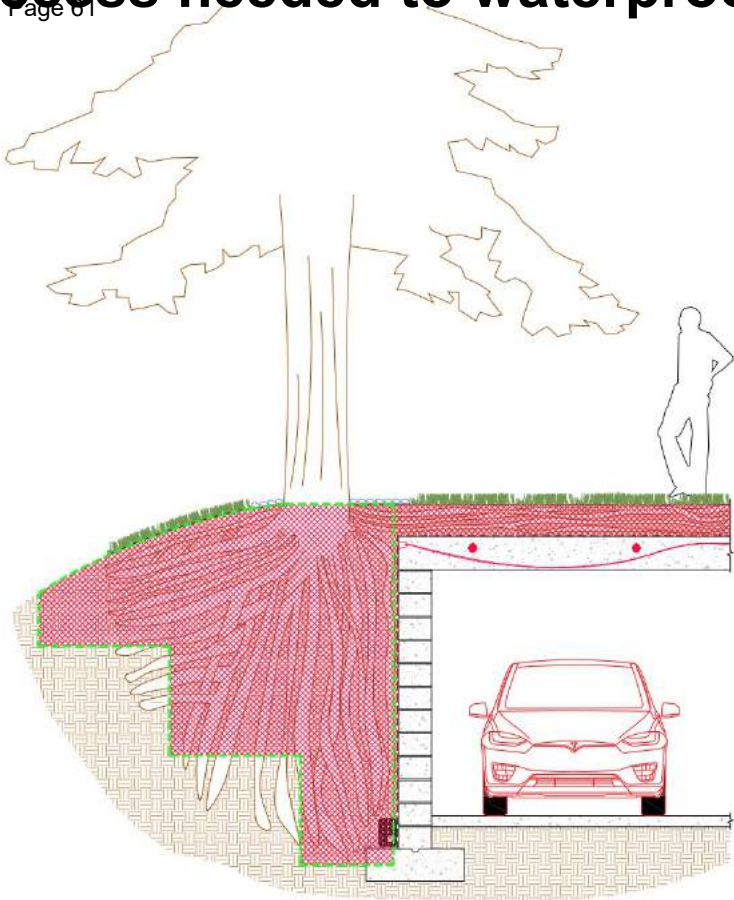
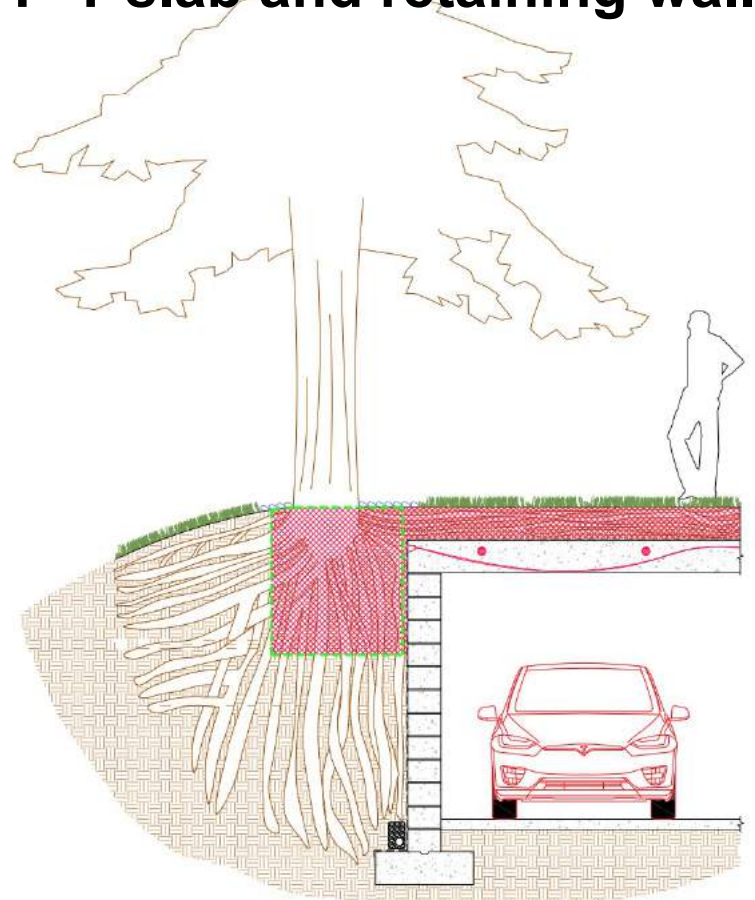
# Access needed to waterproof the P-T slab and retaining walls

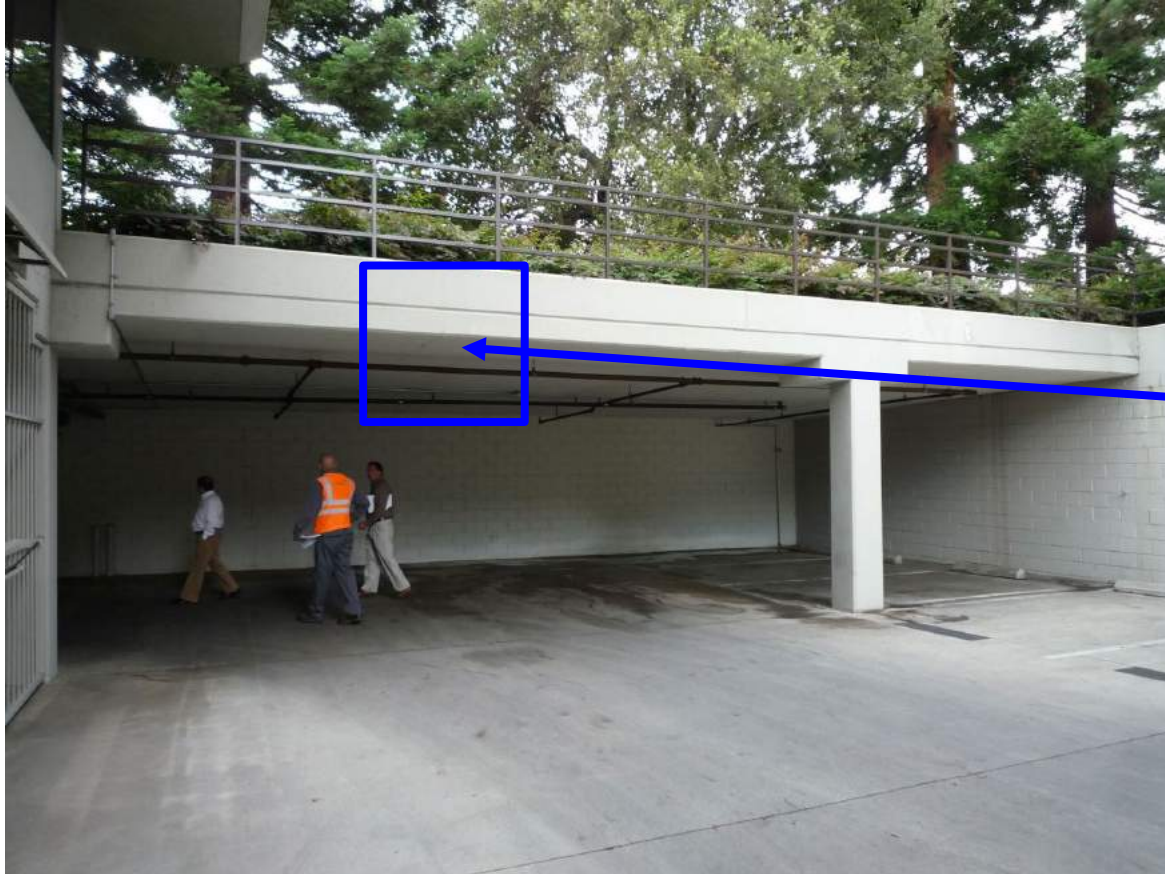
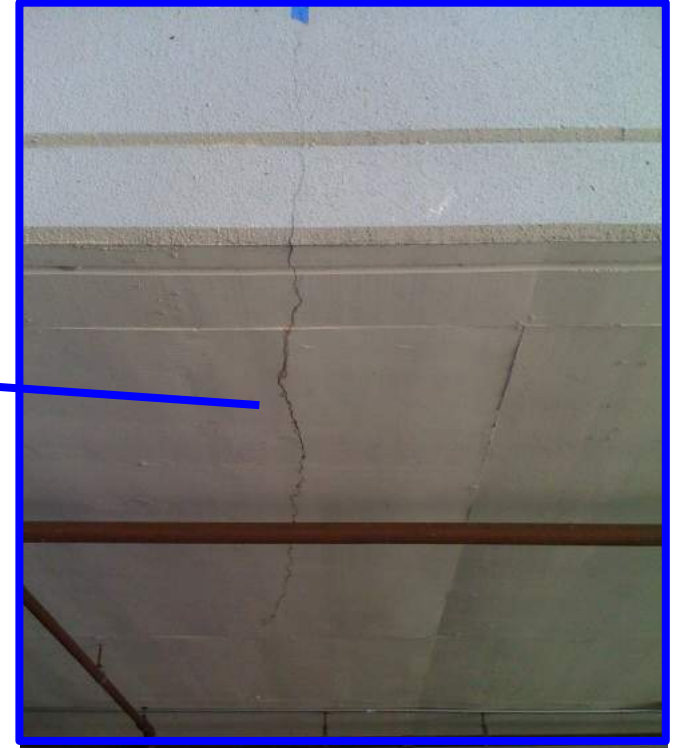
# First noticed cracks and water intrusion

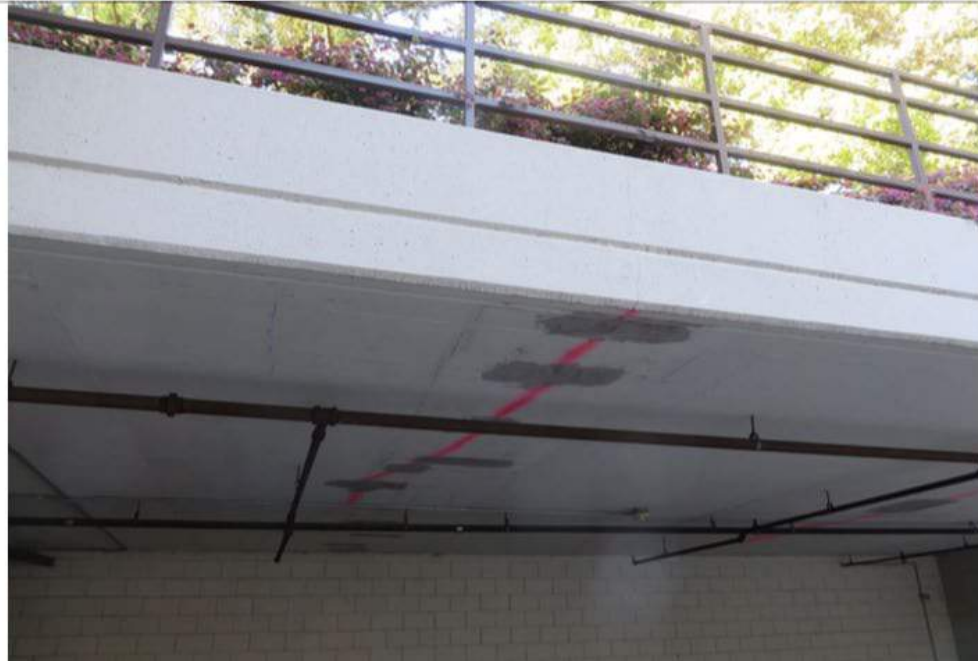
**WE KNEW OF 2 BROKEN TENDONS IN 2014-2015. 1 MORE BROKEN TENDON IN LAST 3 WEEKS. THERE WILL BE MORE**

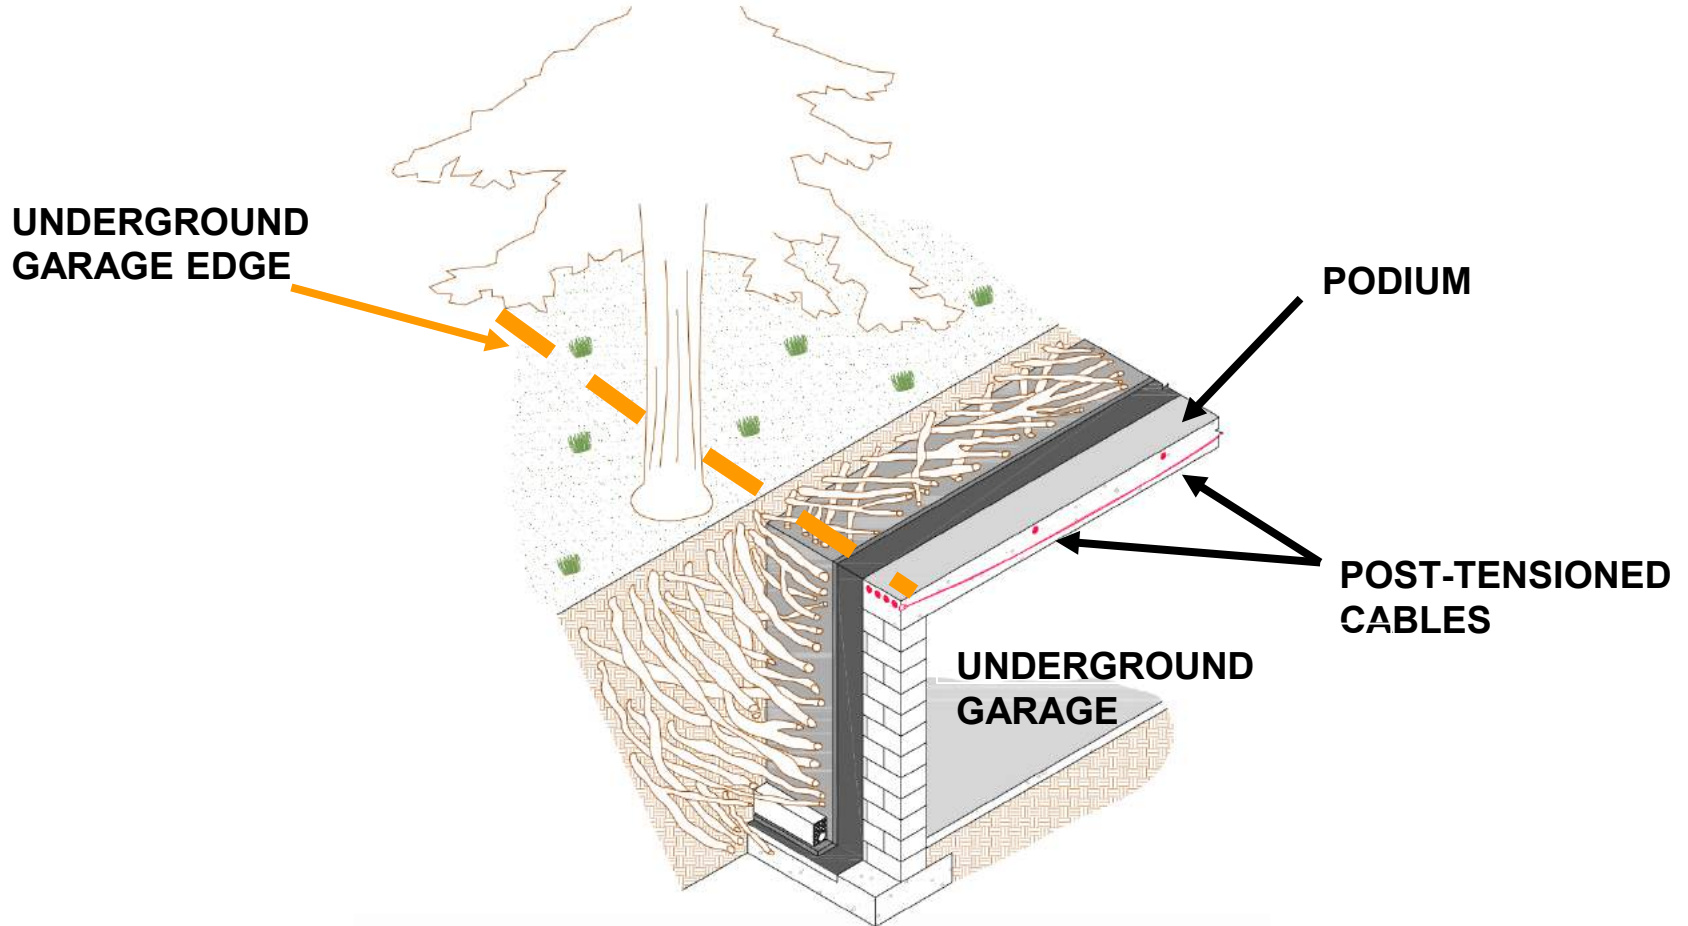
**WATER INTRUSION AND DAMAGE TO UNDERGROUND GARAGE WALL**

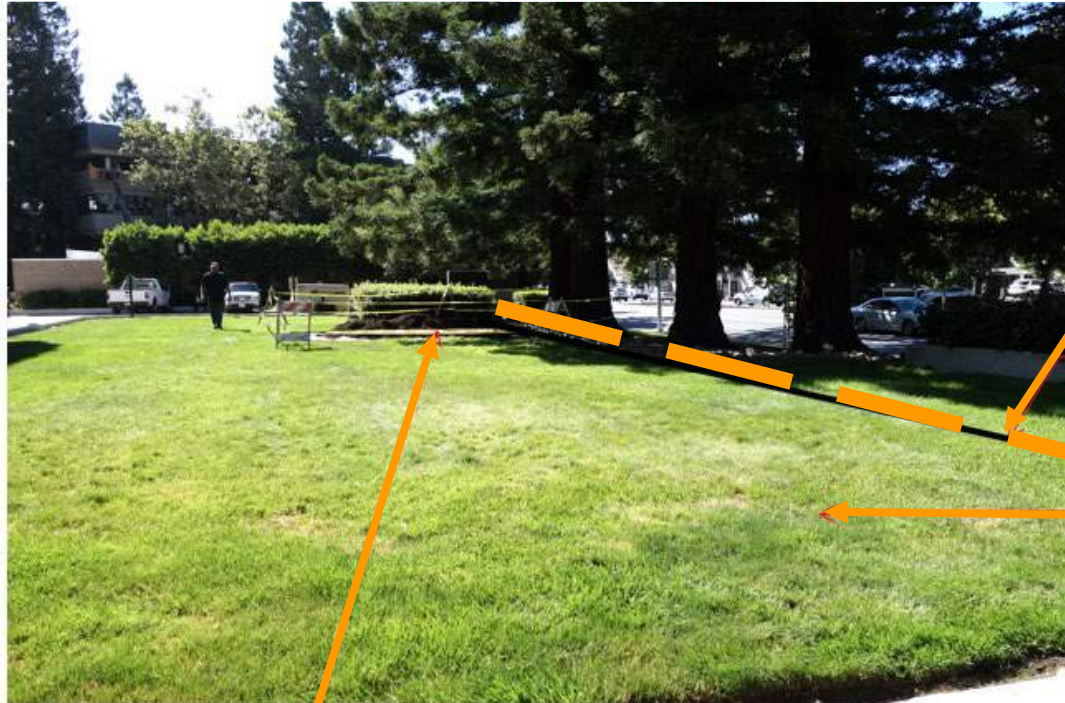
**UNDERGROUND  
GARAGE EDGE**

**PODIUM**

**AREA OF  
EXCAVATION**

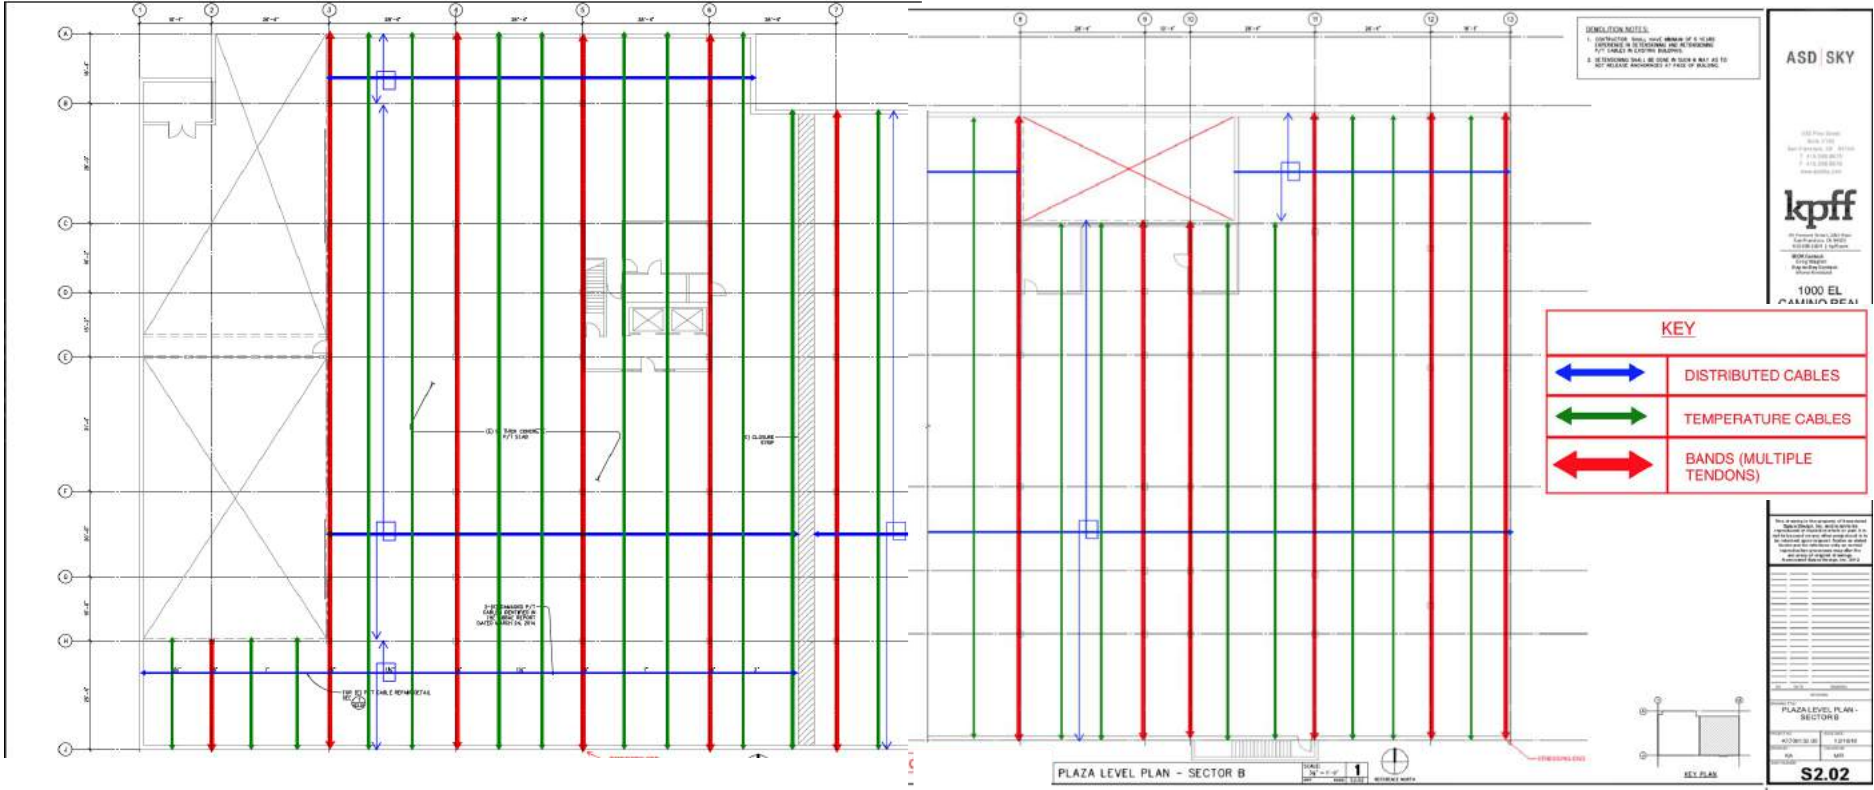
# POST-TENSION CABLES AT 1000 EL CAMINO REAL

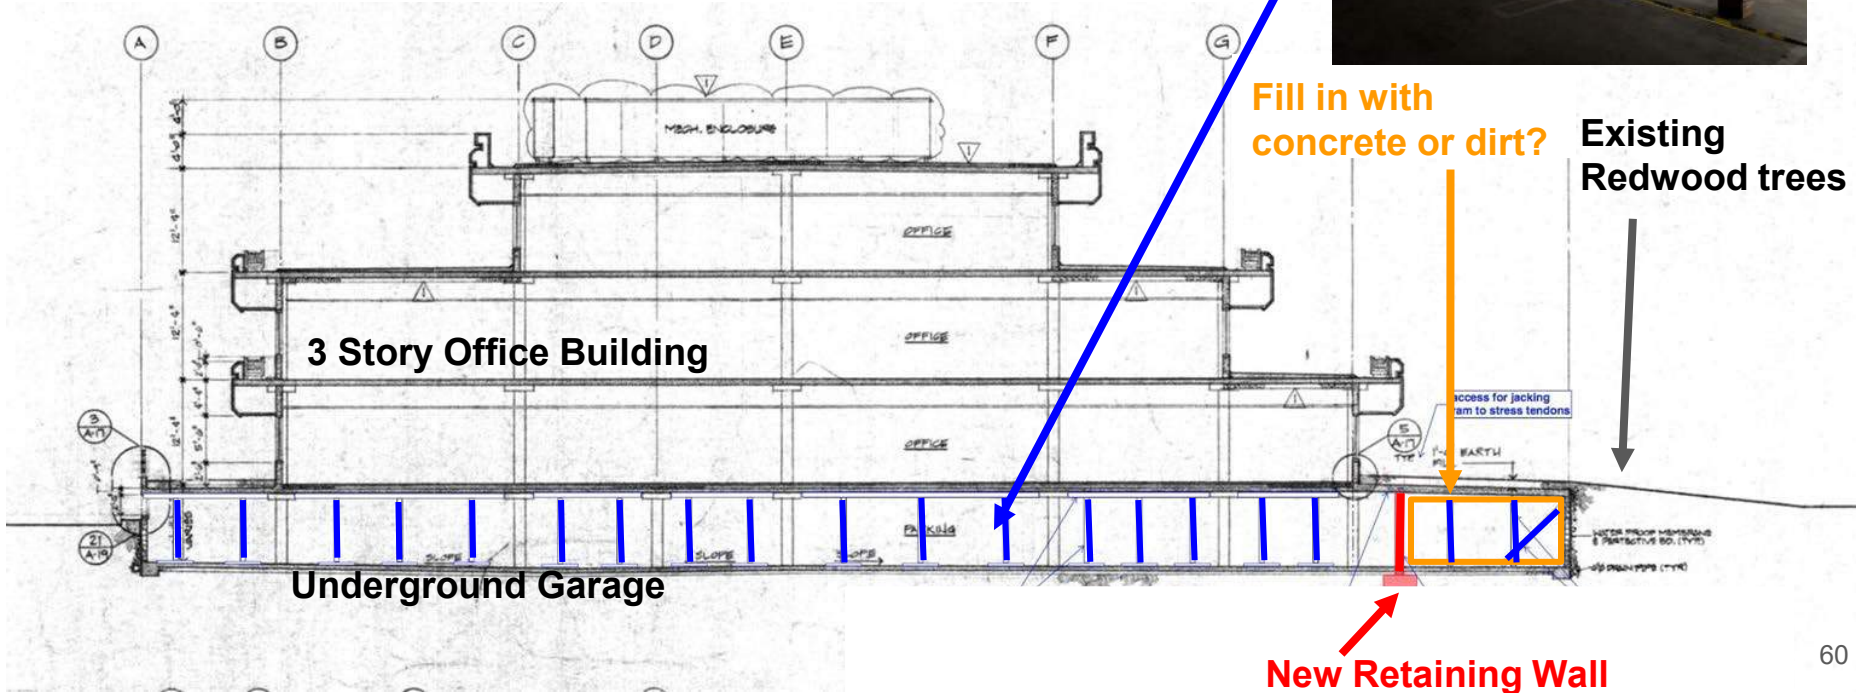
Appellant's suggestion of Saw-cutting Podium Slab and relocating the cables with a new retaining wall within the garage

- **Not industry best practices**
- **Inherently unsafe**
- **Involve extreme risk to the structural integrity of the building**
- **Work is sufficiently dangerous that the tenants must completely vacate the premises for two months**

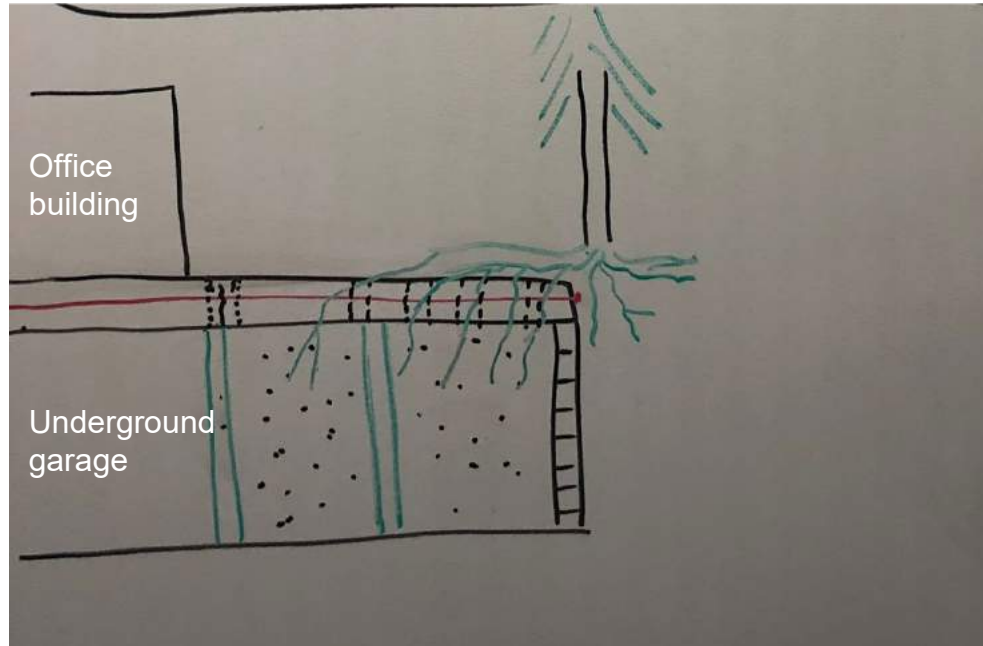
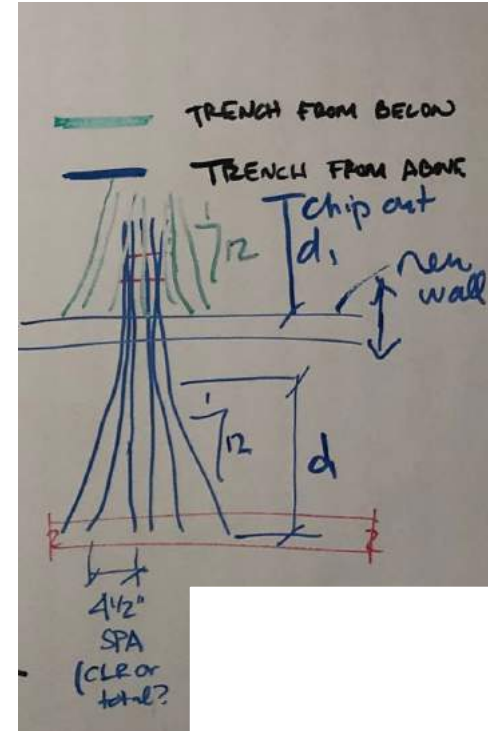
P/T Tendons

Appellant's suggestion of Saw-cutting Podium Slab and relocating the cables with a new retaining wall within the garage
