Environmental Quality Commission

REGULAR MEETING AGENDA

Regular Business: Overview of the Facebook Campus Expansion Project, the Draft Environmental Impact Report (EIR), and Consideration of a Recommendation to the Planning Commission and City Council on a Request to Remove 274 Heritage Trees at 301-309 Constitution Drive

Buildings 21, 22 & Hotel Site
 301-309 Constitution Drive, Menlo Park, California
 Gehry Partners, LLP

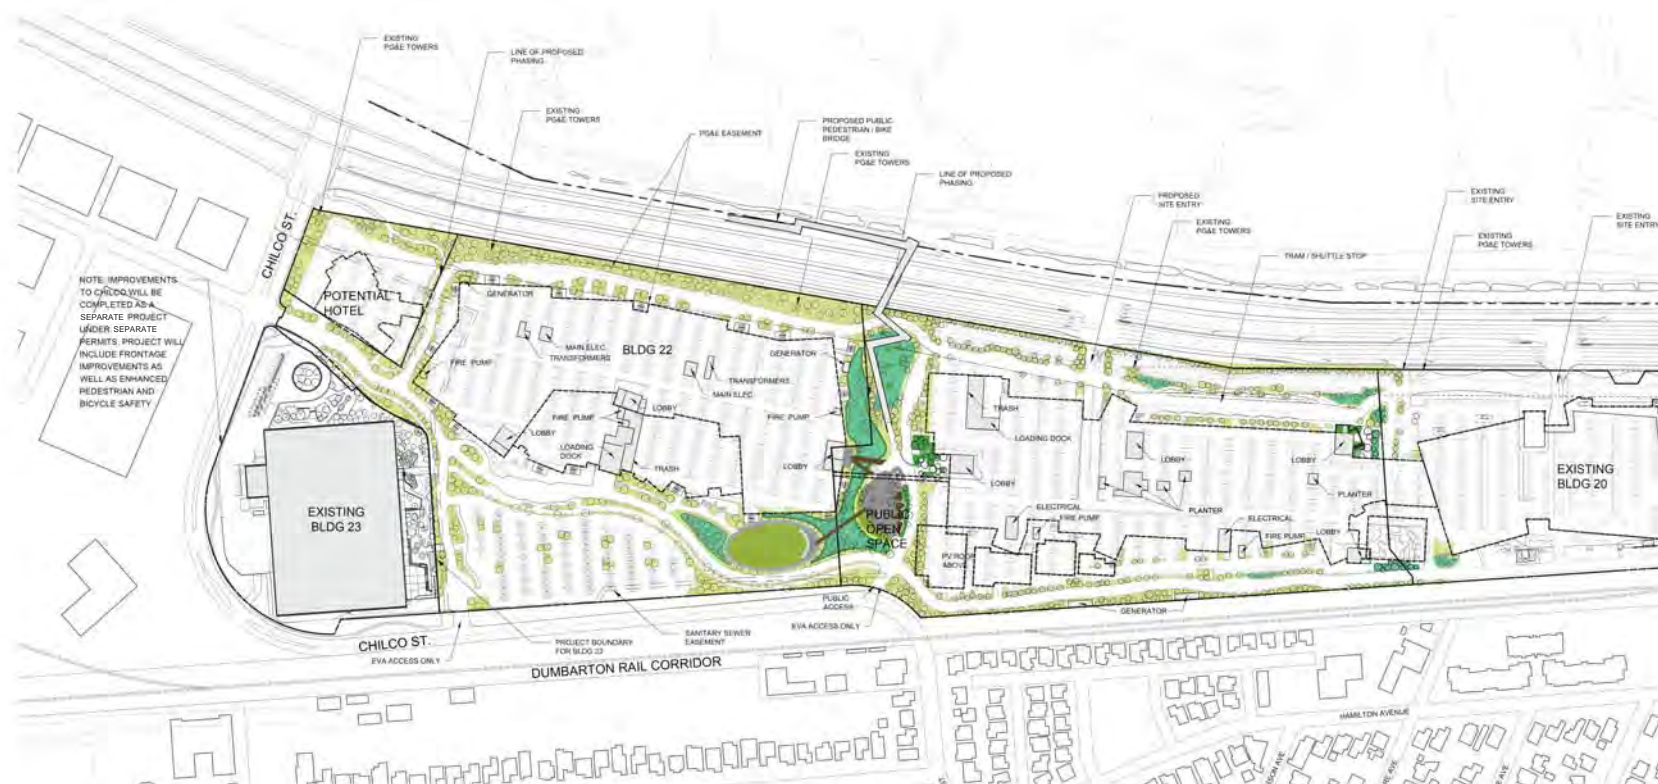
TOTAL VEHICLE PARKING	BLDG 21	BLDG 22	BLDG 23	POTENTIAL HOTEL	TOTAL
REGULAR STALLS : 8'-6" X 16' - 6"	1403	1228	490	230	3351
ENERGY EFFICIENT VEHICLE STALLS (EEV) : 8'-6" X 16' - 6"	44	39	16	7	106
ADA COMPLIANT VEHICLE STALLS : 9'-0" X 18' - 0" (W/ 5'-0" ACCESS AISLE)	25	23	10	7	65
ADA COMPLIANT VAN STALLS : 9'-0" X 18' - 0" (W/ 8'-0" ACCESS AISLE)	4	4	2	1	11
TOTAL VEHICLE PARKING	1476	1294	518	245	3533
BICYCLE PARKING	190	160	30	12	392

The project would provide 3,533 parking spaces for both the office buildings and hotel. The office uses would have 3,288 spaces, which is a ratio of one space for every 348 square feet of gross floor area. The proposed parking ratio would deviate from the Zoning Ordinance standard of one space for every 300 square feet of gross floor area, which can be permitted through the conditional development permit for the Project. The hotel would have approximately 245 spaces, which according to the applicant represents one space per each room and employee. The parking ratio for the hotel would exceed the Planning Division's recommended use based guidelines, which is 1.1 spaces per hotel room. The parking would be located in surface parking lots, and the proposed new office buildings would be located over the surface parking, consistent with the Building 20 design.

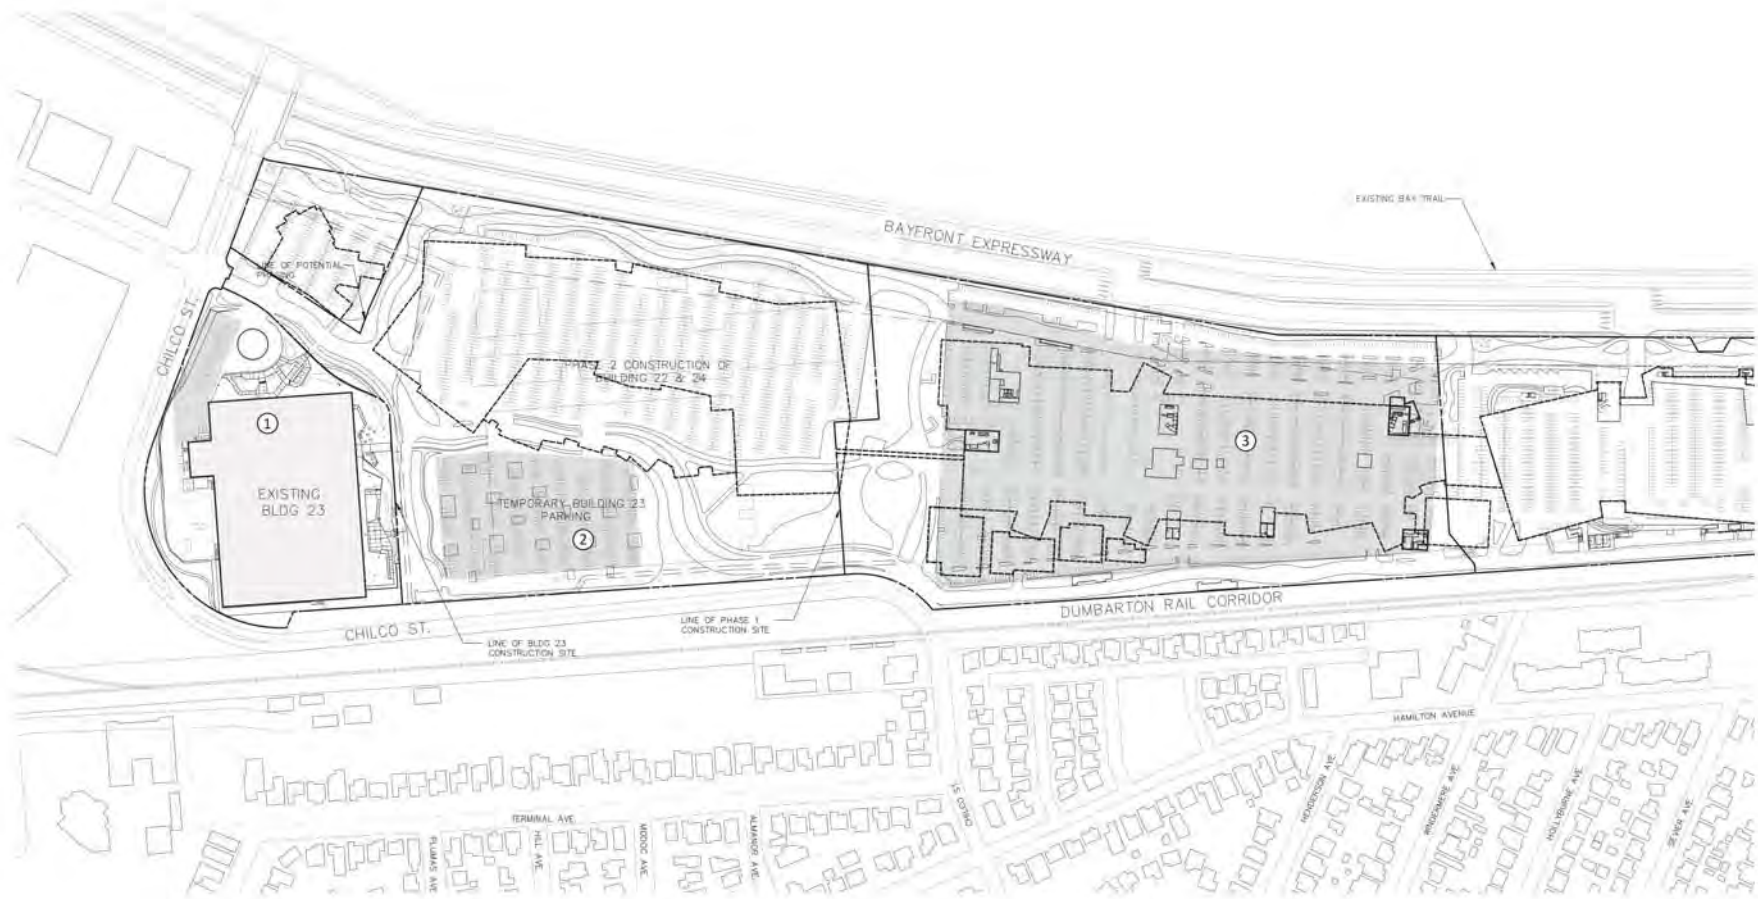
PARKING FOR BUILDING 23 DURING PHASE 2 CONSTRUCTION

NUMBER OF SPACES
1 - BUILDING 23	57
2 - TEMPORARY BUILDING 23 PARKING	282
3 - BUILDING 21 SITE	1,476
TOTAL	1,822

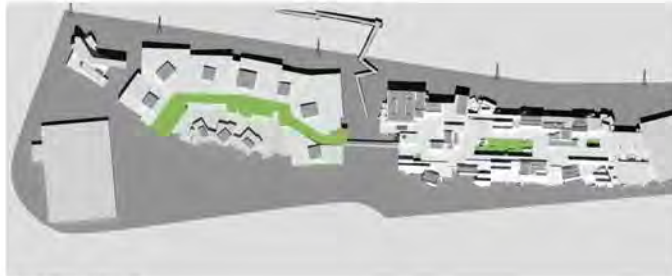
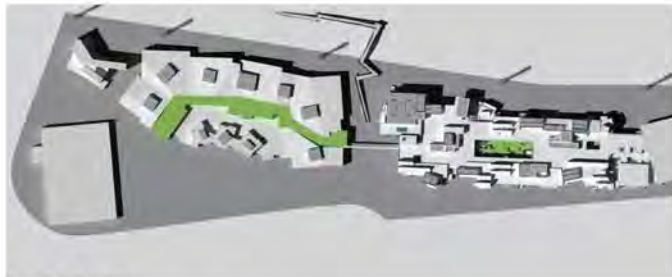
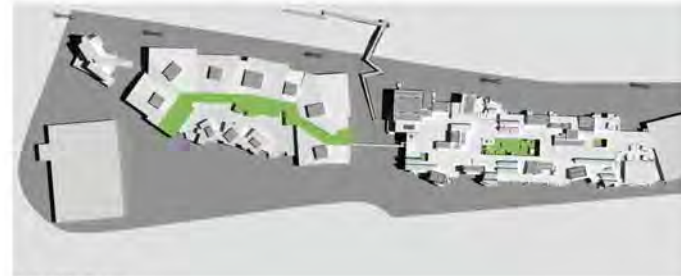
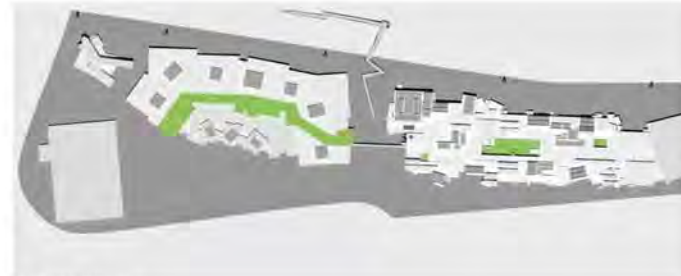
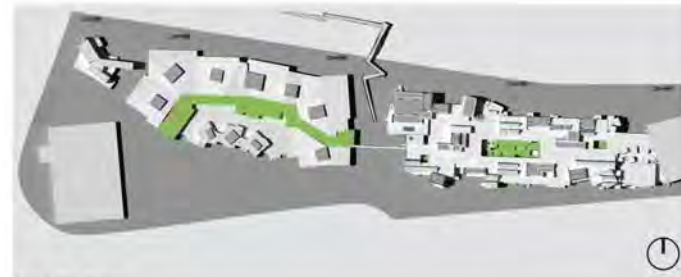
Spring Equinox (March 20) Shadows

March 20, 9 am

March 20, 12 pm

March 20, 3 pm

Summer Solstice (June 21) Shadows

June 21, 9 am

June 21, 12 pm

June 21, 3 pm

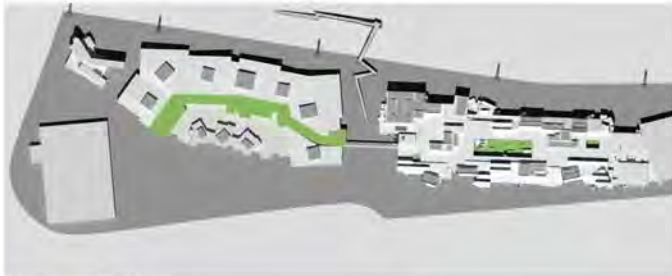
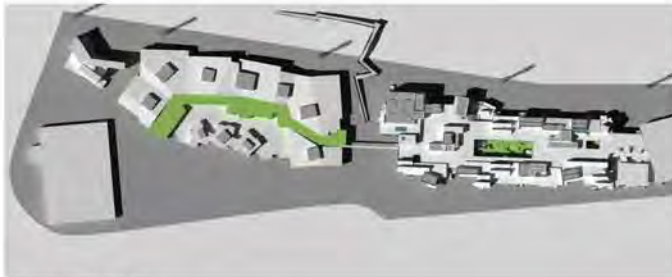
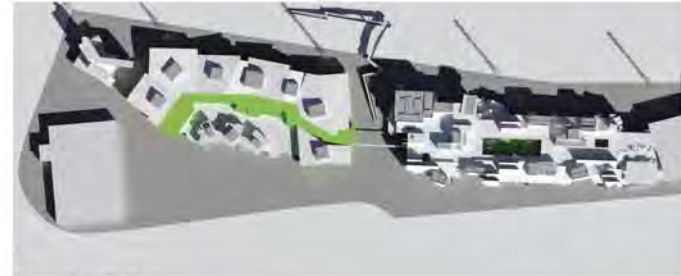
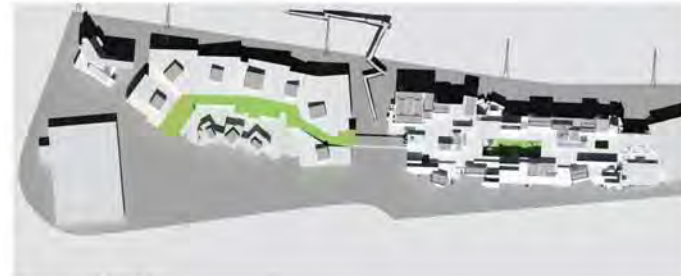
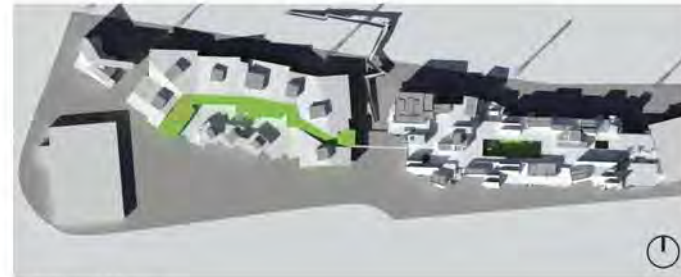
Fall Equinox (September 23) Shadows

September 23, 9 am

September 23, 12 pm

September 23, 3 pm

Winter Solstice (December 22) Shadows

December 22, 9 am

December 22, 12 pm

December 22, 3 pm
