Environmental Quality Commission

REGULAR MEETING MINUTES

D1. Issue determination on appeal of staff's approval of heritage tree permit for removal of seven redwood trees at 1000 El Camino Real.

1000 EL CAMINO HERITAGE TREE APPEAL

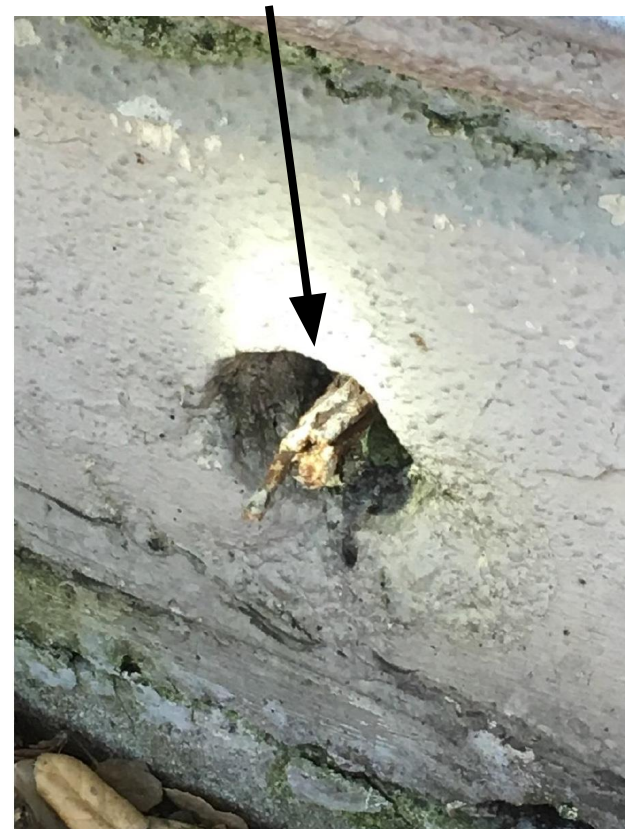
Post-tensioned cable corrosion

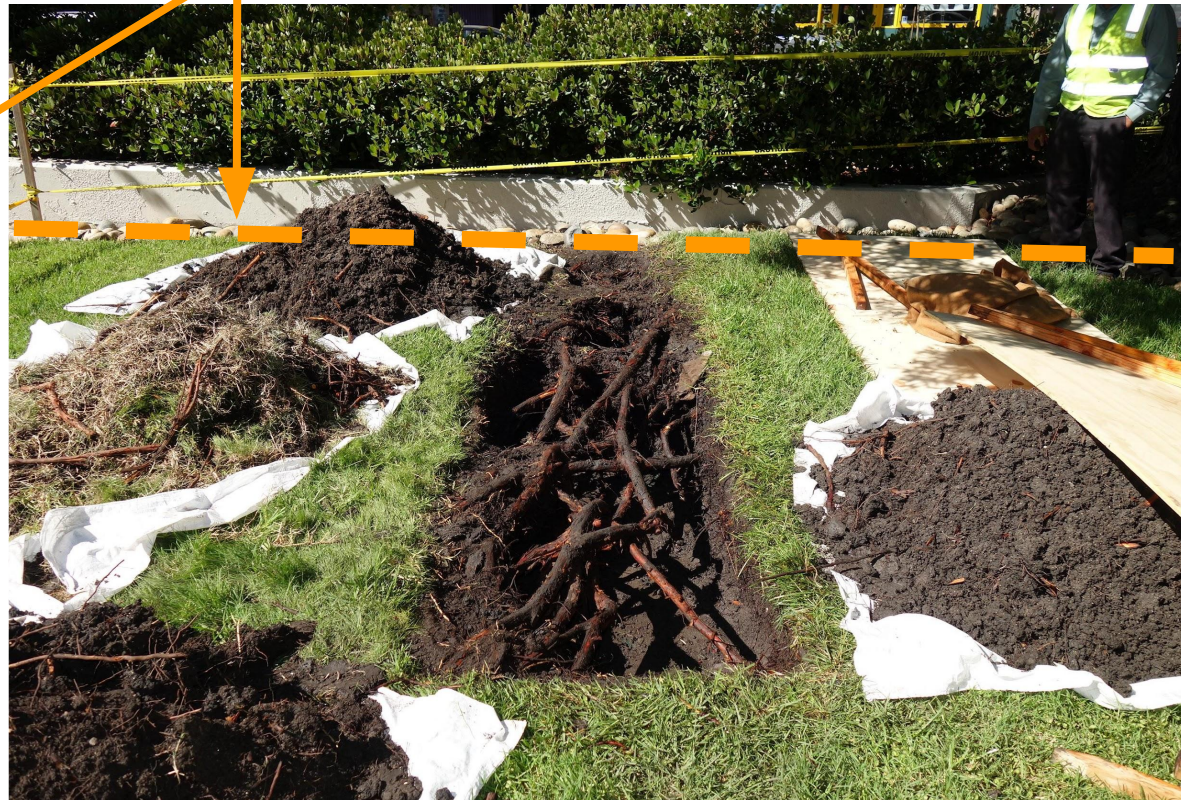
Underground Garage Edge

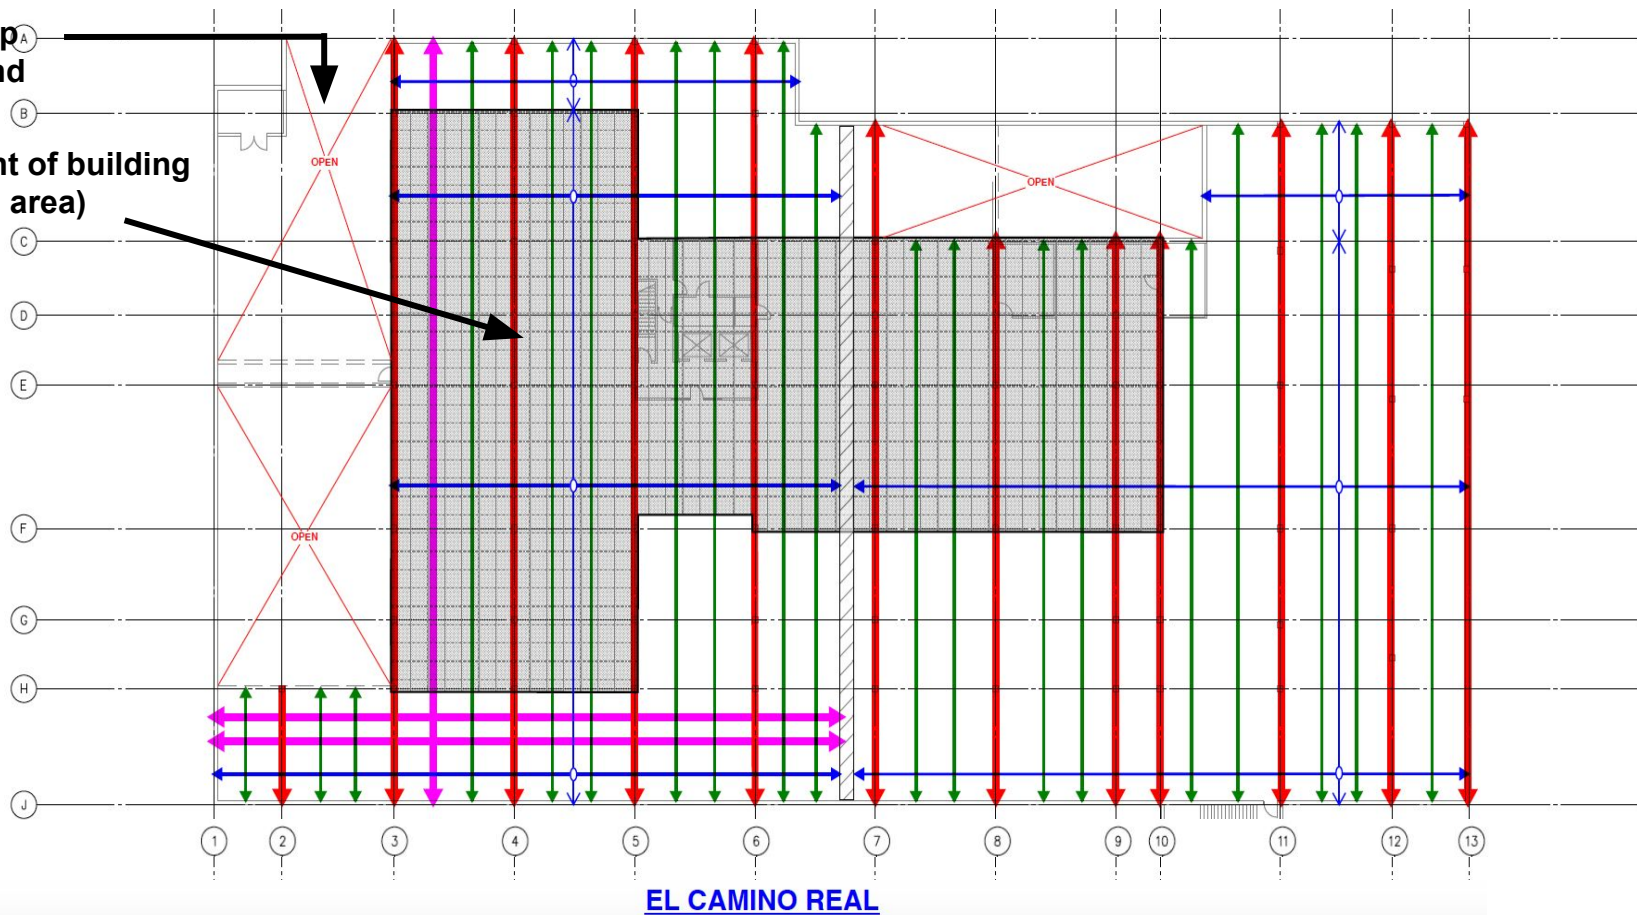
Post-Tensioned Cable Podium Slab

— Known Broken Post-tension Cables
 — Other Existing Post-tension Cables

Entrance Ramp
to Underground
Garage

Footprint of building
(shaded area)

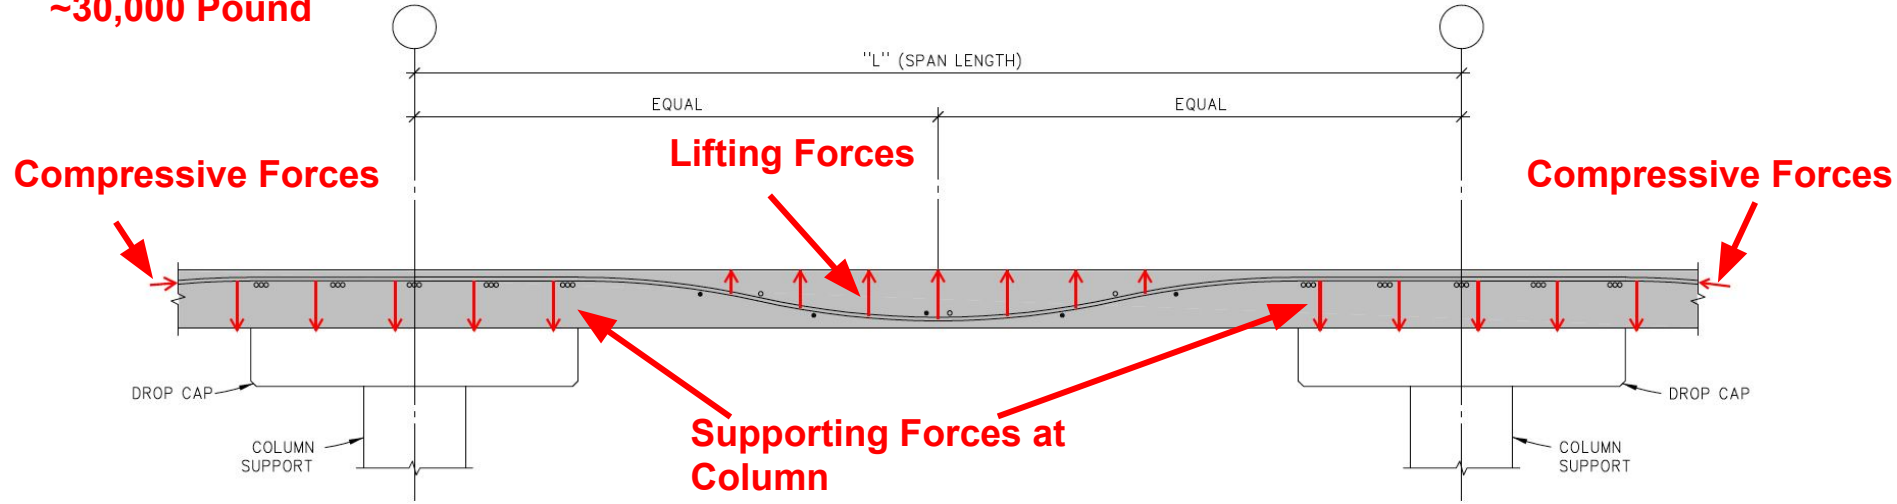
POST-TENSIONED TENDON PROFILE

Post-Tensioned Cable Structural System

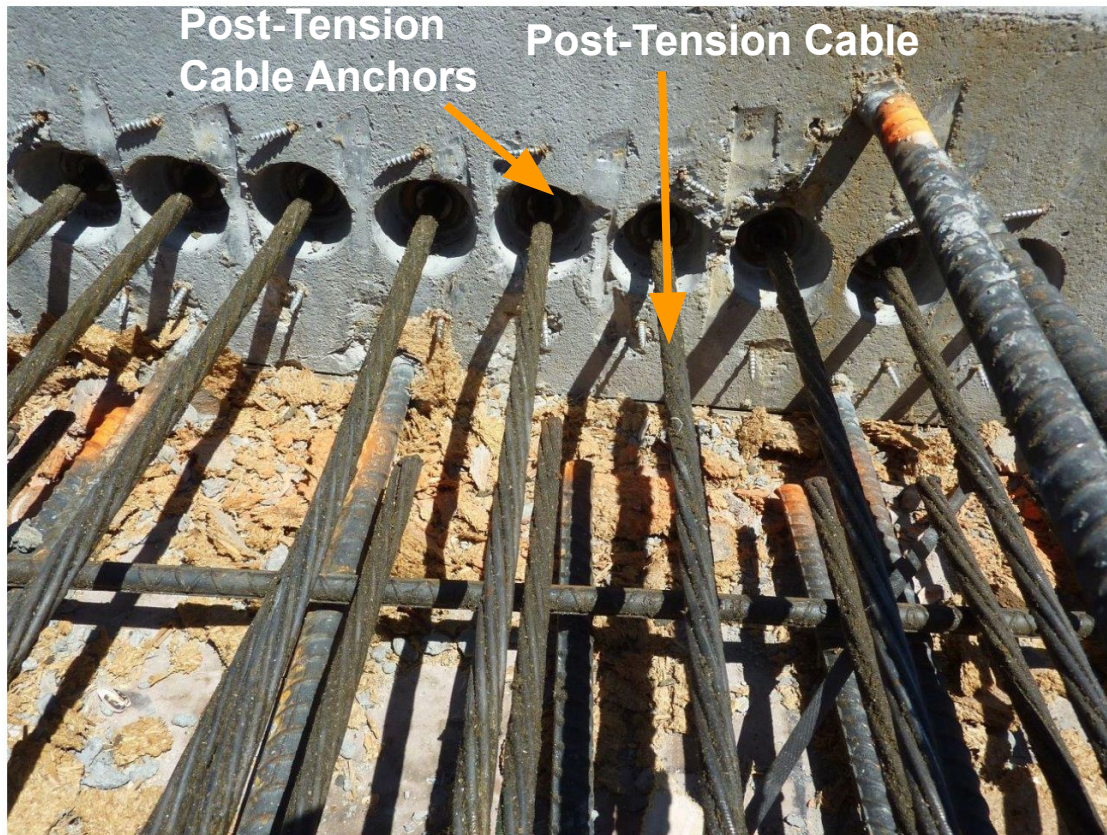
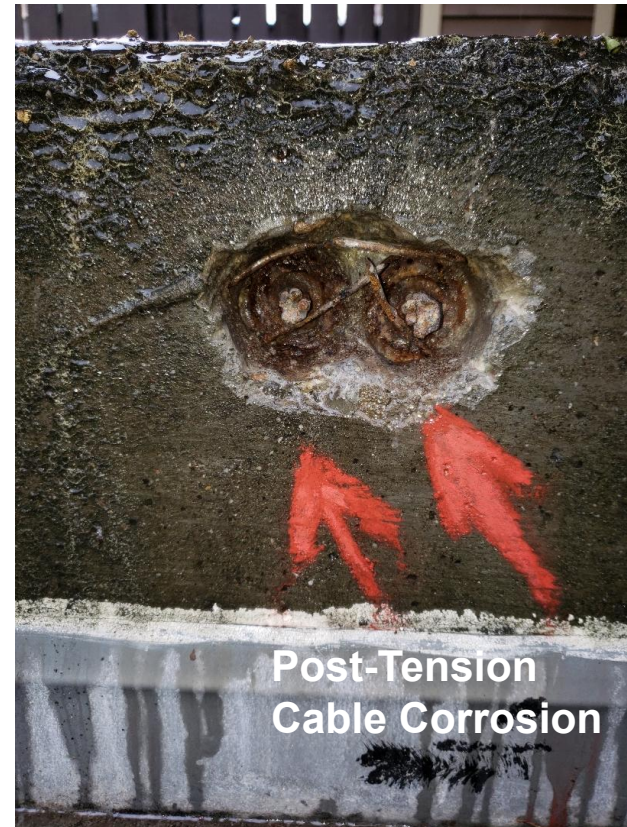
Post-Tensioned Cables and Corrosion

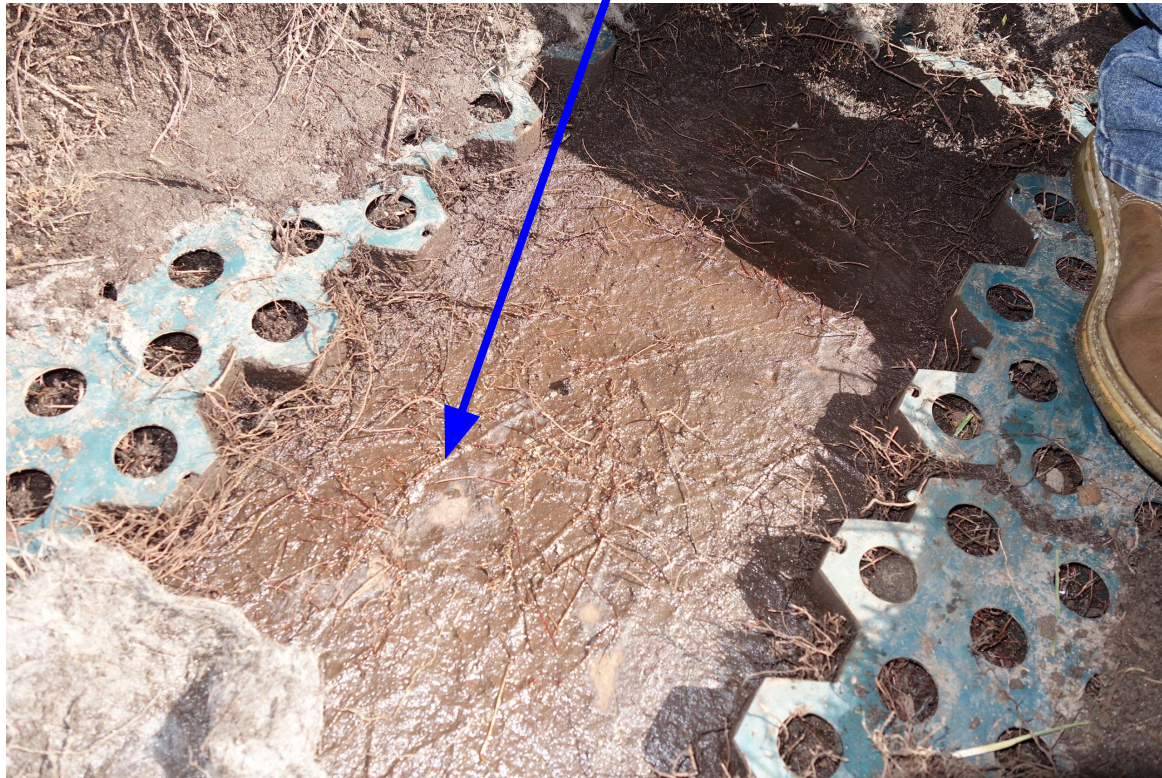
Underground Garage Edge

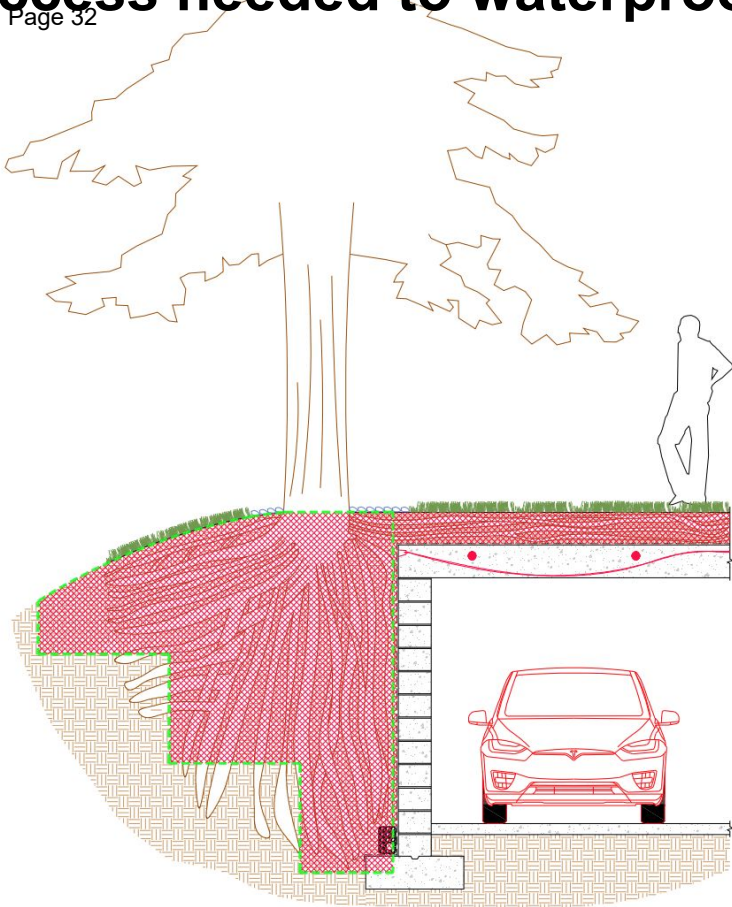
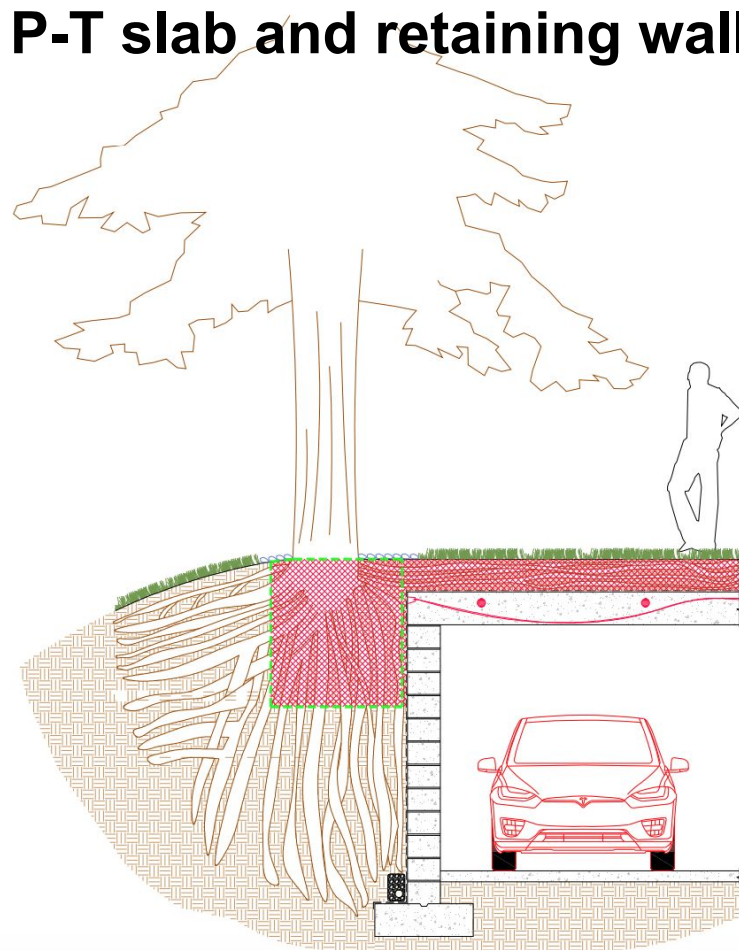
Roots Under Damaged Waterproofing

WATERPROOFING FAILED

Access needed to waterproof the P-T slab and retaining walls

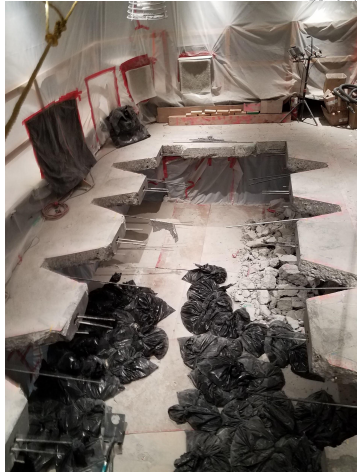
Appellant's suggestion of Saw-cutting Podium Slab and relocating the cables with a new retaining wall within the garage

Cut podium concrete
and relocate
post-tensioned
structural cables

Example image below

Significant problems with Options 7 and 8

- **Not industry best practices**
- **Inherently unsafe**
- **Involve extreme risk to the structural integrity of the building**
- **Work is sufficiently dangerous that the tenants must completely vacate the premises for two months**

- **We do not have the legal right to force our tenants to vacate and then move back into the building**
- **Post-Tension cables are each under 30,000 pounds of tension, and the saw cutting process is risky**

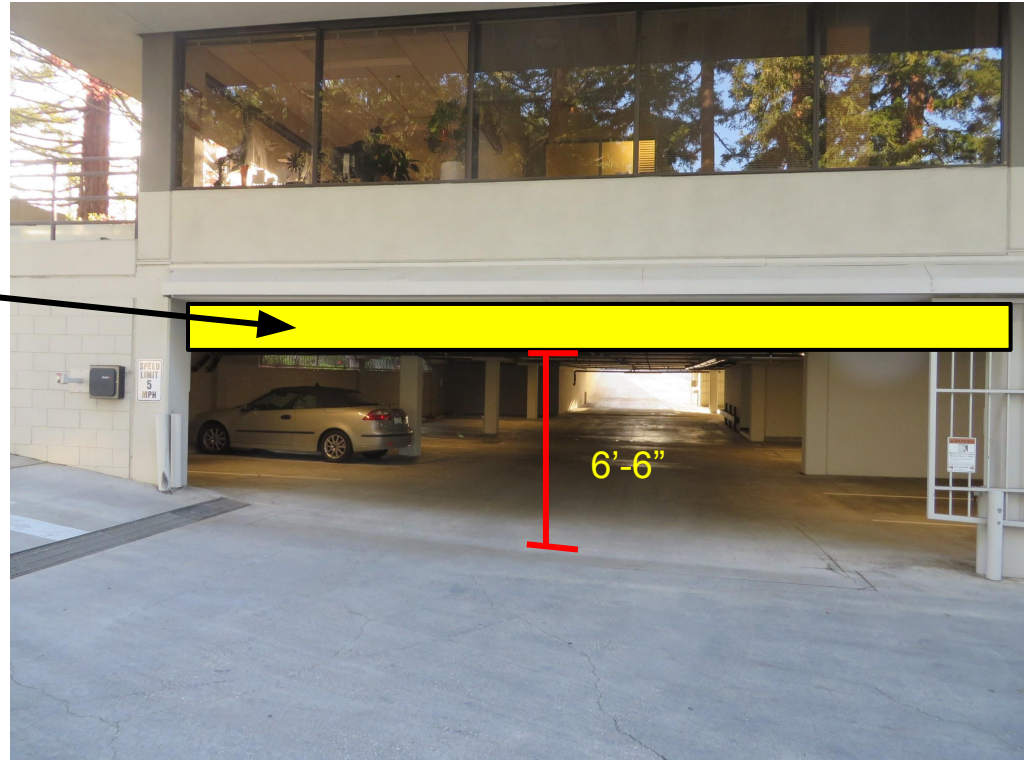
Alternate Option 2

Structurally Retrofit the Podium with Steel Beams

Structural steel throughout garage would block the clearance for cars to enter garage. This would require us to go with option 1 to build a new parking
