# 2021 ANNUAL AQUATIC REPORT

Presented by  
Team Sheeper Inc./Menlo Swim and  
Sport

Prepared for the City of Menlo  
Park Parks and Recreation  
Commission

Menlo Swim and Sport – City of Menlo Park Burgess Pool - Site Visit Photos 1/15/2022 –  
Photos 1 & 2 Men's Shower Rooms

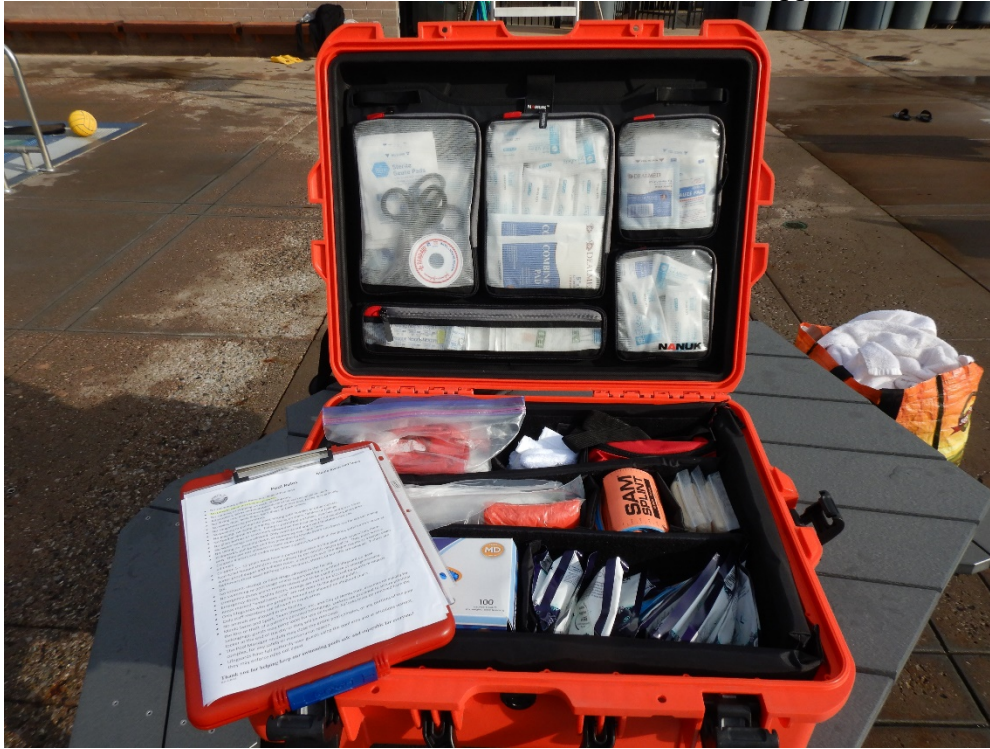
Evaluation Categories	Comments	NI, S, AA, O	Photo #
Lanes lines are in good condition, stored properly with minimal cracked or broken floats	All of the lane lines in the pools are in excellent condition.	O	
Swimming gear is stored properly and in good condition.	The swimming gear was very organized in the gear storage systems.	O	
Rescue tubes are in good condition and those not in use are stored well	The rescue tubes are in good condition and are stored well.	AA	
Back board is on deck, stored appropriately and has functional head stabilizers and proper straps.	I inspected the backboard on deck. It is functional and in good condition.	AA	
Crash bag or other portable medical kit is located in a good location and has equipment "bundled" in it.	The crash box is located in the center of the facility which is excellent. It is well stocked and ready to go. Make sure you have a BVM in or around the Crash Box	AA	P3

Photo 3 & Photo 4 Combined – Crash Box with First Aid Supplies on Deck.

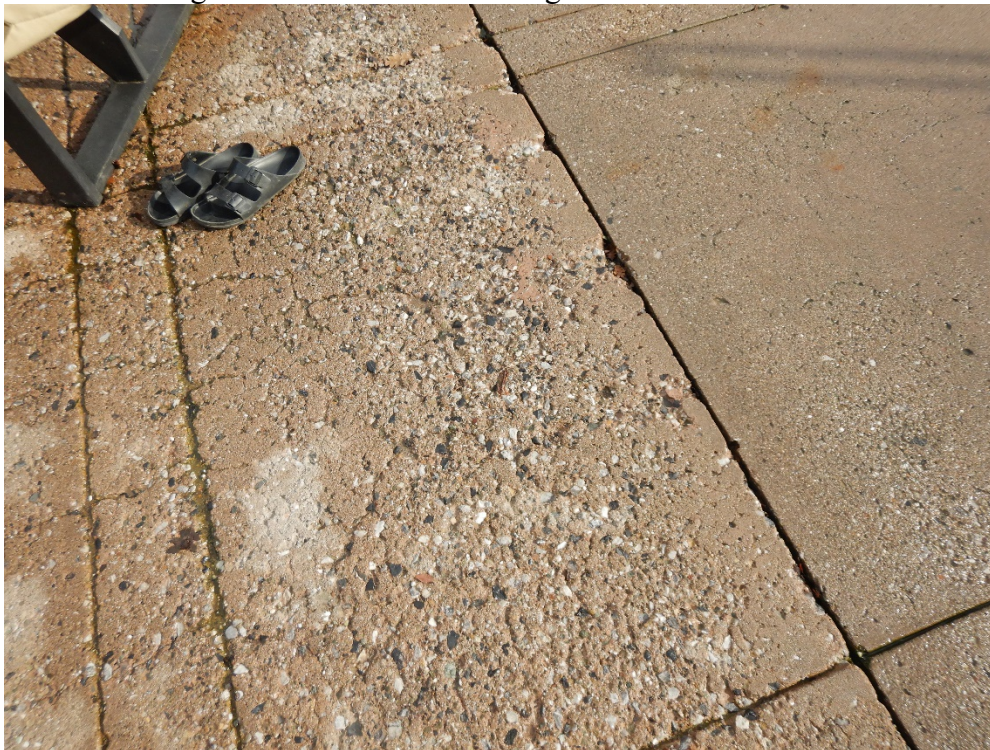
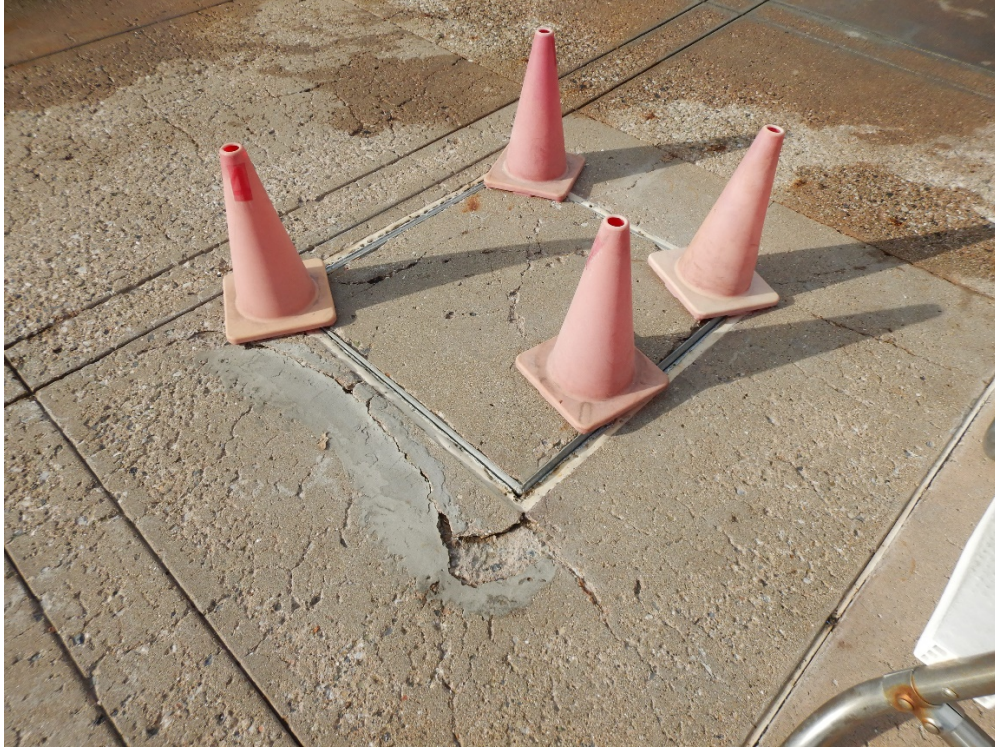
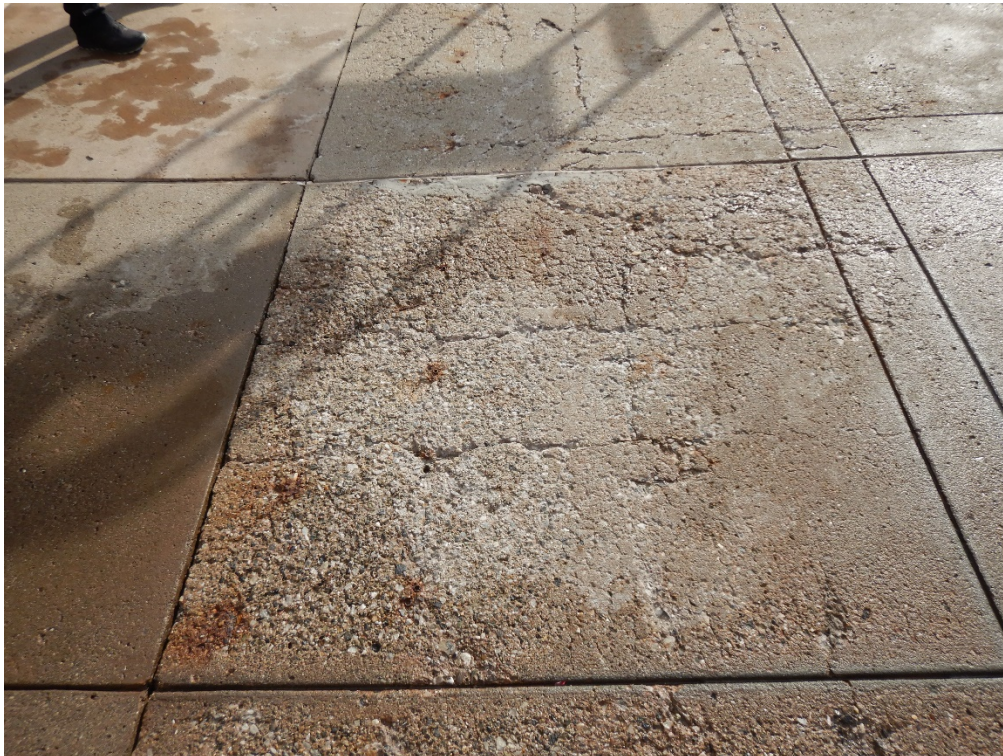
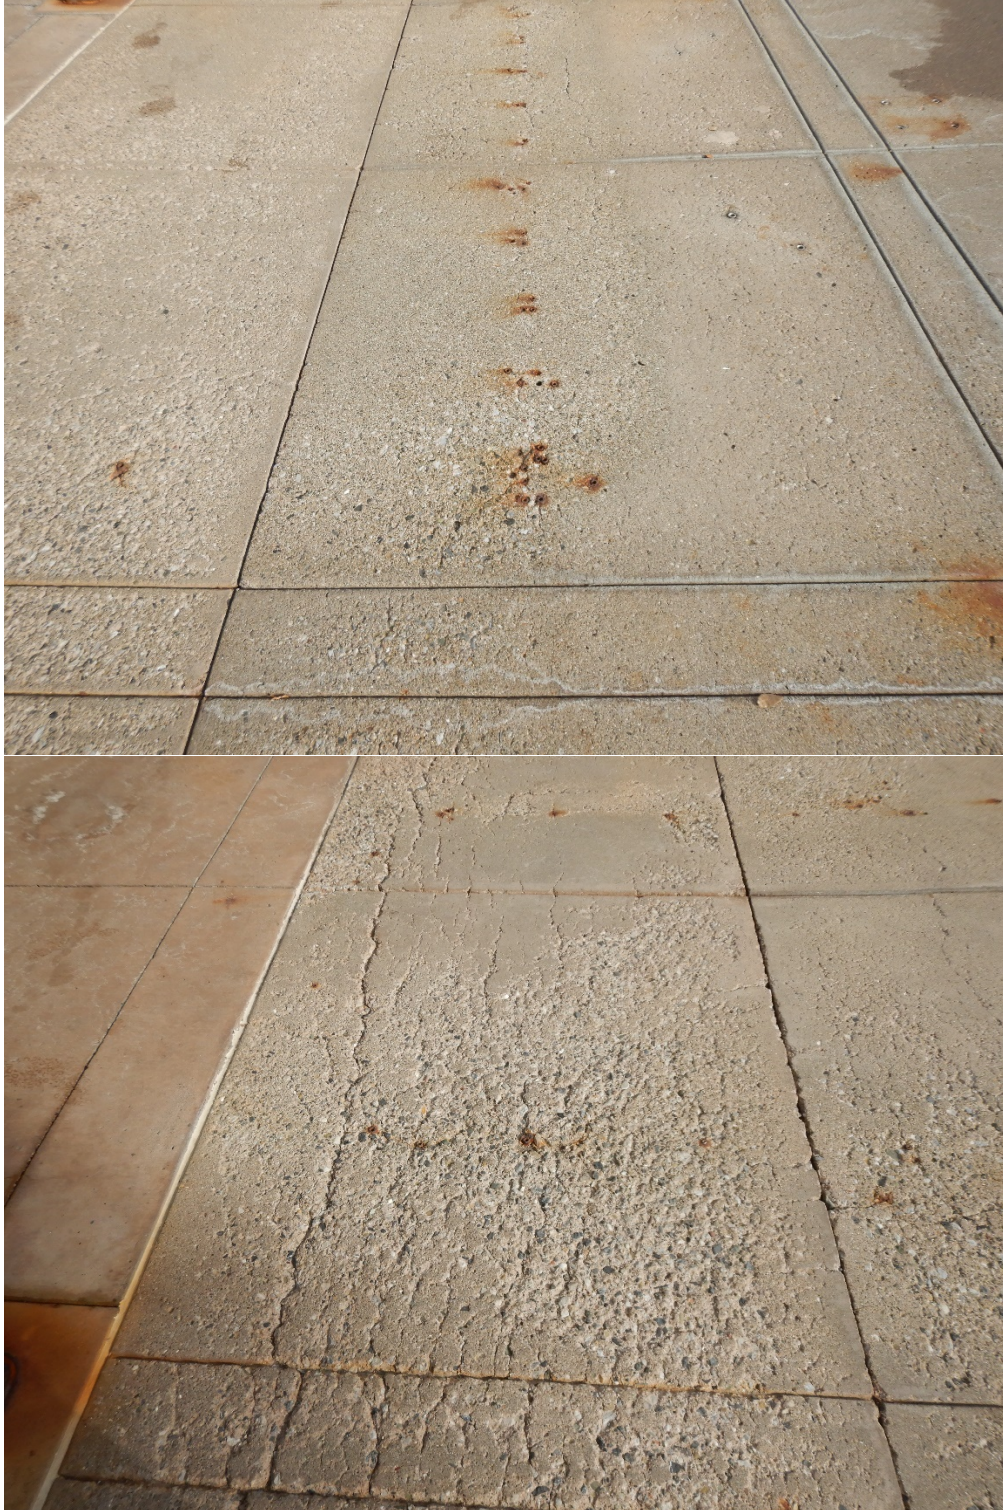
Photos 5 through 10 – Pool Deck Surfacing Condition

Additional signs depending on facility amenities and type of use; No Swimming After Dark, No Running, Shower Before Entering, and others	Good extra signs are posted; shower, no diving, no breath holding, watch your children, non-swimmers wear a PFD.	O		Section Overall
Water appearance is not turbid or cloudy, looks clean and pool bottom is clearly visible at main drain.	The water looks great.	AA		
Facility fences and barriers meet State code	I inspected the entire fence line and found no openings or gaps beyond code.	AA		
Additional Notes	The pool area looks clean and is well organized and maintained. There are some issues surrounding the pool deck surface, pool plaster and expansion joint sealant that will require significant repairs (capital level for deck and plaster) that will need to be planned to address in the future.

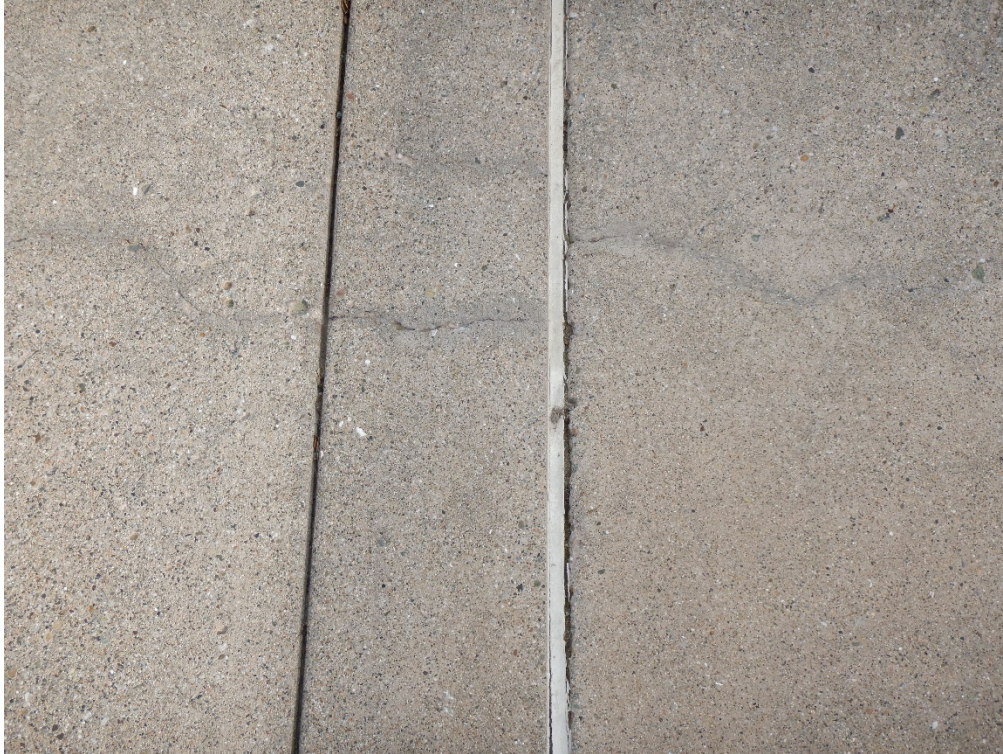
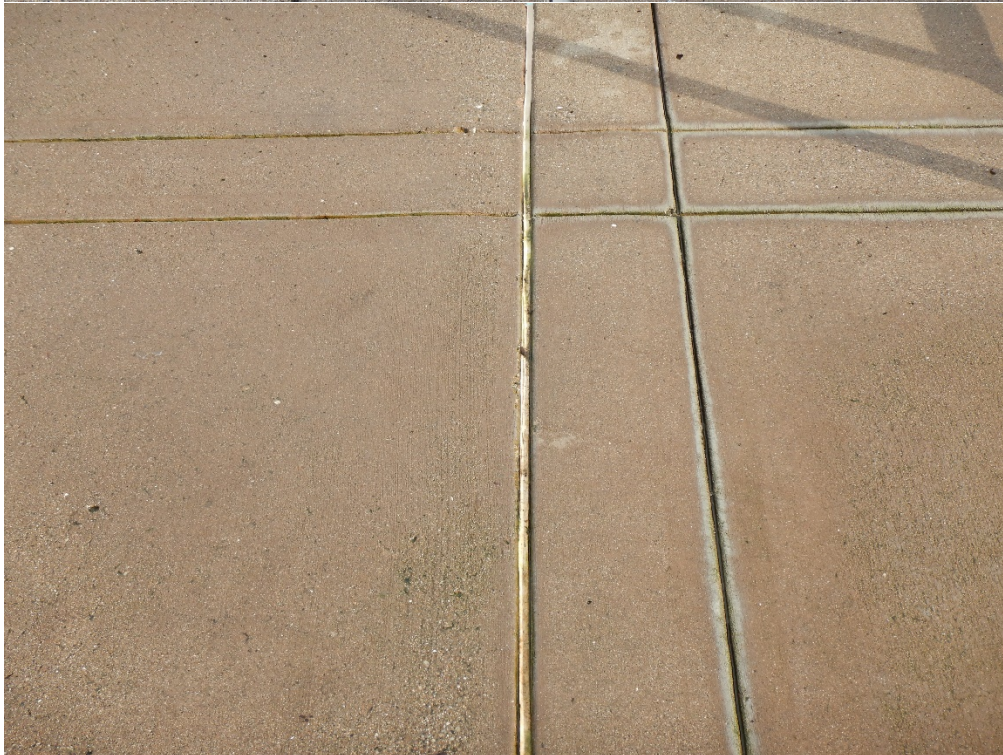
Photos 11 and 12 Expansion joint sealant

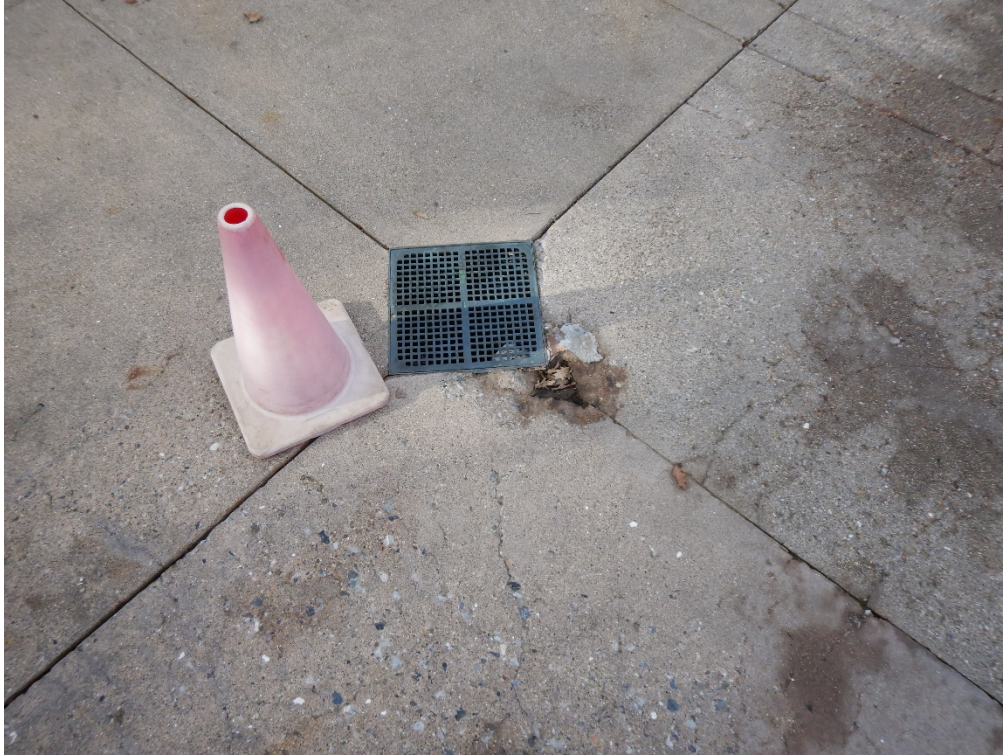
Evaluation Categories	Comments	NI, S, AA, O	Photos #
General appearance of the pool area.	The pool area looks clean and all is well organized.	AA	
Large equipment is properly stored away from the pool.	The pool cover reels, lane line reel and polo goals are well stocked.	AA	
Drinking Fountains are clean and functional	The drinking fountain is clean and functional.	AA	
Decks are clean and free of cracks, chips and standing water.	The chemical pitting on many areas of the pool deck is close to being an area of concern. Some of the cracks and pitting are approaching hazard levels.	S	P5-P10
Deck expansion joints are well sealed and impenetrable	Expansion joint sealant is still acceptable but will need resealing soon. The bad seals let water intrude and can undermine the structure integrity of the concrete slabs.	AA	P11, P12
Deck drains are in good condition and functional.	The drains look good. One needs patching around the frame.	AA	P13

Photo 13 Deck Drain

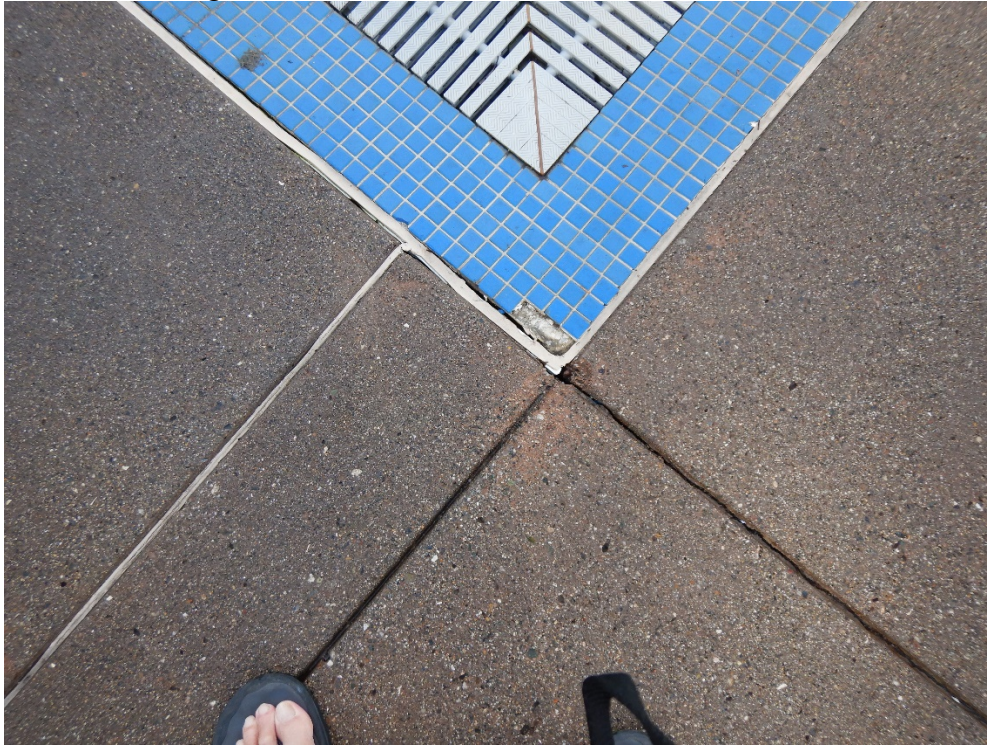
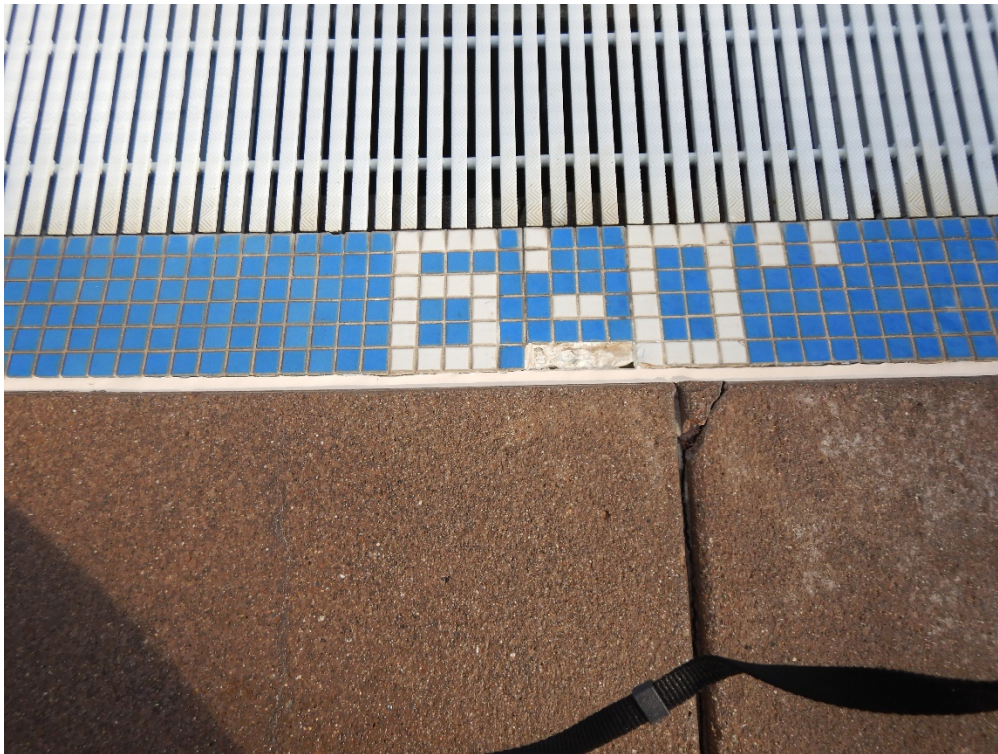
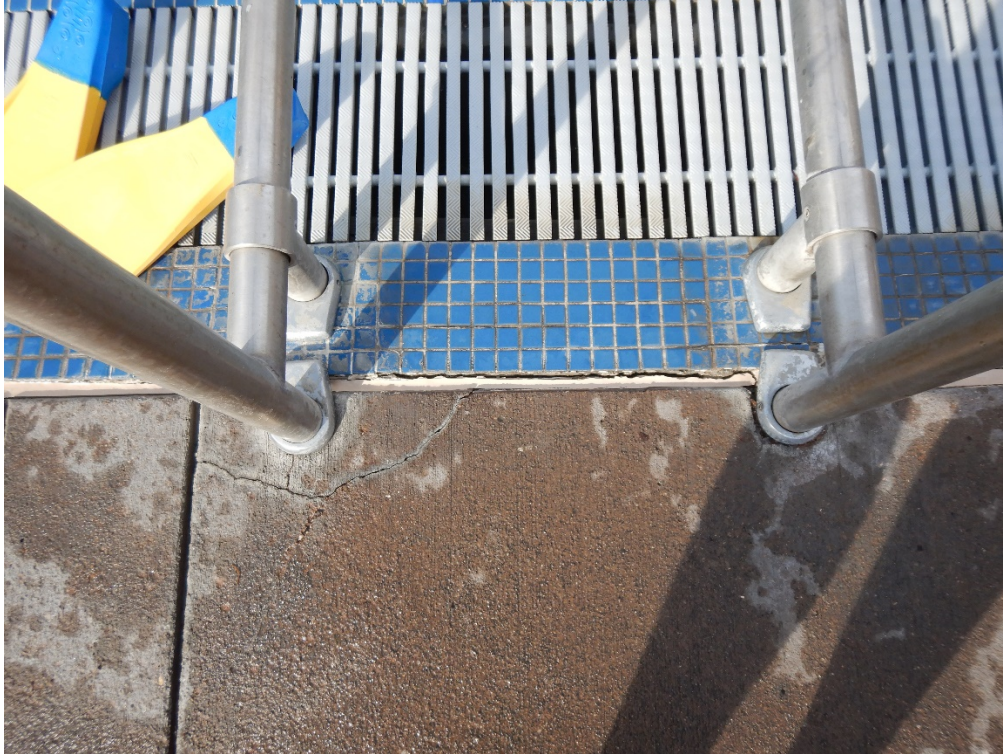
Photos 14 through 17 Perimeter Tiles

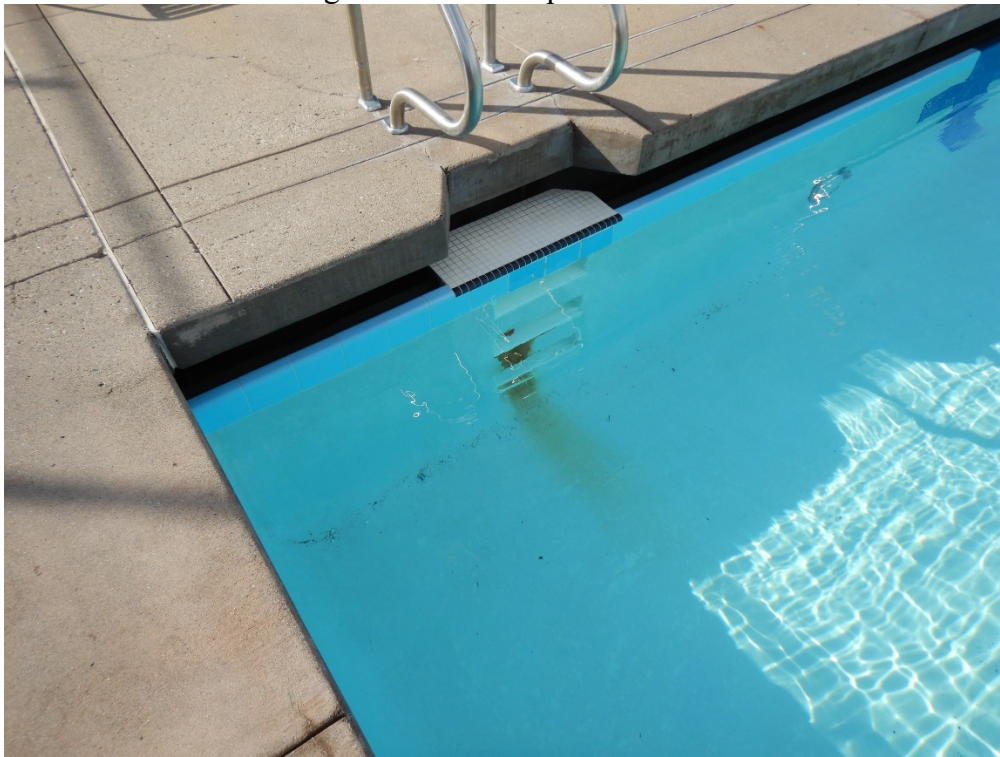
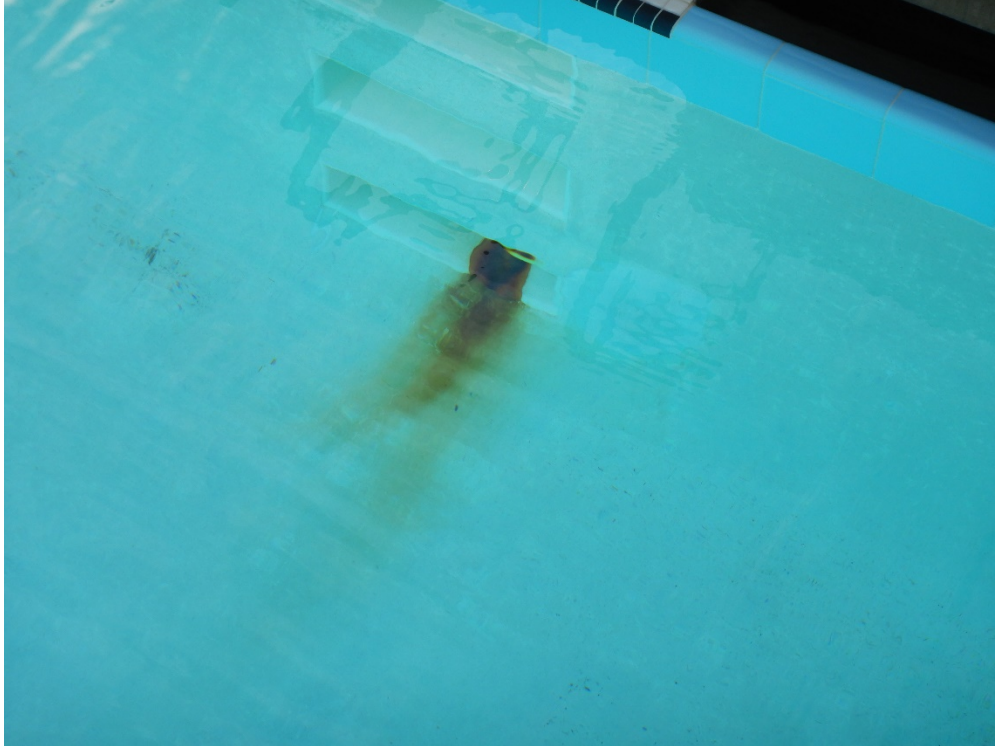
Ladder handrails are tight, ladder entry steps are in good condition	I checked all the handrails. They are in good condition. Some of the steps have brown staining from re-bar close to the plaster surface. This is standard issue and should be addressed next plaster job.	AA	P18-P19	Section Overall
Functional lifeguard stands, includes; steps, rails, platforms, seat and no potential "strap hooks"	I inspected all three lifeguard stands, steps, bolts, surfaces, seats and all are safe and in good working order.	AA		
Pool cover and lane line reels, handles, wheels, brakes, bearings.	I inspected all four pool cover reels and found them to be in good condition.	AA		
ADA Compliance for means of pool entry, placement of pool lifts and alternate means of entry ramps, stairs	ADA lifts are in place. They are to be accessible and working and in place whenever the pool is open. They should be able to be operated by the user without assistance.	AA

Photos 18 and 19 Staining from rebar “seep” on two sets of built-in ladder stairs

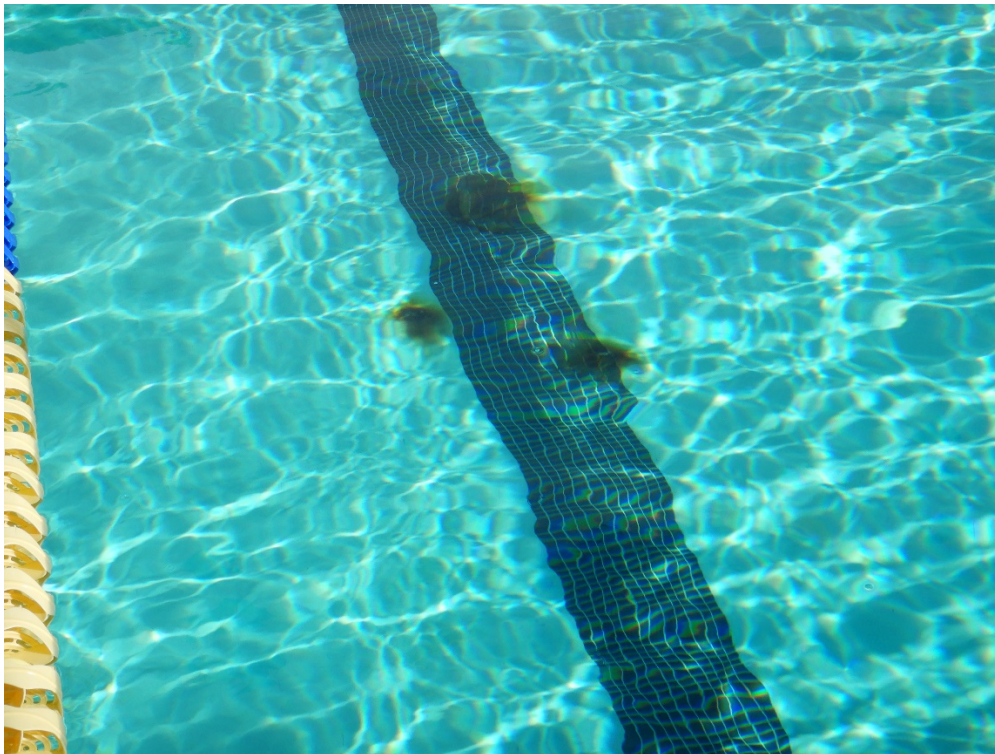
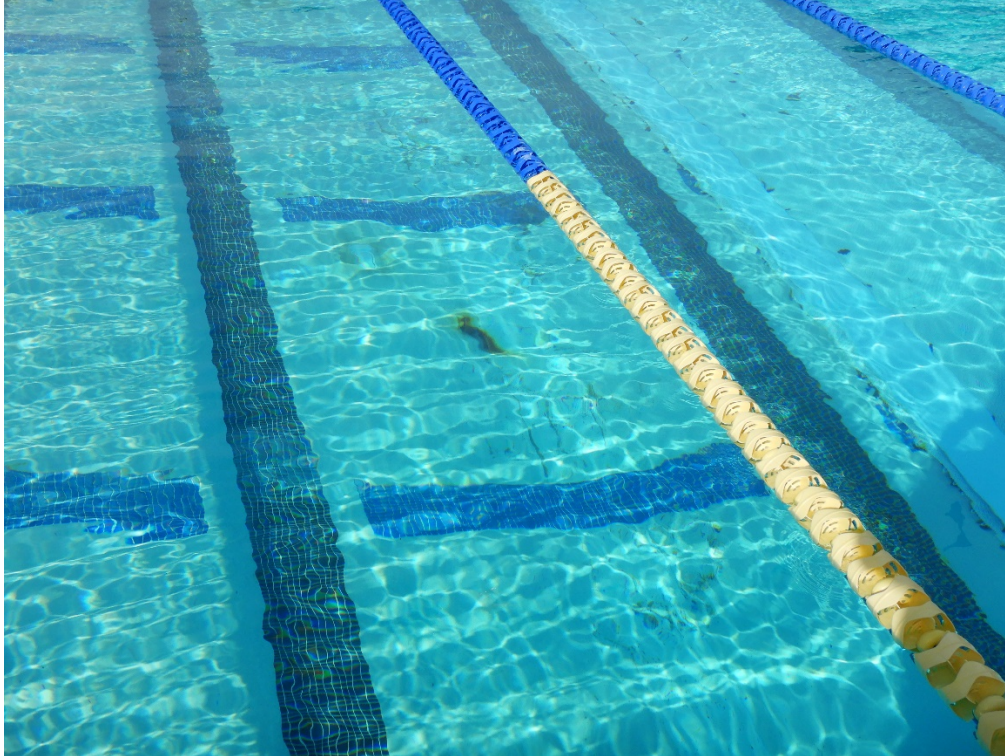
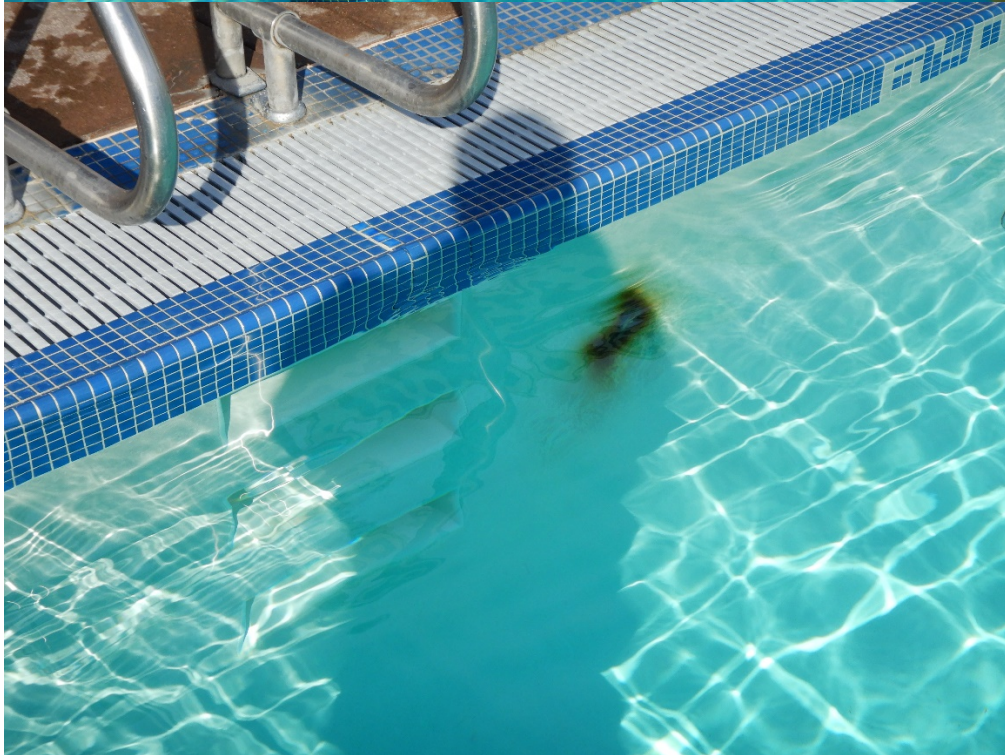
Photos 20 and 21

Pool surface is uniform in color and surface is acceptable, lane markings are visible and in good condition.	The lane markings and hockey bottom are in good condition. There is rust staining on the bottom due to re-bar proximate to plaster surface "bleeding" through. This is a standard issue and should be addressed next plaster job.	AA	P20-P22	
Pool drain covers are VGB Compliant, Inlets and other covers are in good condition.	The drains appear to be VGB compliant. They need inspection, replacement and certification every 5, 7 or 10 years depending on the type of drain.	AA		
Pool signs meet code requirements, including; Capacity, 911, RB/CPR, Active Diarrhea, Pool Rules. No Diving; No LG on Duty,	Fill in signs for all three pool areas. Need capacity, pool address and emergency hospital, urgent care or closest facility address and phone number. Pool capacity is determined by multiplying length times width of the pool and divide by 20.	AA	P23

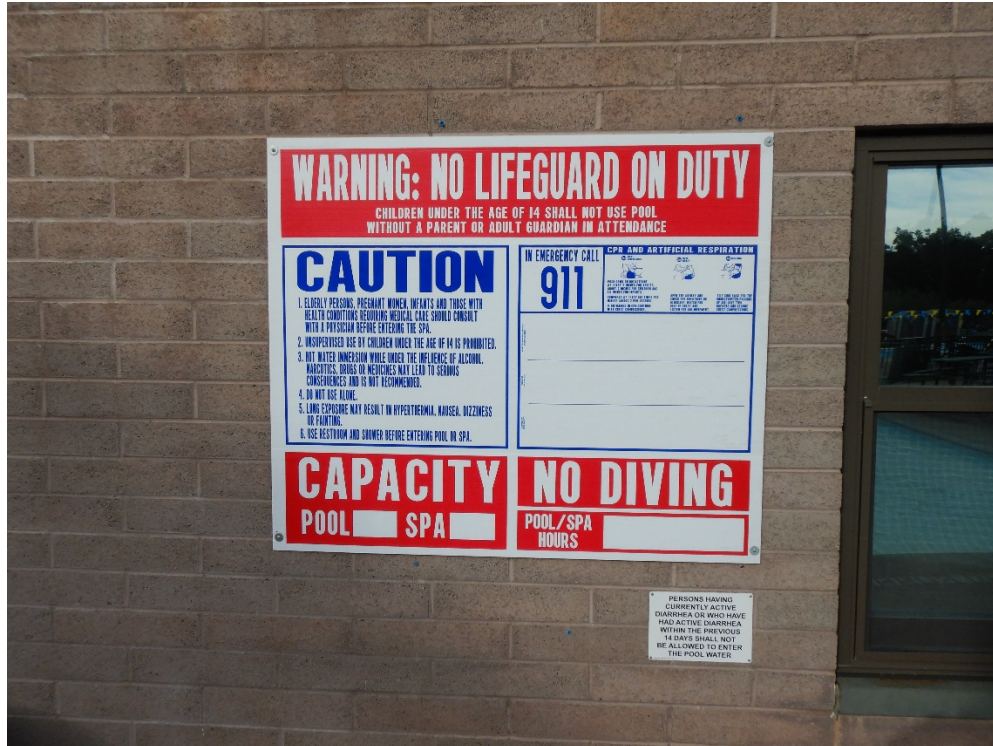
## Pool Code Compliance Signs
