# Environmental Quality Commission

## SPECIAL MEETING AGENDA

## STAFF REPORT

Staff recommends the Environmental Quality Commission (EQC) deny the appeal and uphold staff's decision to deny the Heritage Tree removal permit application at 262 Yale Rd.

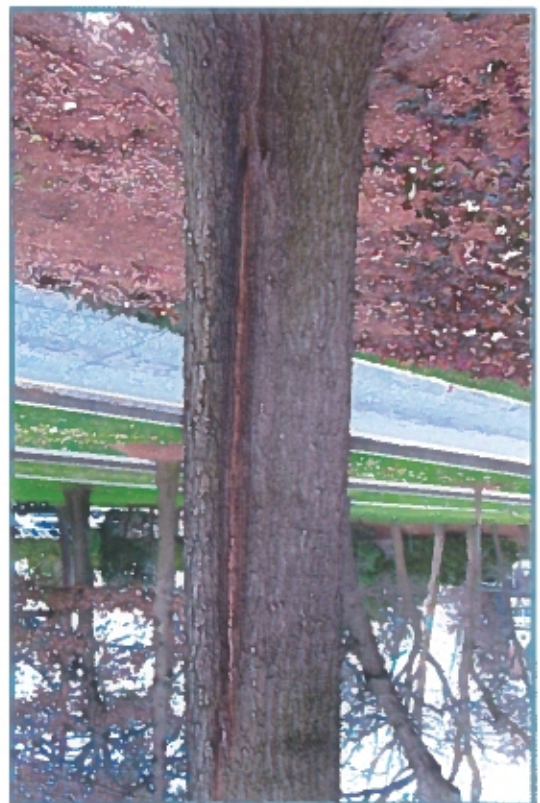
**Figure 7.2: Improbable:** This seam from frost cracking is an example of *improbable* likelihood of failure. The tree or branch is not likely to fail during normal weather conditions and may not fail in many severe weather conditions within the specified time frame.

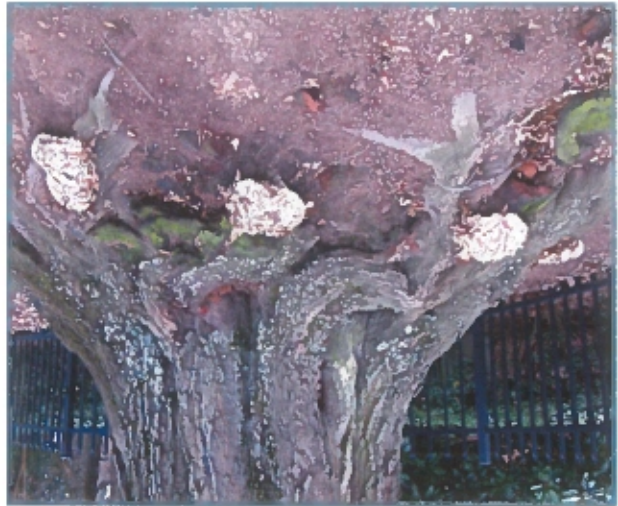
**Figure 7.4: Probable:** These conks indicate widespread and serious root decay, making the likelihood of failure *probable*. Failure may be expected under normal weather conditions.

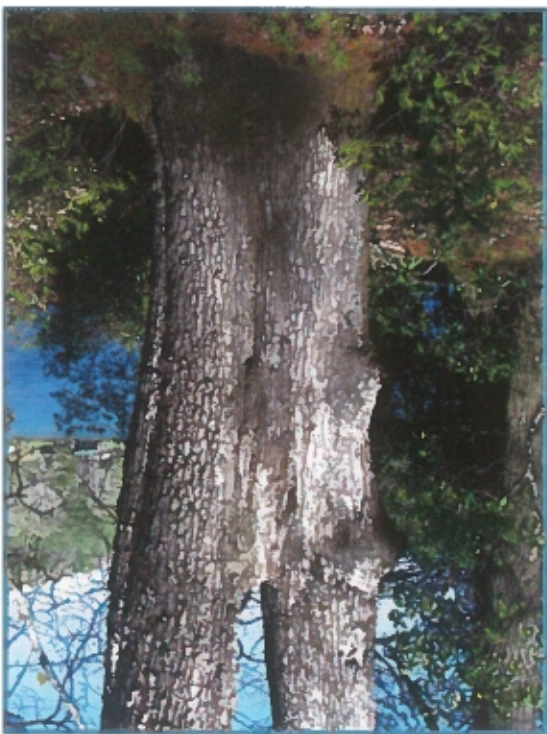
**Figure 7.3: Possible:** The codominant junction shows significant response growth, indicating a *possible* likelihood of failure. Failure could occur, but it is unlikely during normal weather conditions within the specified time frame.

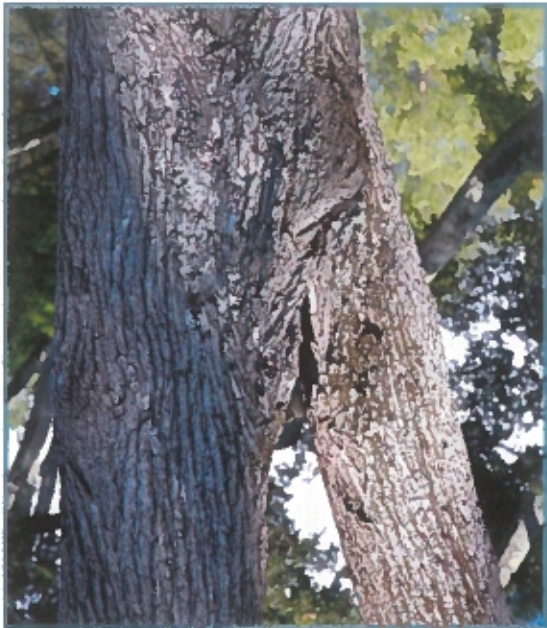
**Figure 7.5: Imminent:** The likelihood of failure of the left codominant stem is *imminent* due to the open and active crack in the junction. Failure has started or is most likely to occur in the near future, even if there is no significant wind or increased load.
