Environmental Quality Commission

REGULAR MEETING AGENDA

STAFF REPORT - AMENDED

On November 8, 2017 a permit application was started to remove seven coast redwood trees at 1000 El Camino Real to address water damage in the underground parking garage (Attachment A.) The below grade parking garage and podium structurally supports the entire office building.

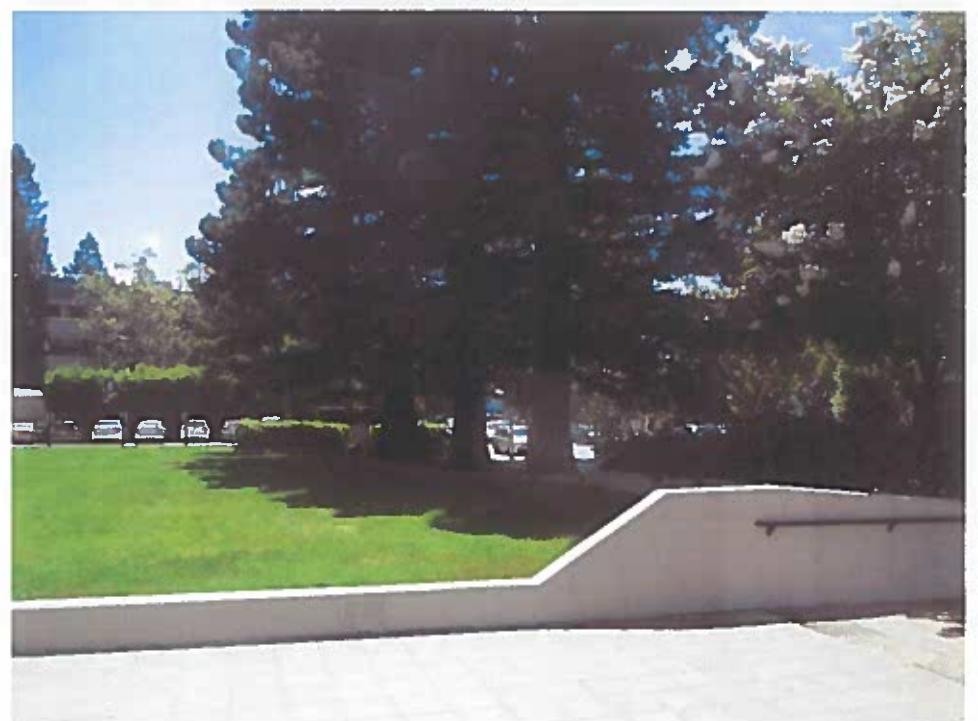
Photo 1. Photo shows the four redwood trees located at the south end of the row.

None of the trees can be retained due to the safety concerns resulting from the level of root loss that will occur.

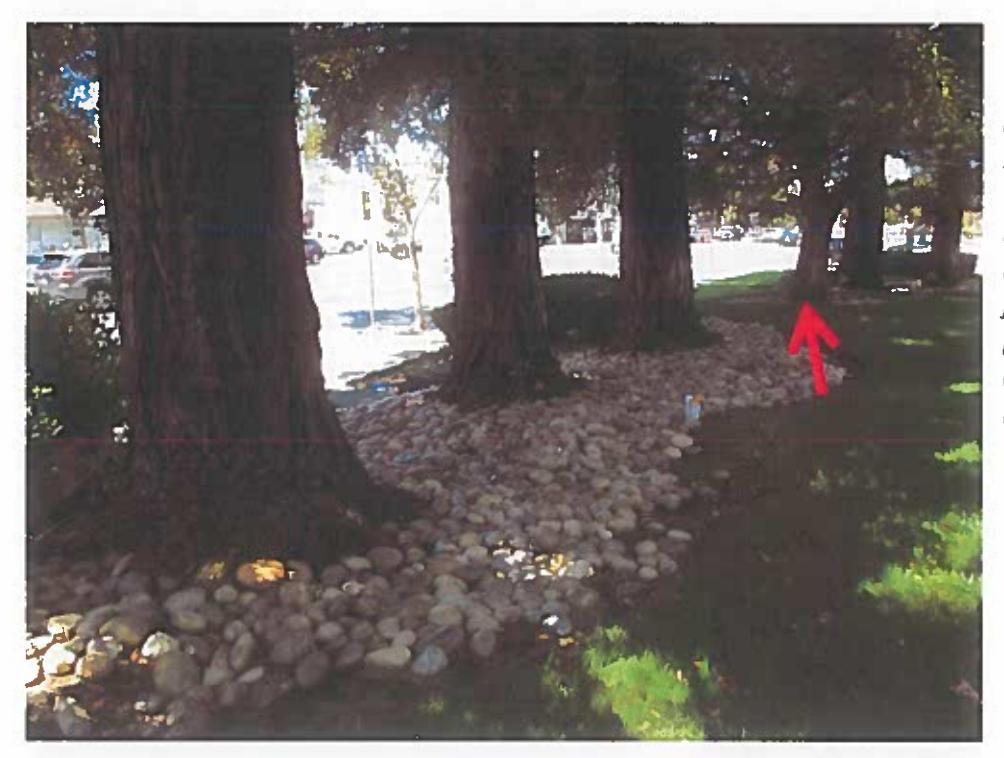
Photo 2. Photo above shows trees 5 through 8. Oak tree #8 is in the background (arrow). The oak is farther from the proposed work activities and can likely be retained.

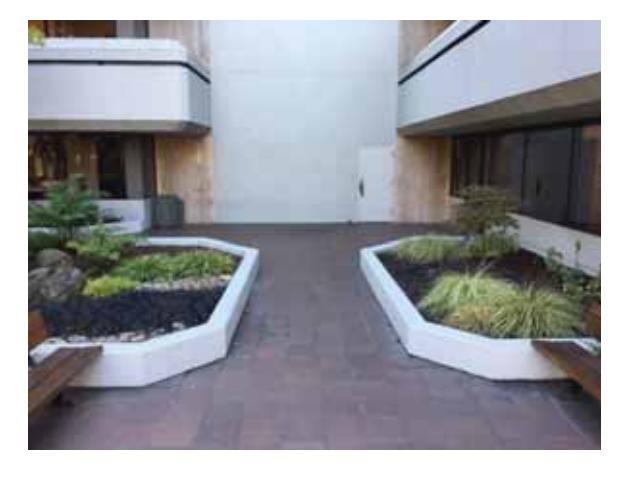
EXISTING LANDSCAPE CONDITIONS AT THE BACK PATIO (NORTH SIDE)

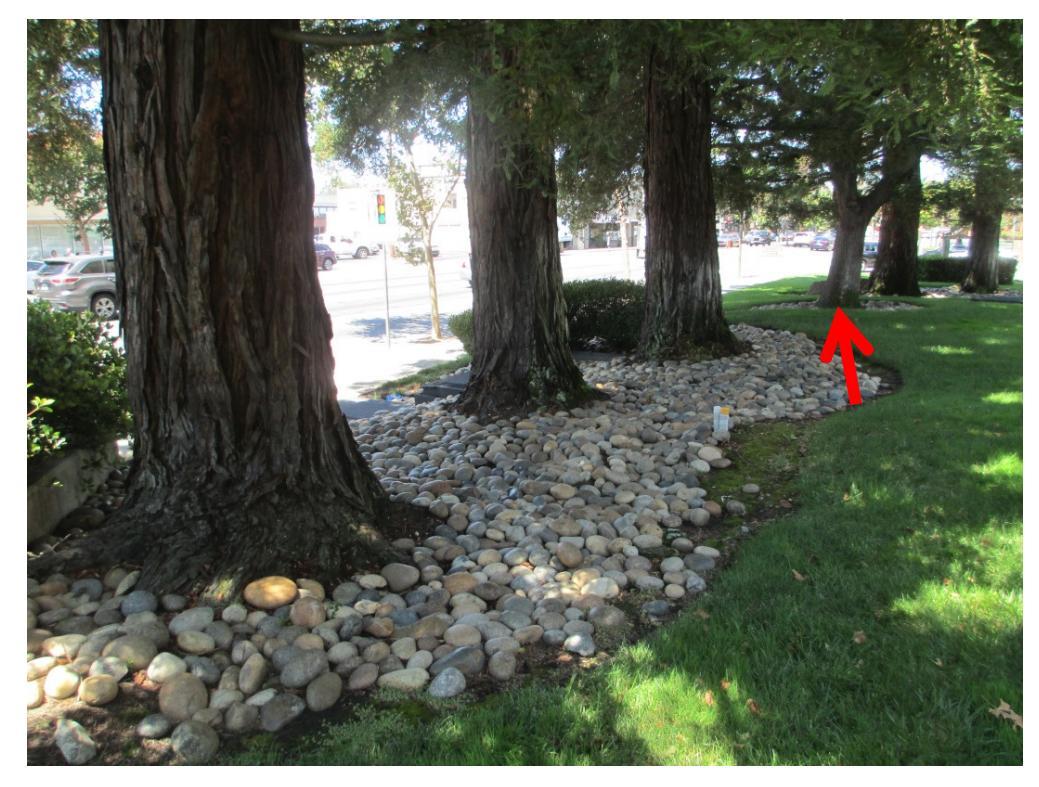
Photo 2. Photo above shows trees 5 through 8. Oak tree #8 is in the background (arrow). The oak is farther from the proposed work activities and can likely be retained.

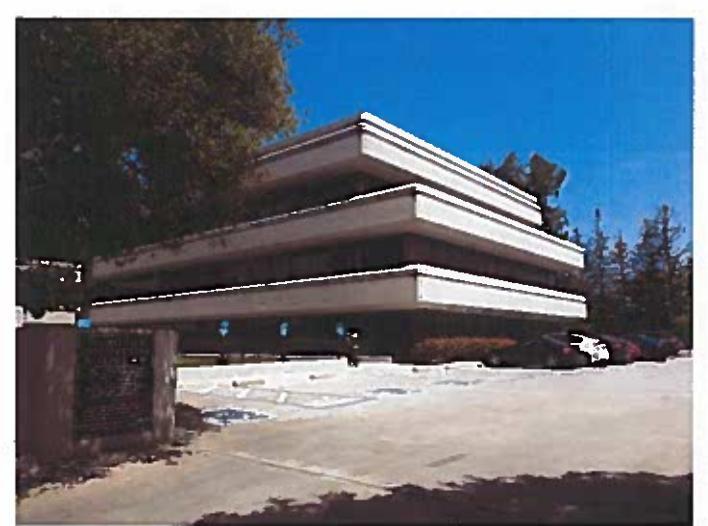
The Menlo Park Office Center is a multi-story office building constructed over a reinforced concrete podium structure. The podium is depressed approximately 8'-0" below grade and is the roof structure of the parking garage. The portion of the podium not covered by the office tower is an open pedestrian plaza with large areas of planted grasses and gardens. The building is over 30 years old.

Figure 1 Menlo Park Office Center

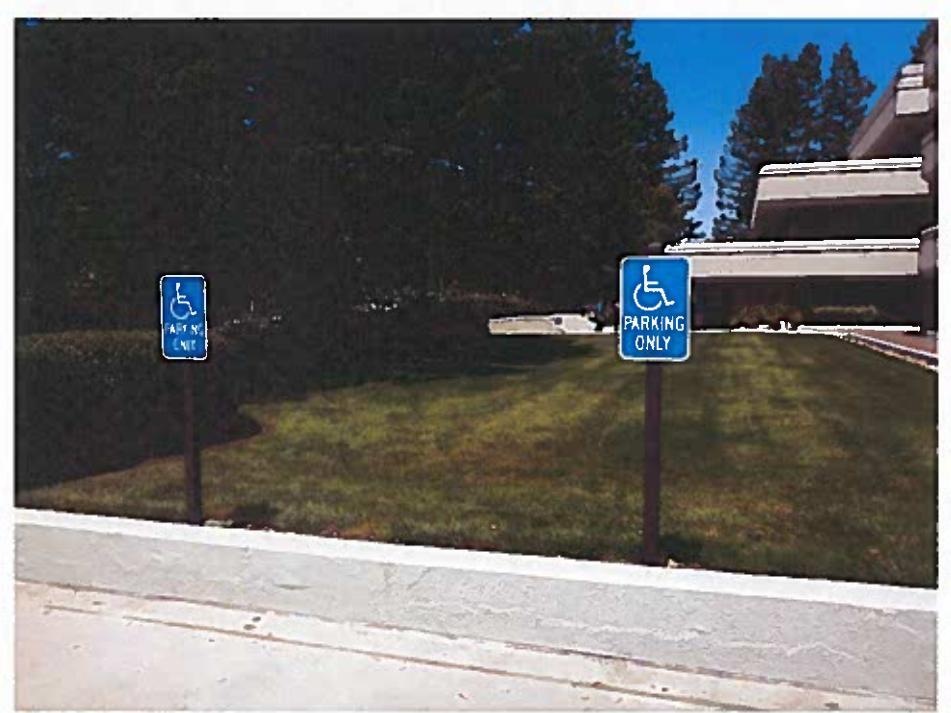
Figure 8 Overview of grass covered podium over garage; note large trees along El Camino Real.

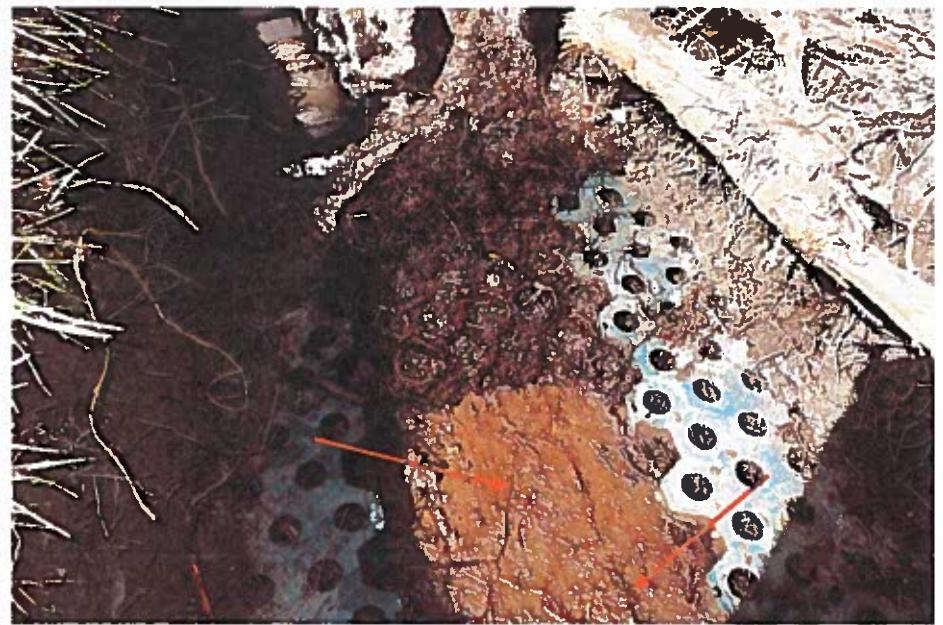
Figure 9 Destructive testing (DT) area where grass, soil, etc. to expose waterproofing. Note how the small root hairs are embedded within the waterproofing membrane.

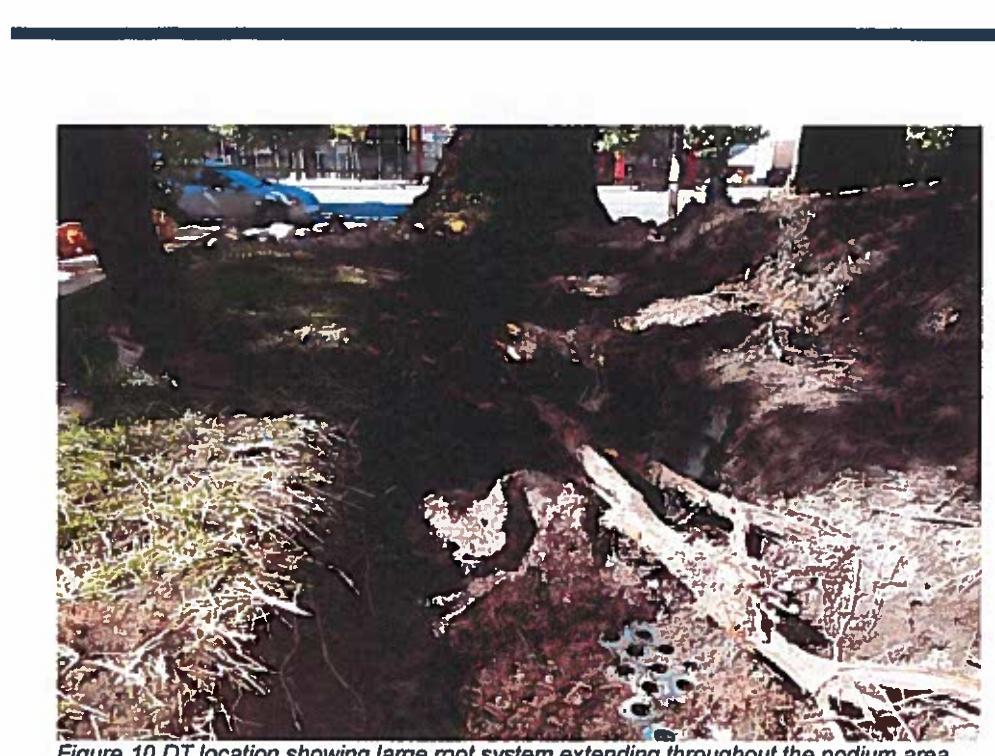
Figure 10 DT location showing large root system extending throughout the podium area. Root system is damaging the waterproofing membrane through surface abrasion and by penetrating the membrane - opening pathways for water intrusion into the podium slab.

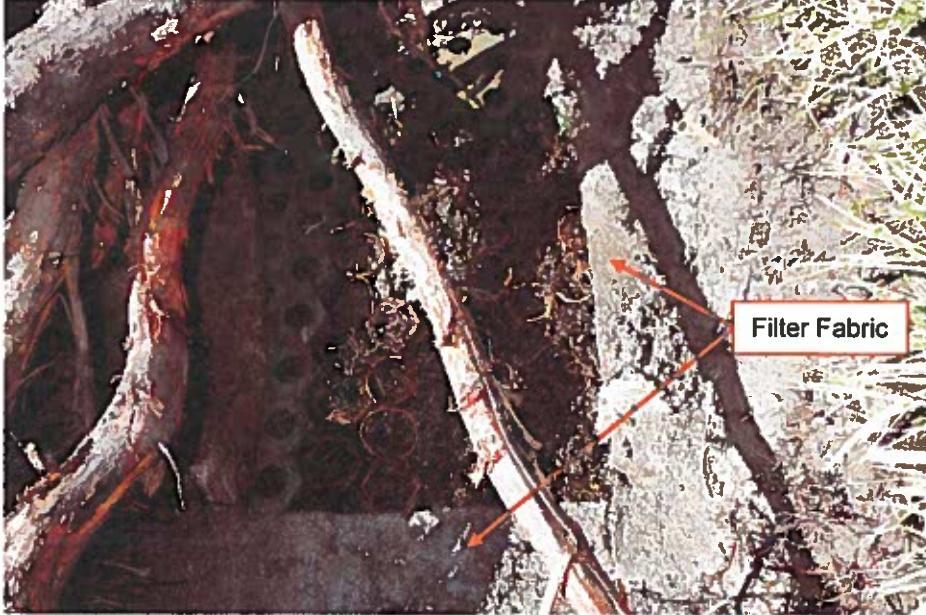
Figure 11 Close-up of root system running above and below the filter fabric.

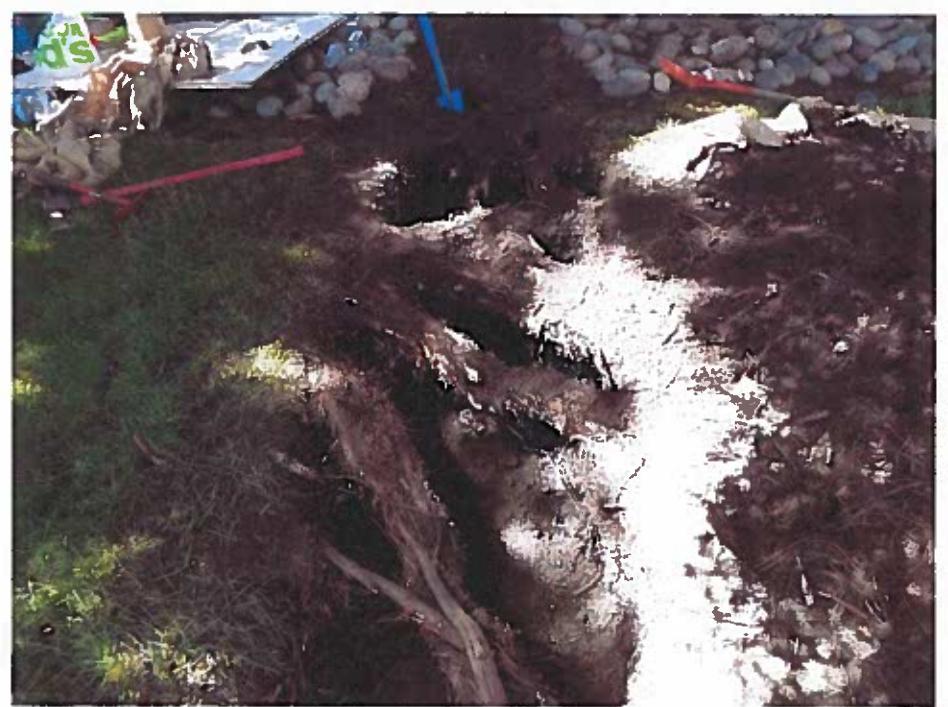
Figure 12 Large roots extending from trees along El Camino Real toward the building (above the podium area.) These roots are throughout the podium.

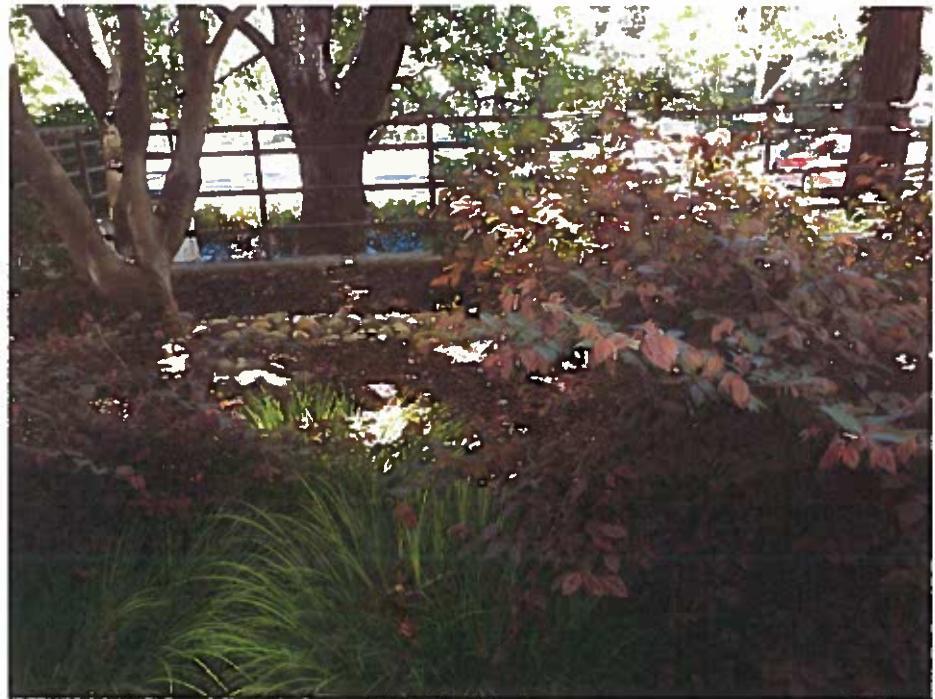
Figure 13 Courtyard planter area prior to DT.

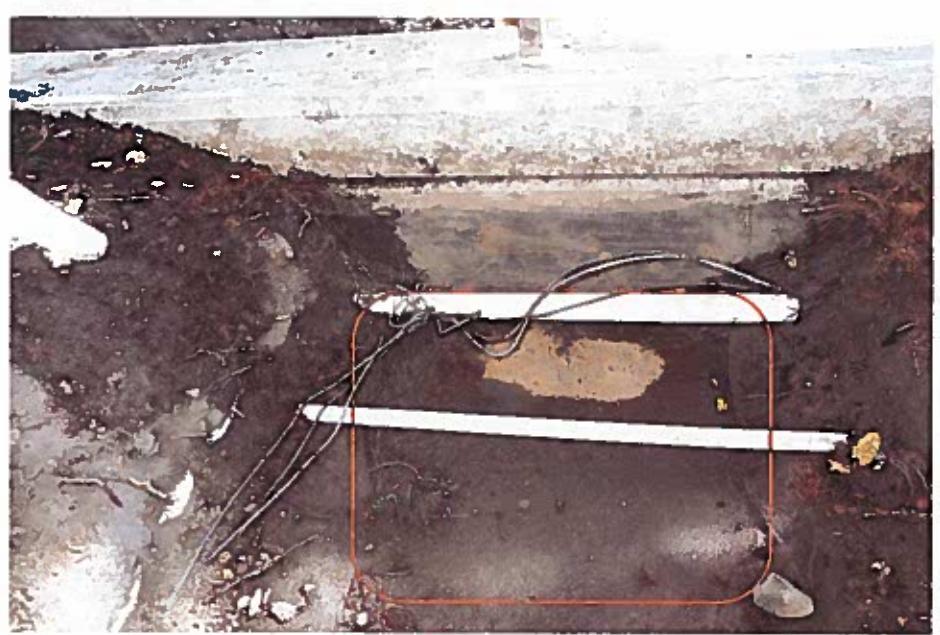
Figure 14 DT location in courtyard planter - exposing waterproofing membrane.

<u>Courtyard area podium waterproofing</u>: The podium waterproofing requires replacement due to extensive water intrusion through the waterproofing membranes. All overburden above the podium must be removed in order to access and replace the waterproofing membrane. This will include the removal of grasses, plantings, trees, rocks, etc. above the podium in the planter areas, and tile and mortar bed at walkway areas. Hot rubberized asphalt waterproofing is the proposed waterproofing system.

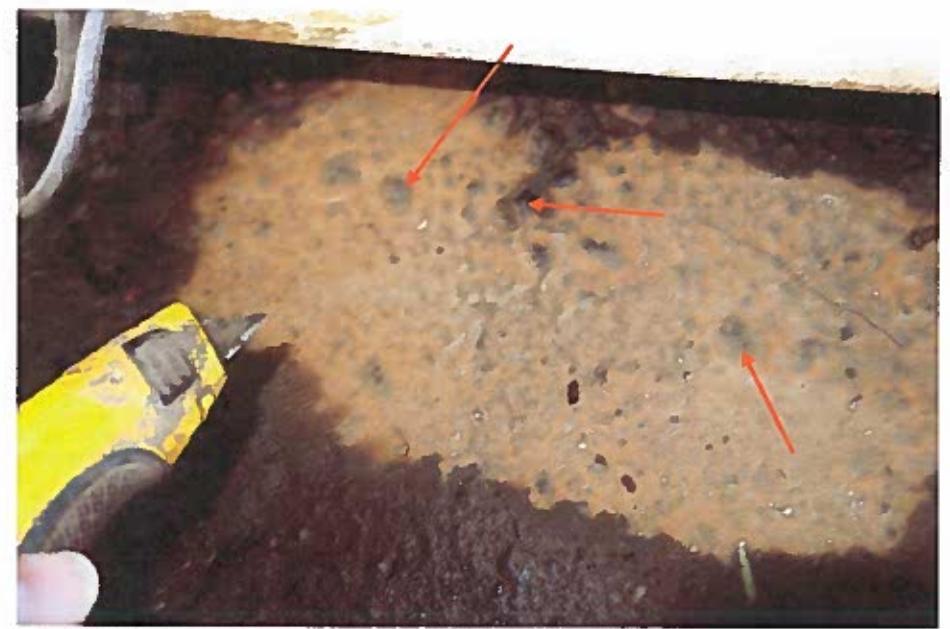
Figure 15 Close-up of waterproofing membrane showing blistering.

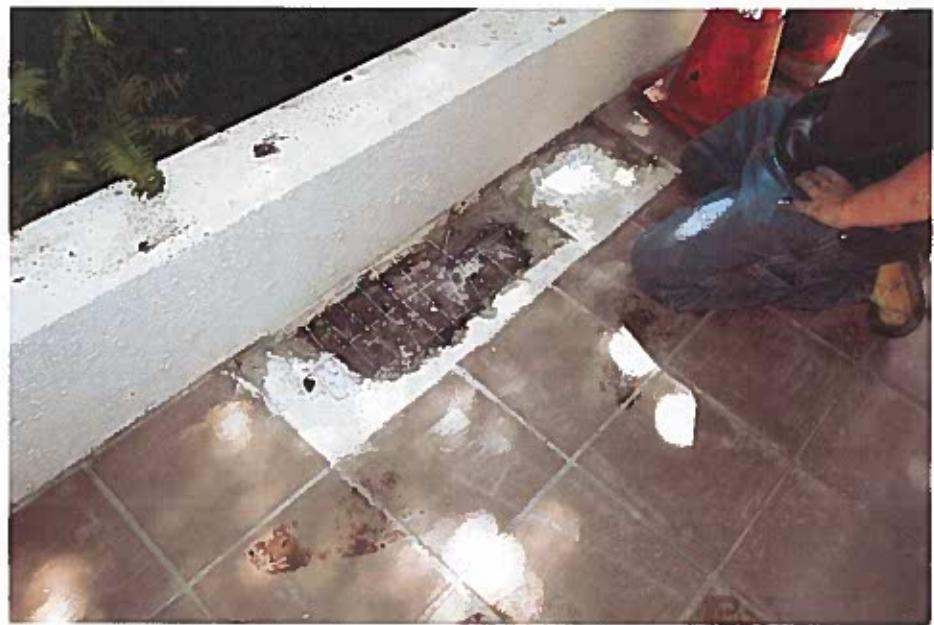
Figure 19 DT location at the walkway adjacent to the planter area.

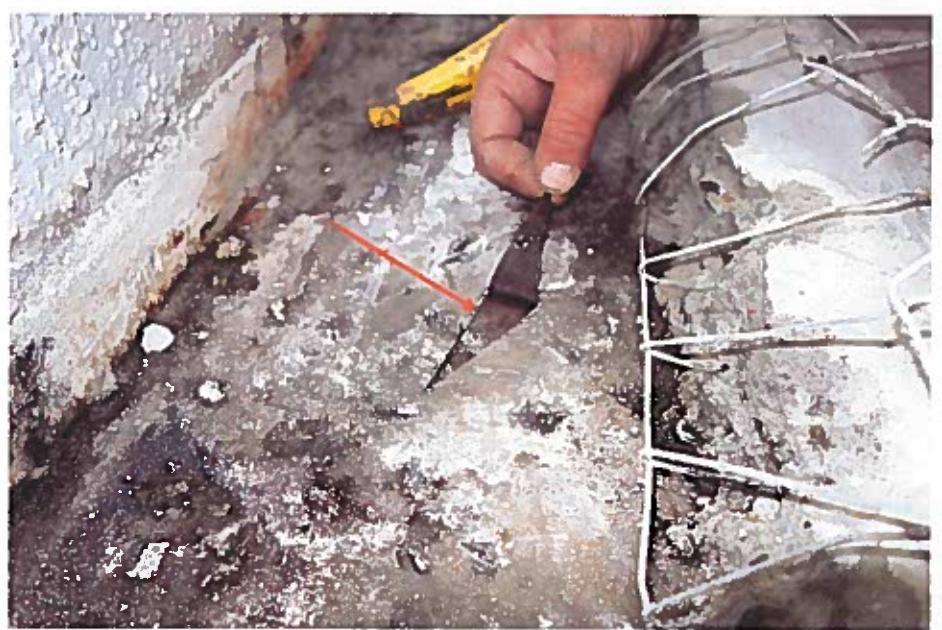
Figure 20 Adhesion pull-test was performed on the waterproofing membrane. Adhesion was poor.

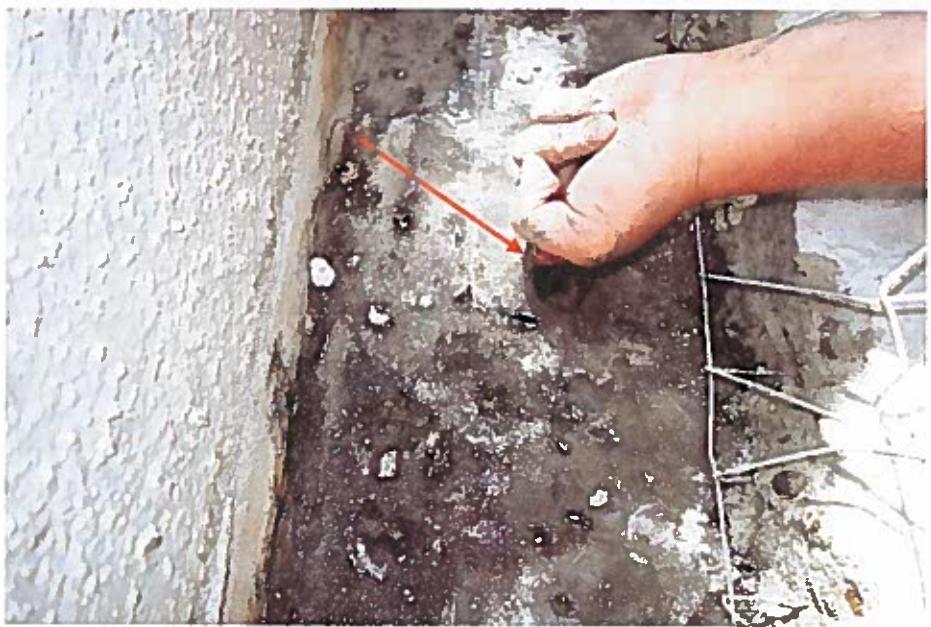
Figure 21 Note the void in the membrane where it is unadhered to the slab below.

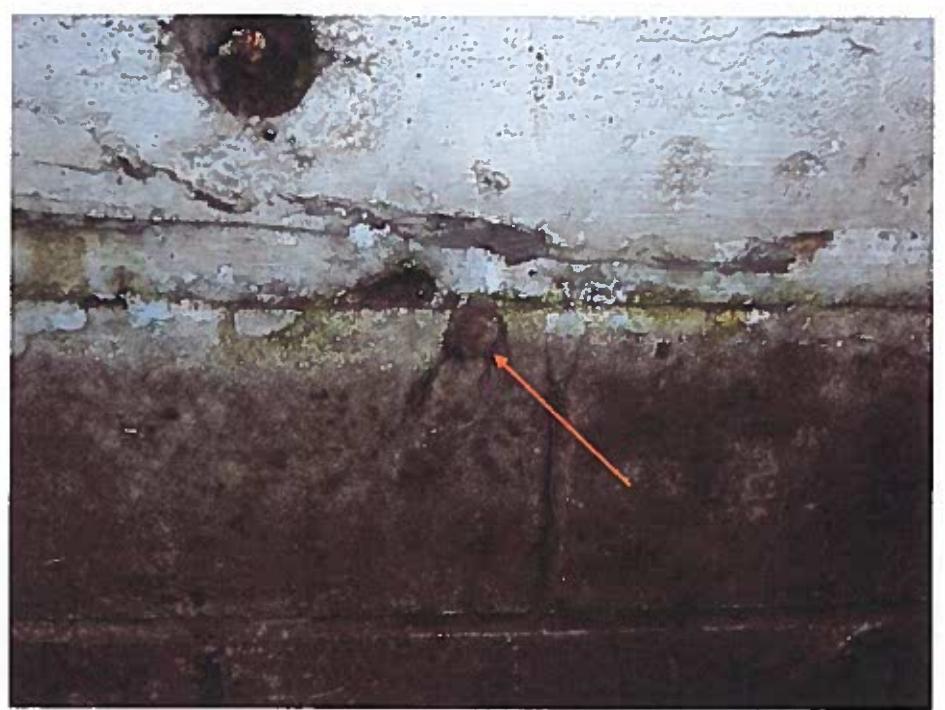
Figure 24 Close-up of attachment pin. Attachment frequency was insufficient.

<u>Foundation wall waterproofing</u>: The foundation wall waterproofing requires replacement due to extensive water intrusion through the waterproofing membranes. The foundation wall will need to be exposed, with overburden removed, in order to access and replace the waterproofing membrane. This will include the removal of grasses, trees, plantings, rocks, etc. adjacent to the wall. Self-adhering membrane is the proposed waterproofing system.

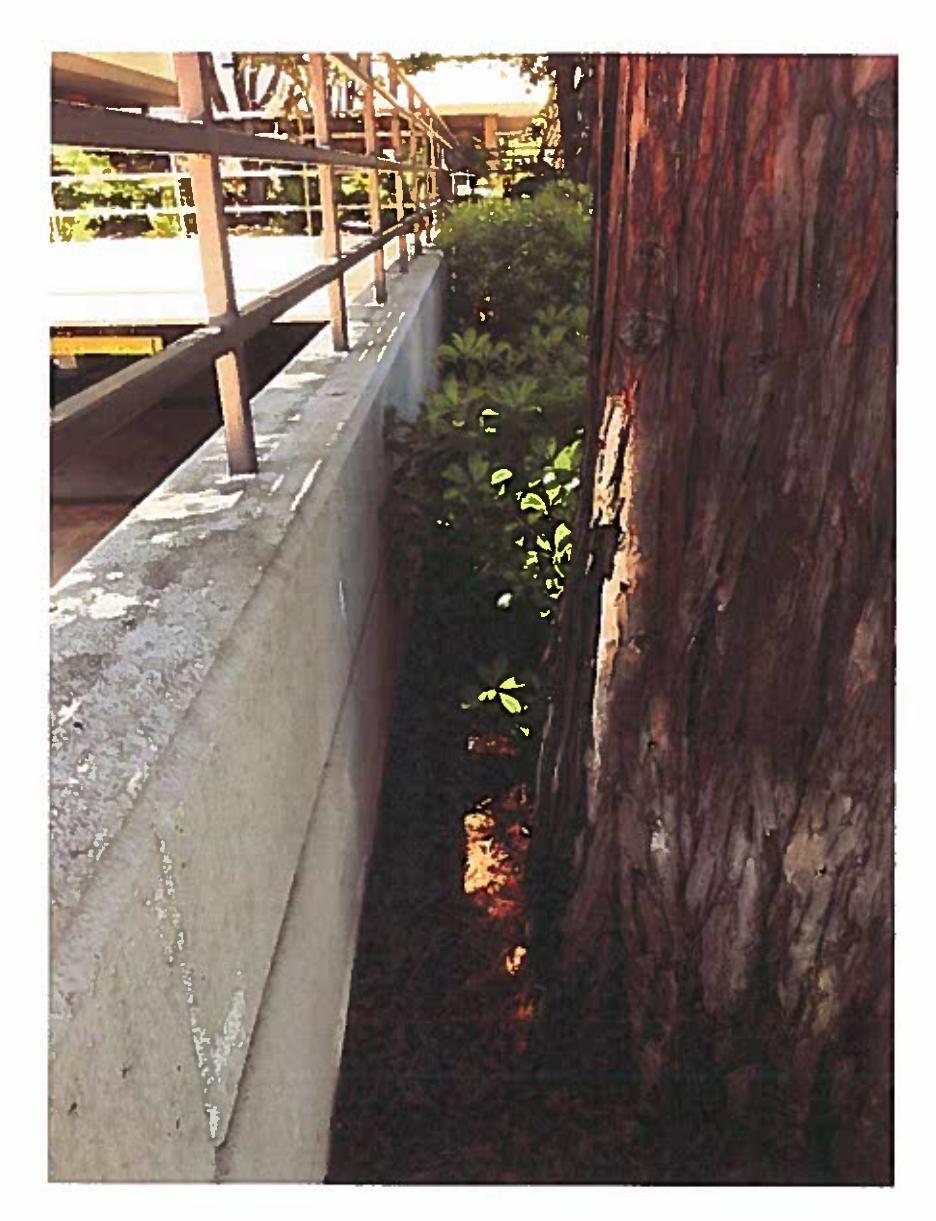
Photo 4 - Redwood trees close to the basement retaining wall

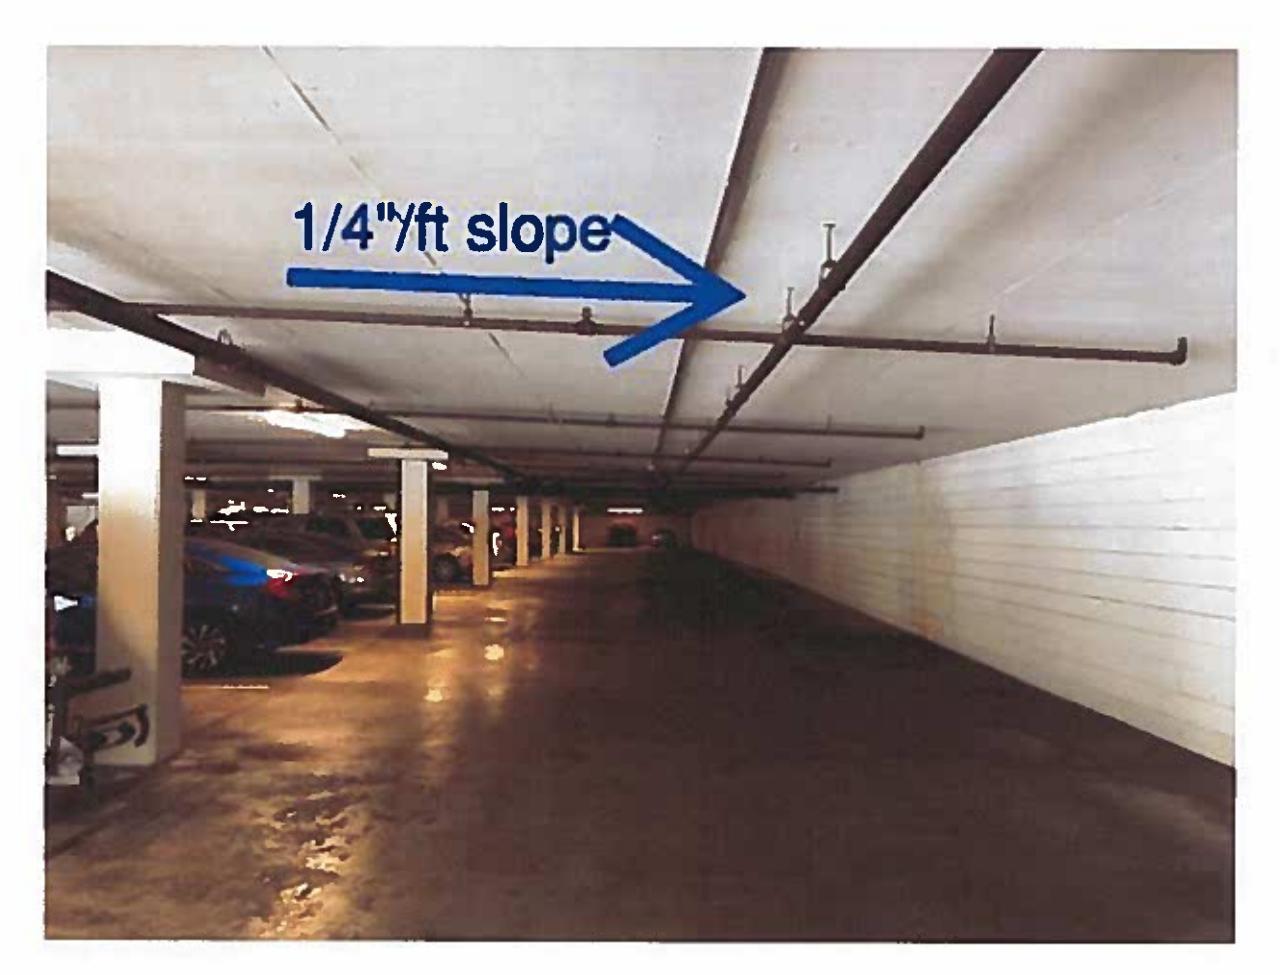
Photo 5 - Podium slope between gridlines H1 & J looking east

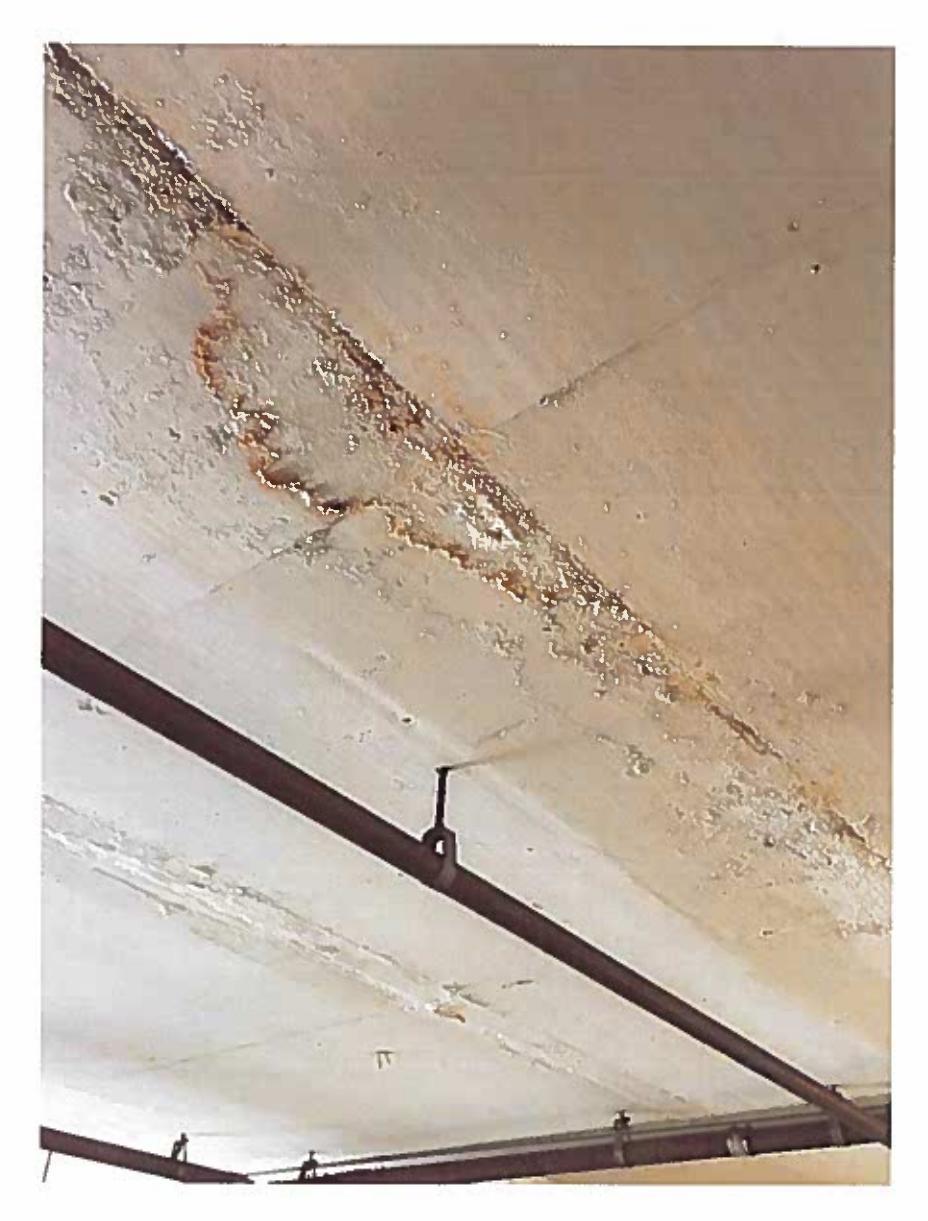
- **1.06** Observed at gridlines 6.8/B.5, there were water stains on the underside of the podium slab at the edge of the closure pour. See photo 7 & figure 1. There could be potential corrosion issues for the reinforcement crossing the closure pour and the P/T anchorage at the edge of the closure pour. The condition of the concrete and the waterproofing membrane above should be investigated.

Photo 7 - Concrete discoloring at the closure strip near gridline 6.8/B.5

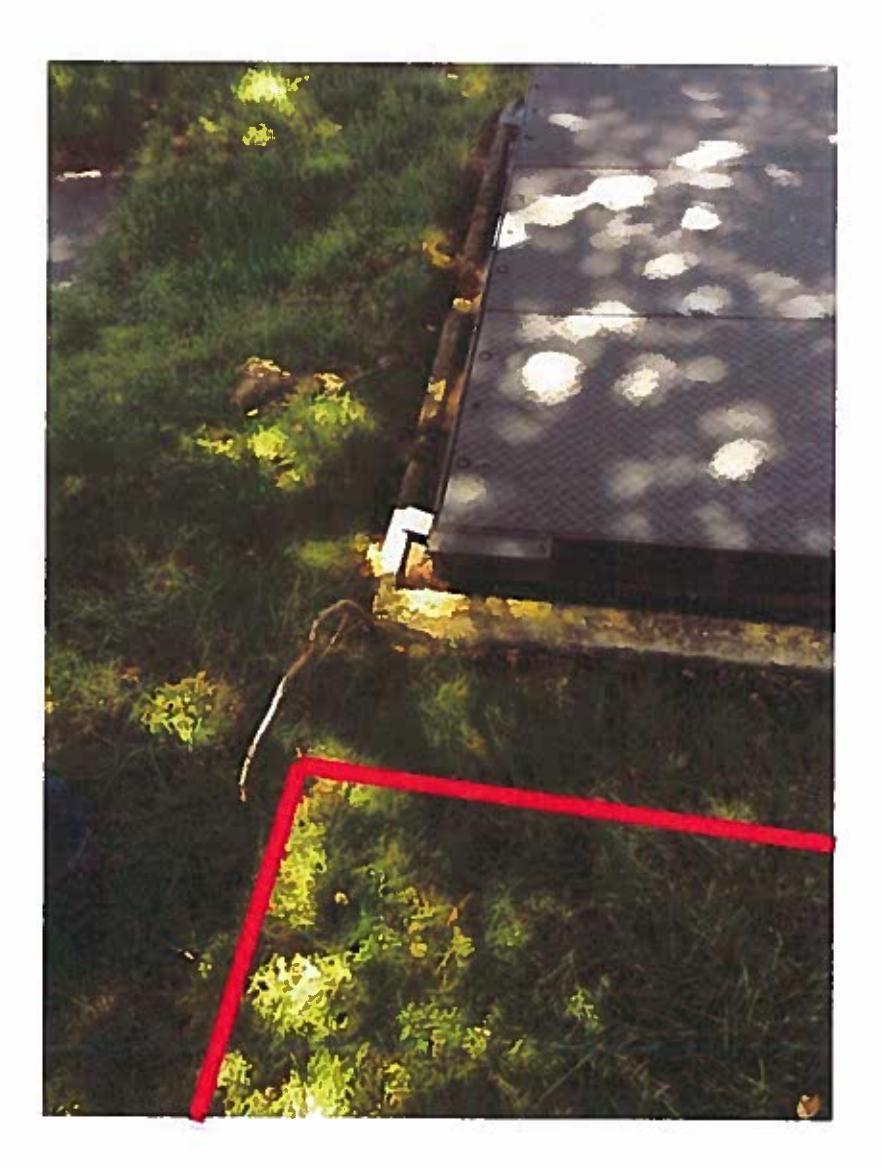
- 1.03 Observed the region above the podium slab at gridline 1/J. See figure 1 and photos 8-9 for approximate edge of podium slab overlaid on the existing landscaping. The edge of podium slab is near some utility pits/boxes as seen in photo 9. Note that access to the top of the podium slab to observe the condition of the concrete and waterproofing membrane would require removal of the existing landscape in local areas.

Photo 8 - Approximate edge of podium shown in red

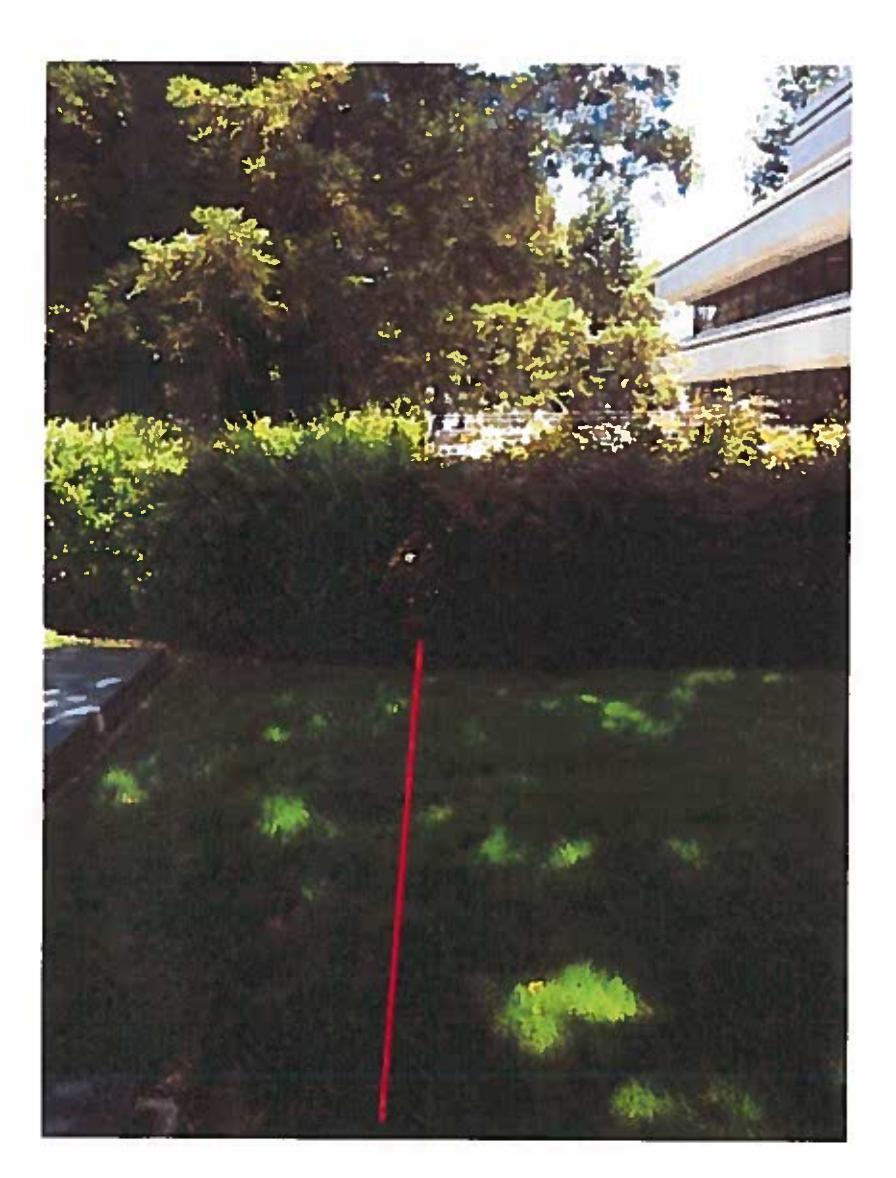
Photo 9 - Approximate edge of podium shown in red. Looking south.

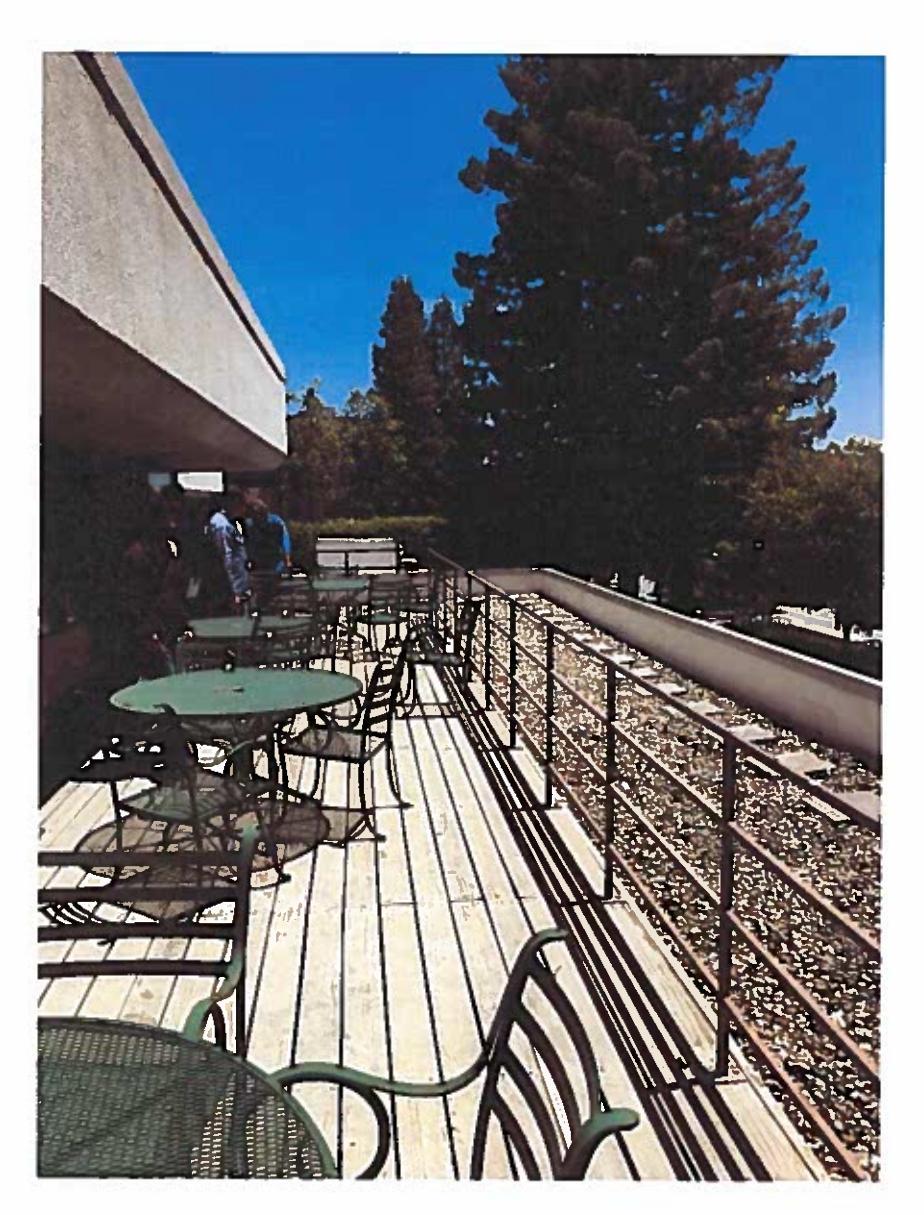
- 1.07 Observed the existing level 2 wood deck over the concrete P/T slab between gridlines 3-5 & G.8-H.1. See photo 10. It was discussed that the deck may be expanding to the edge of the structure near gridline H.1 in the future.

Photo 10 - Level 2 wood deck over the P/T concrete slab

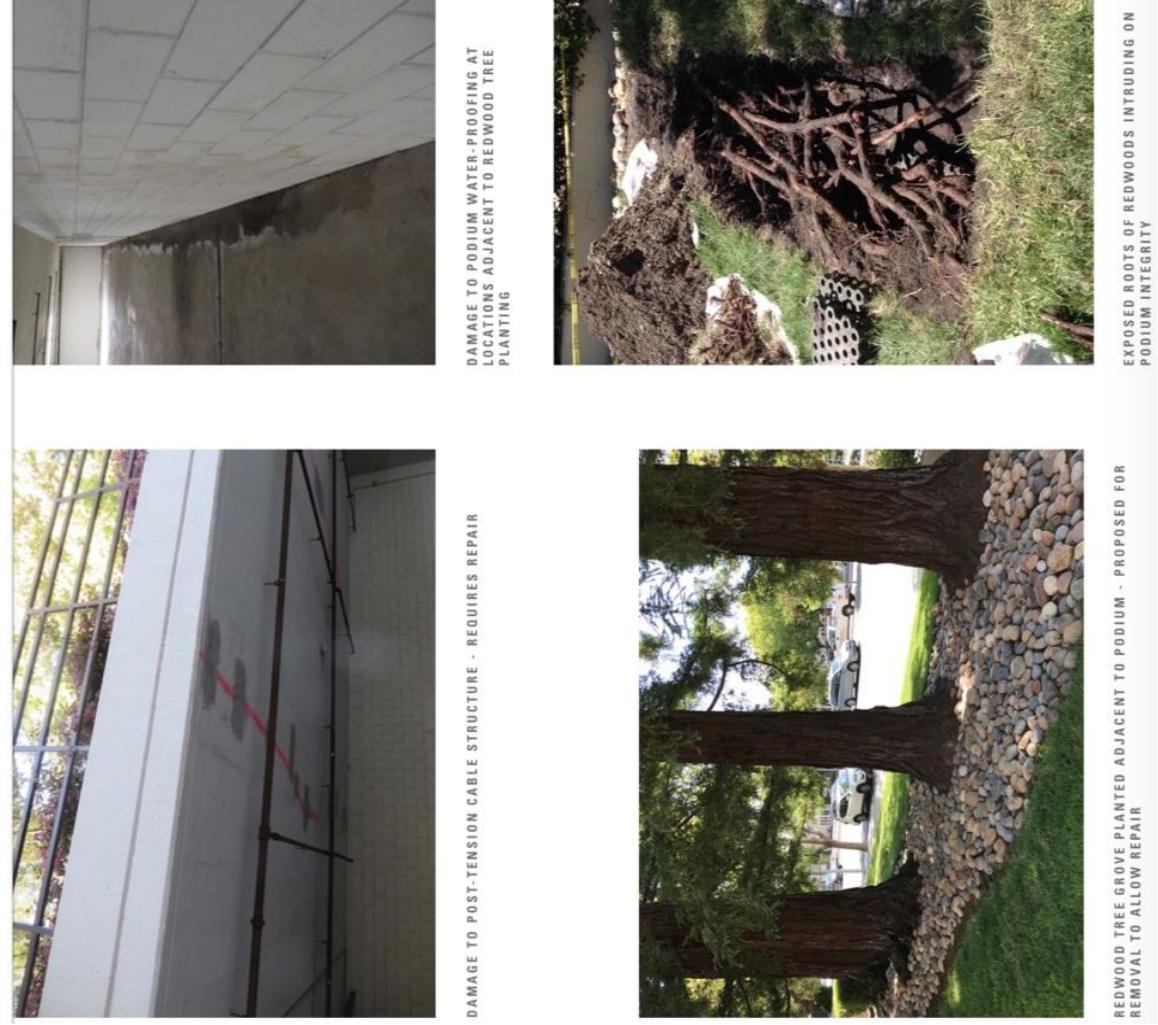
EXISTING LANDSCAPE CONDITIONS AT FRONT OF BUILDING (SOUTH SIDE). EXTENSIVE TURF LAWN PLANTING WITH REDWOODS INTRUDING UPON PO-DIUM STRUCTURE

A-1.7 - Existing conditions at 1000 El Camino Real.

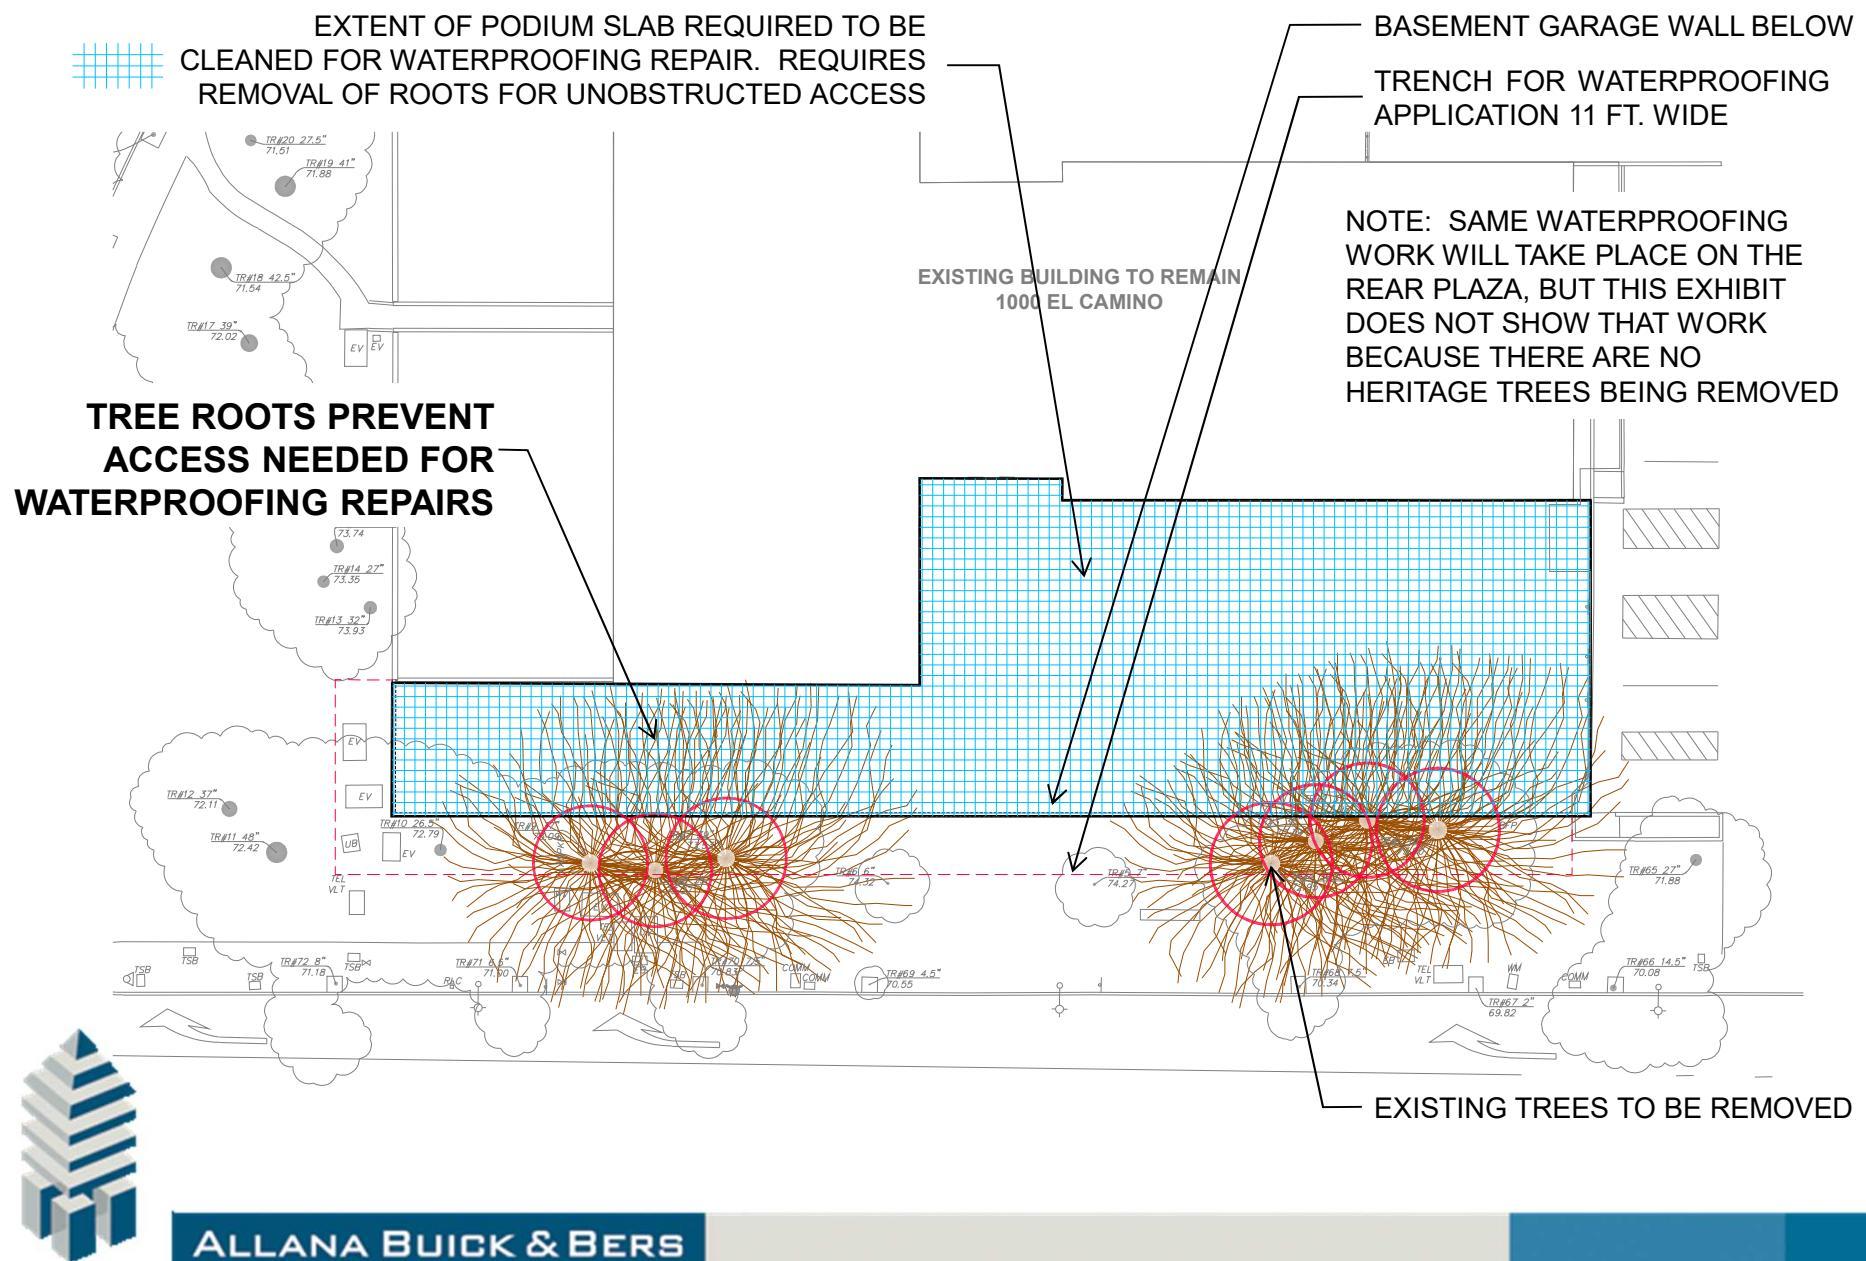
CURRENT CONDITIONS REQUIRED ACCESS AREAS AT THE PODIUM SURFACE
