Environmental Quality Commission

REGULAR MEETING AGENDA

STAFF REPORT - AMENDED

On November 8, 2017 a permit application was started to remove seven coast redwood trees at 1000 El Camino Real to address water damage in the underground parking garage (Attachment A.) The below grade parking garage and podium structurally supports the entire office building.

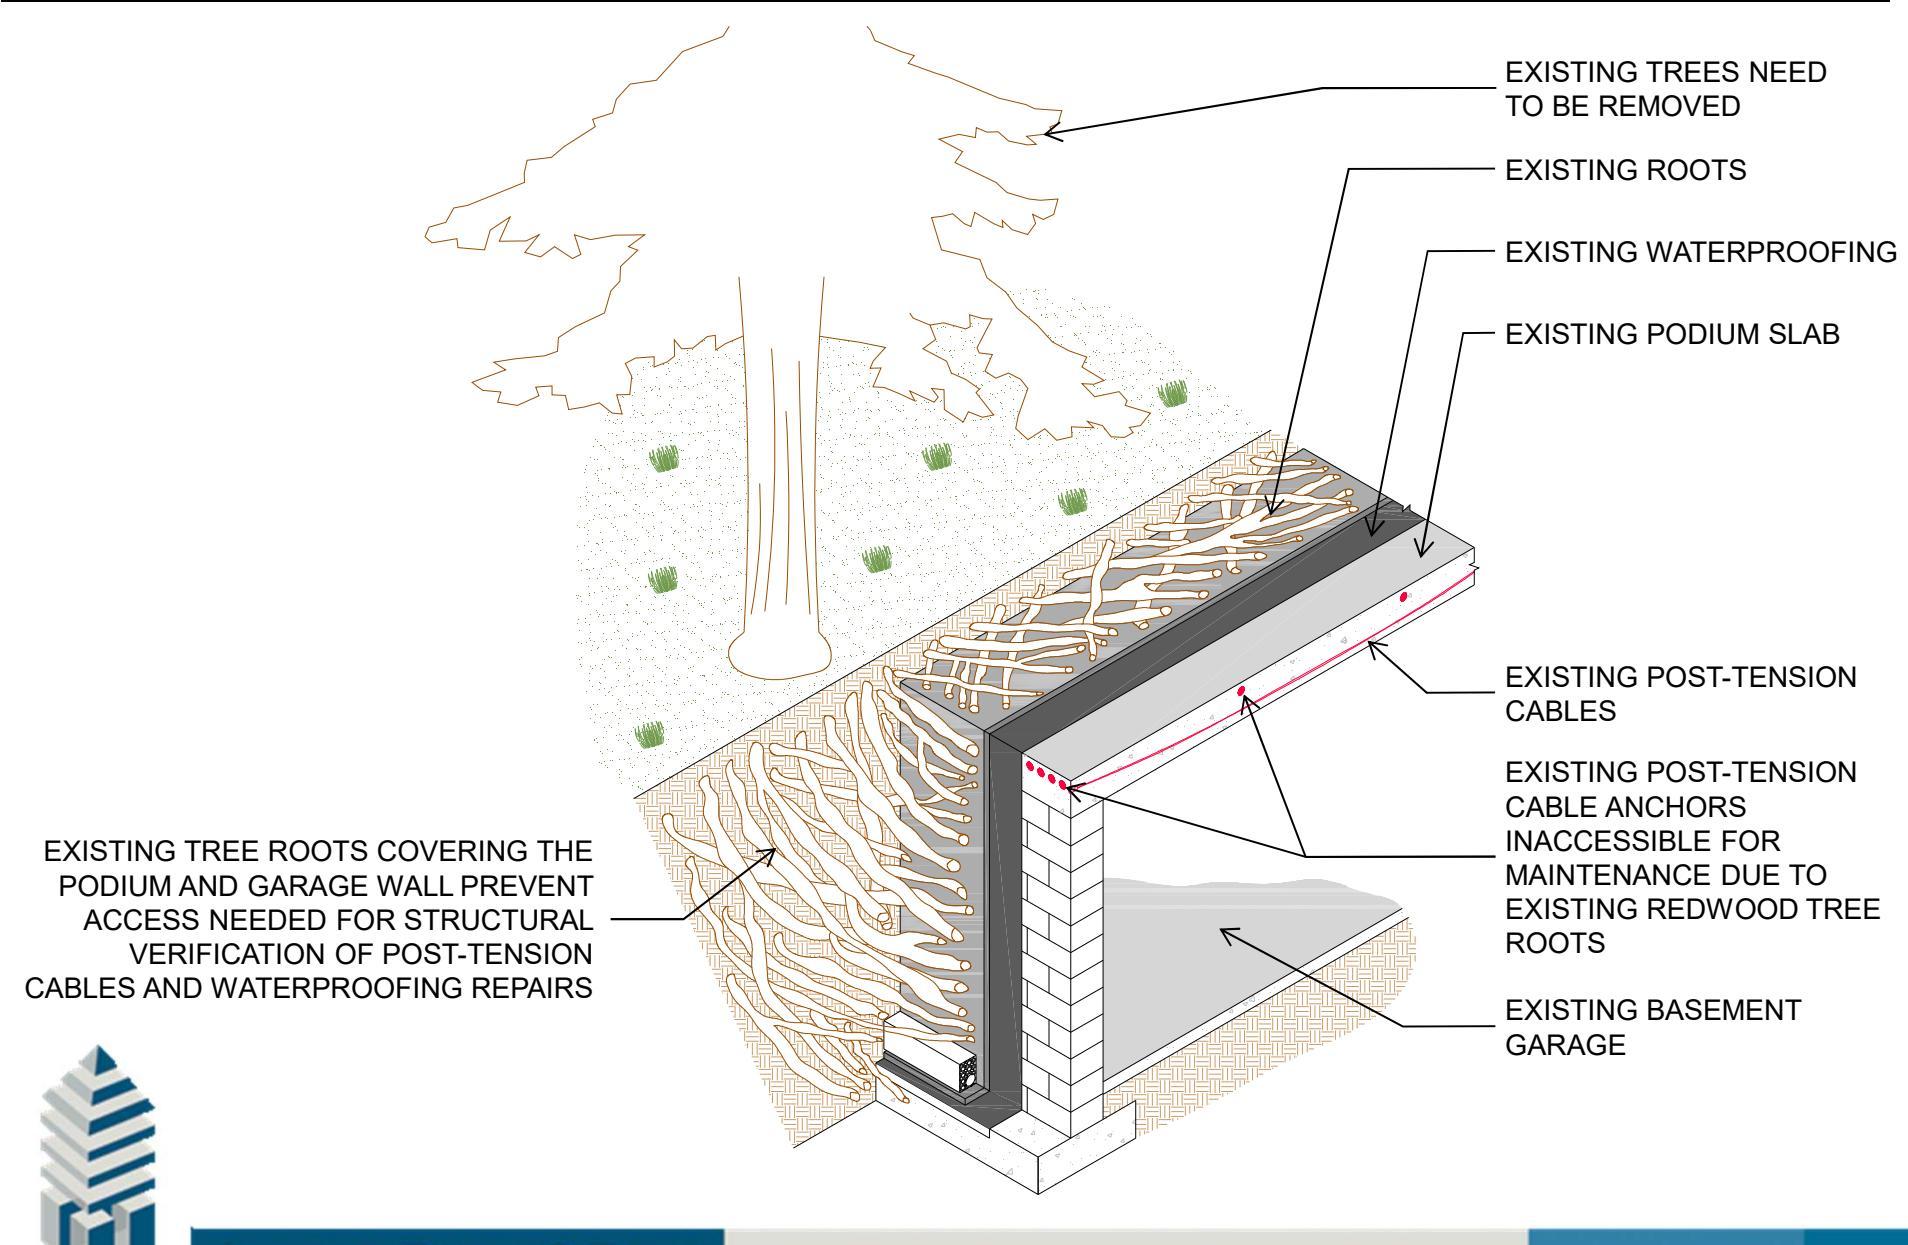
CUTAWAY VIEW – PREVENT ACCESS NEEDED FOR STRUCTURAL VERIFICATION OF POST-TENSION CABLES AND WATERPROOFING REPAIRS

<u>Podium waterproofing</u>: The podium waterproofing requires replacement due to extensive water intrusion through the waterproofing membranes. All overburden above the podium must be removed in order to access and replace the waterproofing membrane. This will include the removal of grasses, plantings, trees, rocks, etc. above the podium. Hot rubberized asphalt waterproofing is the proposed waterproofing system.

The large trees and plantings along El Camino Real require removal due to the extent of root network over the podium area and along the foundation wall. There is no method for repairing or replacing the existing waterproofing without complete access.

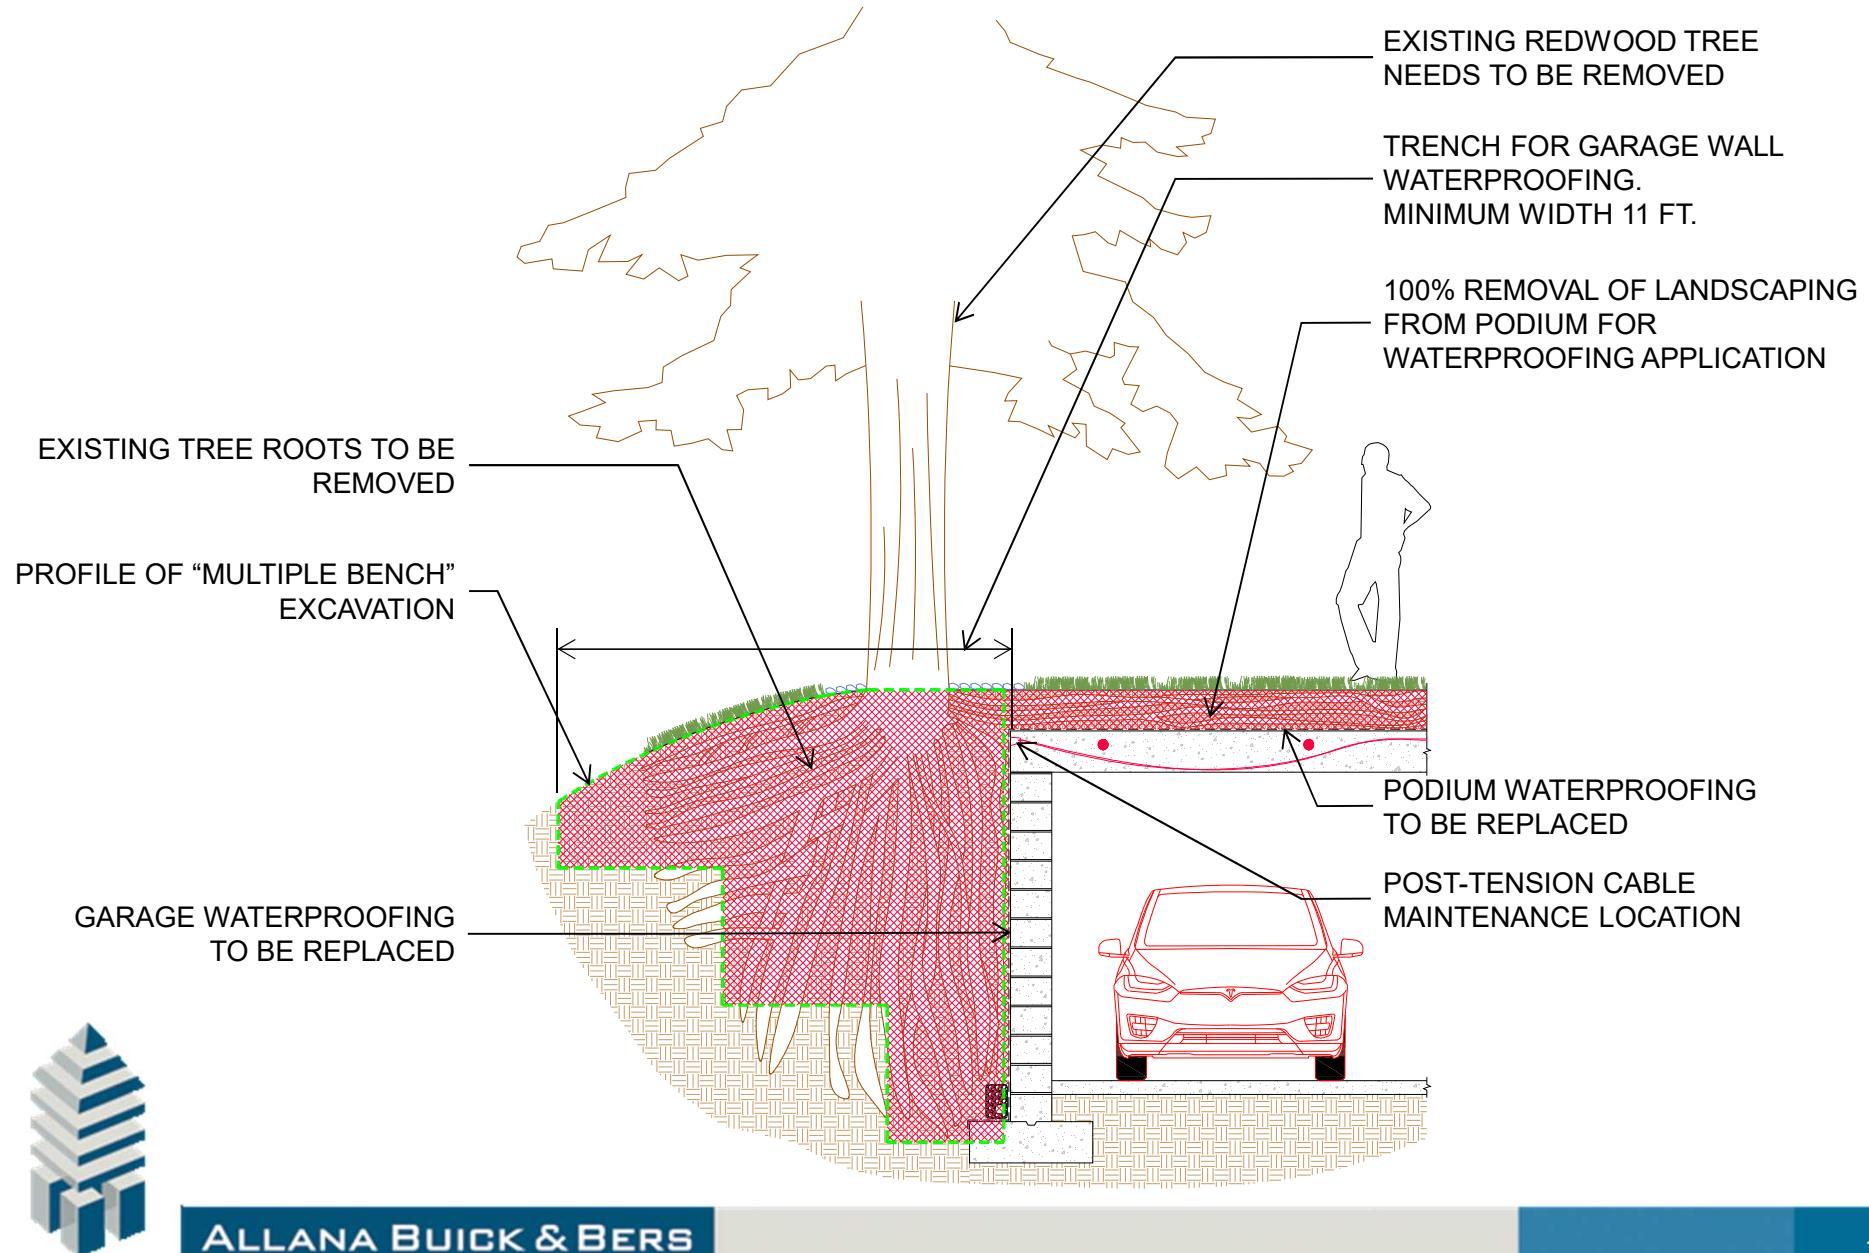
OPTION 3 PHASED REDWOOD TREE REMOVAL [INFEASIBLE]

"**Conclusion:** This option is infeasible because phasing of the tree removal doesn't allow for complete access to the entire podium perimeter walls and surface to repair the waterproofing. Complete access requires removal of all seven existing trees and their root system".

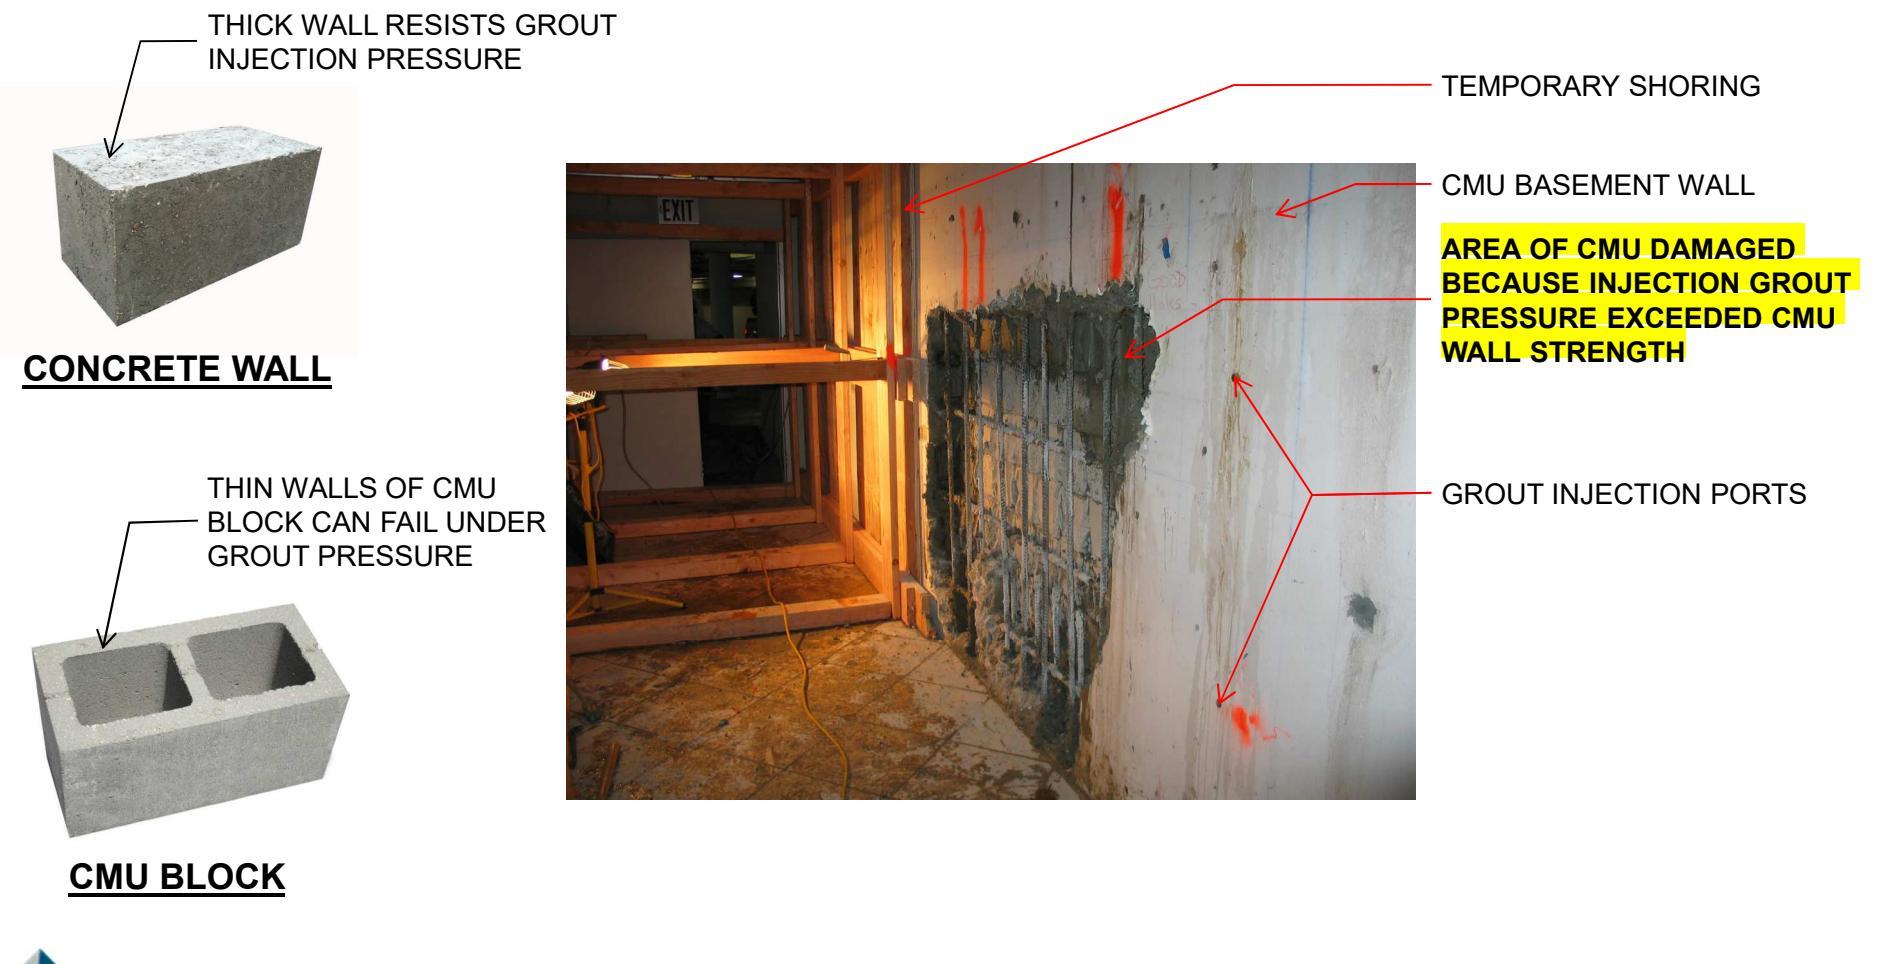
USING GROUT INJECTION FOR THE VERTICAL GARAGE WALLS

The grout is injected at high pressure to do this. This is not a problem with a thick concrete wall. But a thin-walled CMU block cannot stand up to the pressure of the grout, and will often crack or break, making the wall weak and requiring structural repair. Unfortunately, the basement walls at 1000 El Camino are CMU and thus not suitable for grout injection and would be prone to a blow-out. The following slide shows an example of a different project where a blow-out occurred.

"**Conclusion**: This option is infeasible because it does not provide access to the exterior of the podium concrete slab to perform the waterproofing. The combination of the existing trees and their extensive and intertwined roots make is impossible to repair the waterproofing without their removal. Grout injection is also not an option for the podium surface because there is insufficient soil pressure to confine the grout between the podium and the landscape soil."

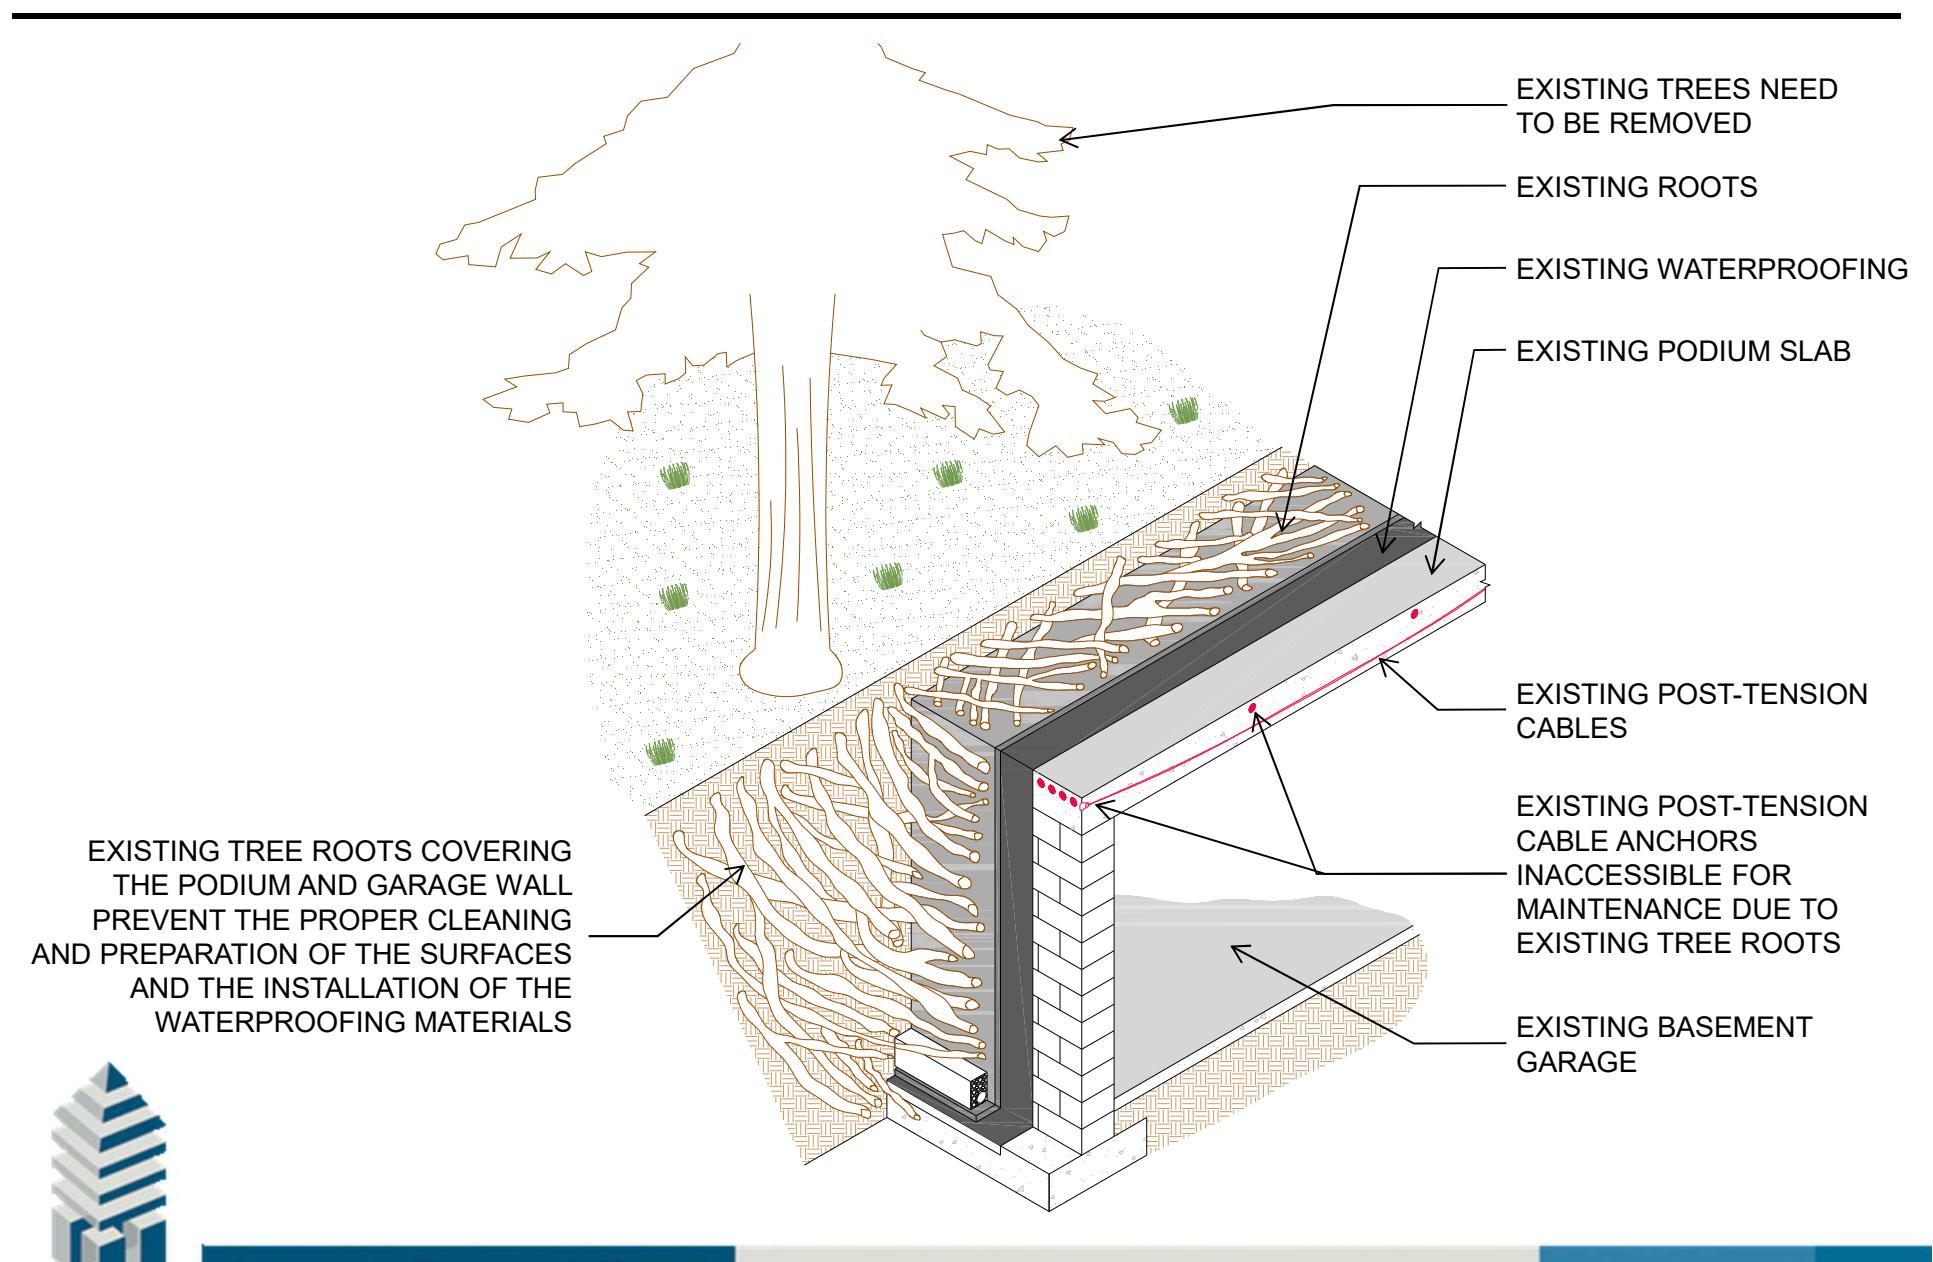
The extensive network of roots over the podium area are causing damage to the waterproofing through abrasion and penetration. The fine roots are getting below the filter fabric and burrowing into the membrane. This creates pathways for water intrusion. Additionally, the membranes have poor adhesion to their structural substrates, which is allowing water intrusion to travel below the waterproofing.

CUTAWAY VIEW - ROOTS INTERFERE WITH WATERPROOFING WORK

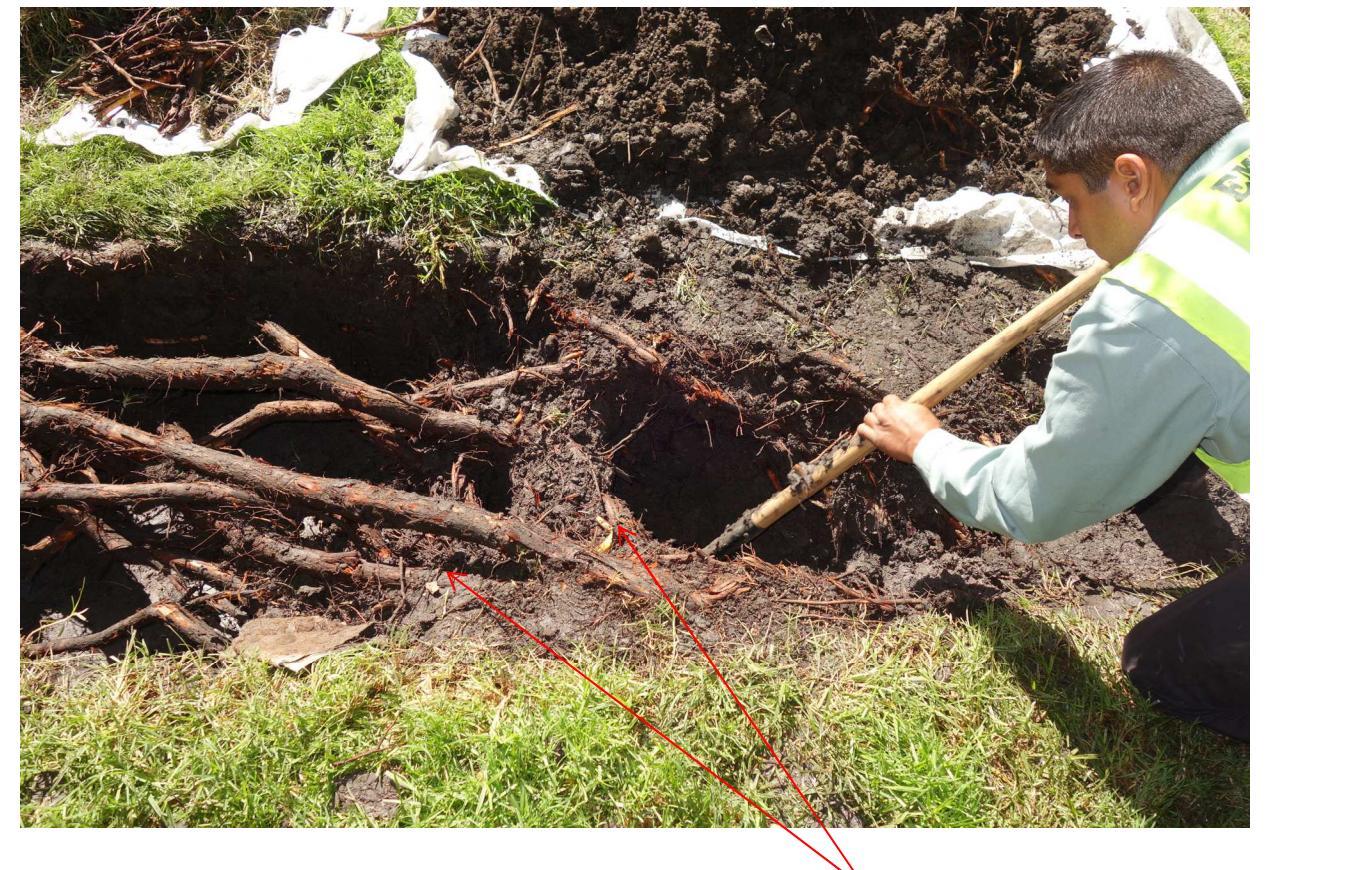
ROOT EXCAVATION

EXISTING TREE ROOTS

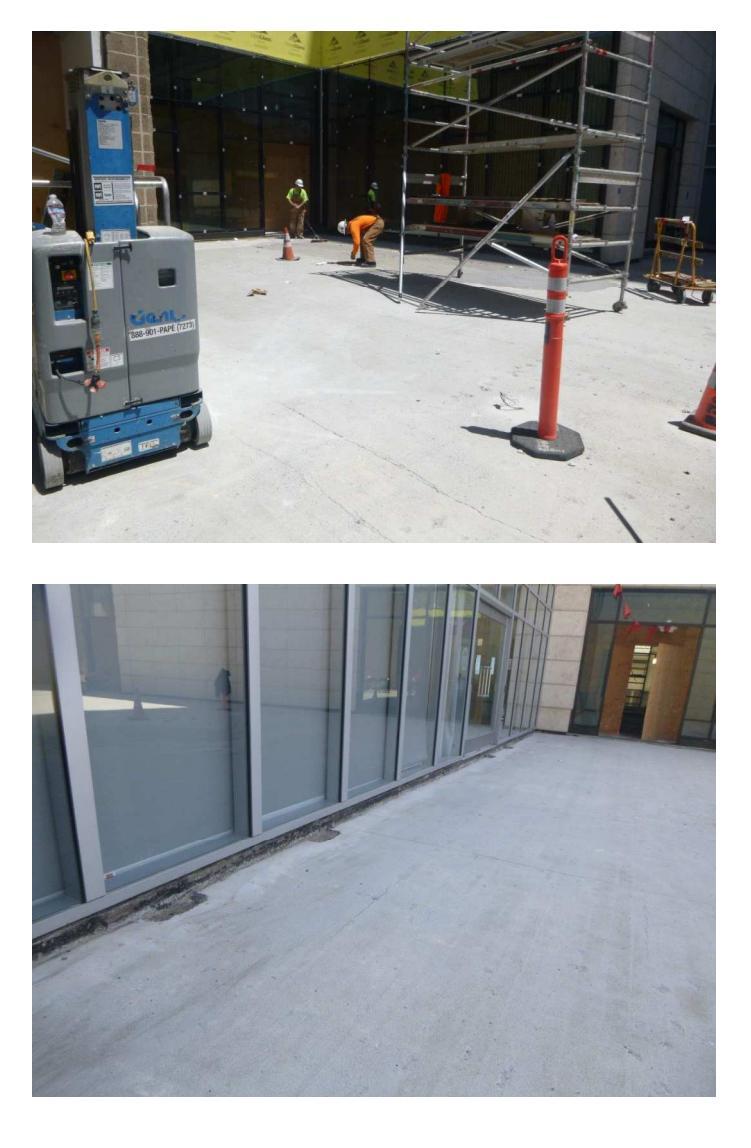
PHOTOS OF CLEAN PODIUM SLAB

Existing waterproofing membrane must be completely removed. Then, existing concrete slab is to be cleaned free of all dirt, dust and debris and be completely dry before new waterproofing can be installed. This impossible with tree roots in the way
