# Environmental Quality Commission

## REGULAR MEETING AGENDA

## Tree Removal Request for

REGARDING: FOUNDATION INSPECTION AND CONDITION ASSESSMENT  
2458 Sharon Oaks Drive  
Menlo Park, CA.

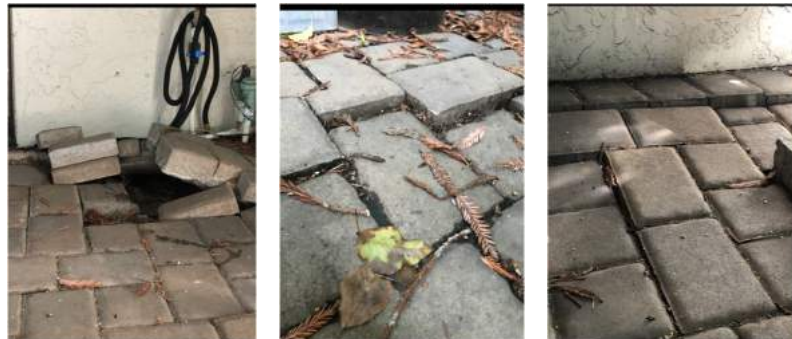
Damage caused to stairway

Damage to patio flooring

The three Coast redwoods all receive fair ratings for both Health and structure based on the table below. The trees have DBH's of 54", 53.5" and 25.5" respectively. These three trees stand 90', 90, and 75' with canopy spreads of 45', 35' and 25'. The images below show the damage being caused by the roots of the large Coast redwoods.

Redwoods are frequently planted as a “quick screening tree” in developments. The problem is that nobody thinks about how large these trees grow (120’+) and how aggressive their roots systems are. You cannot plant Redwoods in the vicinity of structures without expecting major damages. Sharon Oaks HOA will experience this problem again and again as the trees mature at this site. All of the Redwoods near structures will eventually need to be removed and replaced. There are several ongoing issues with Redwoods and complaints from homeowners. These three Redwoods represent the most urgent need. The parking lot adjacent to these trees was recently redone and it is already showing signs of new disruptions. The adjacent homeowners are also complaining about patio encroachments and damage to their slab foundations.

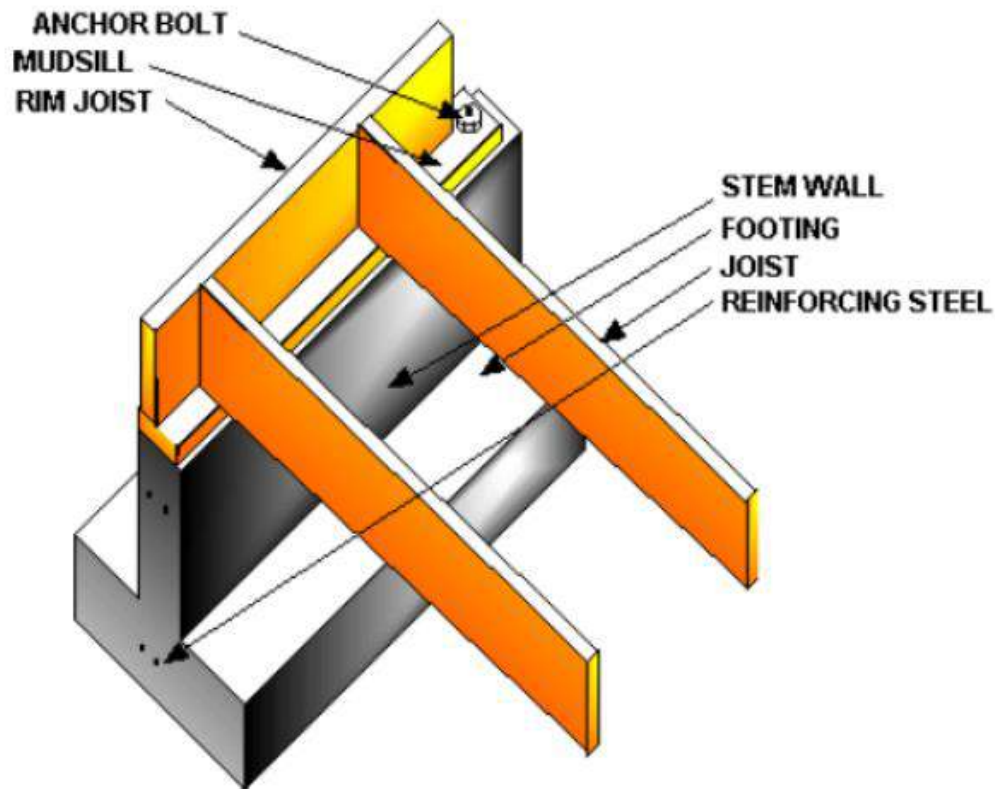
**SPREAD FOOTING:** A spread footing foundation, as the name implies, is designed to distribute (spread) the structures loads over a wide footprint on the near surface soil. The footing configuration is illustrated below.

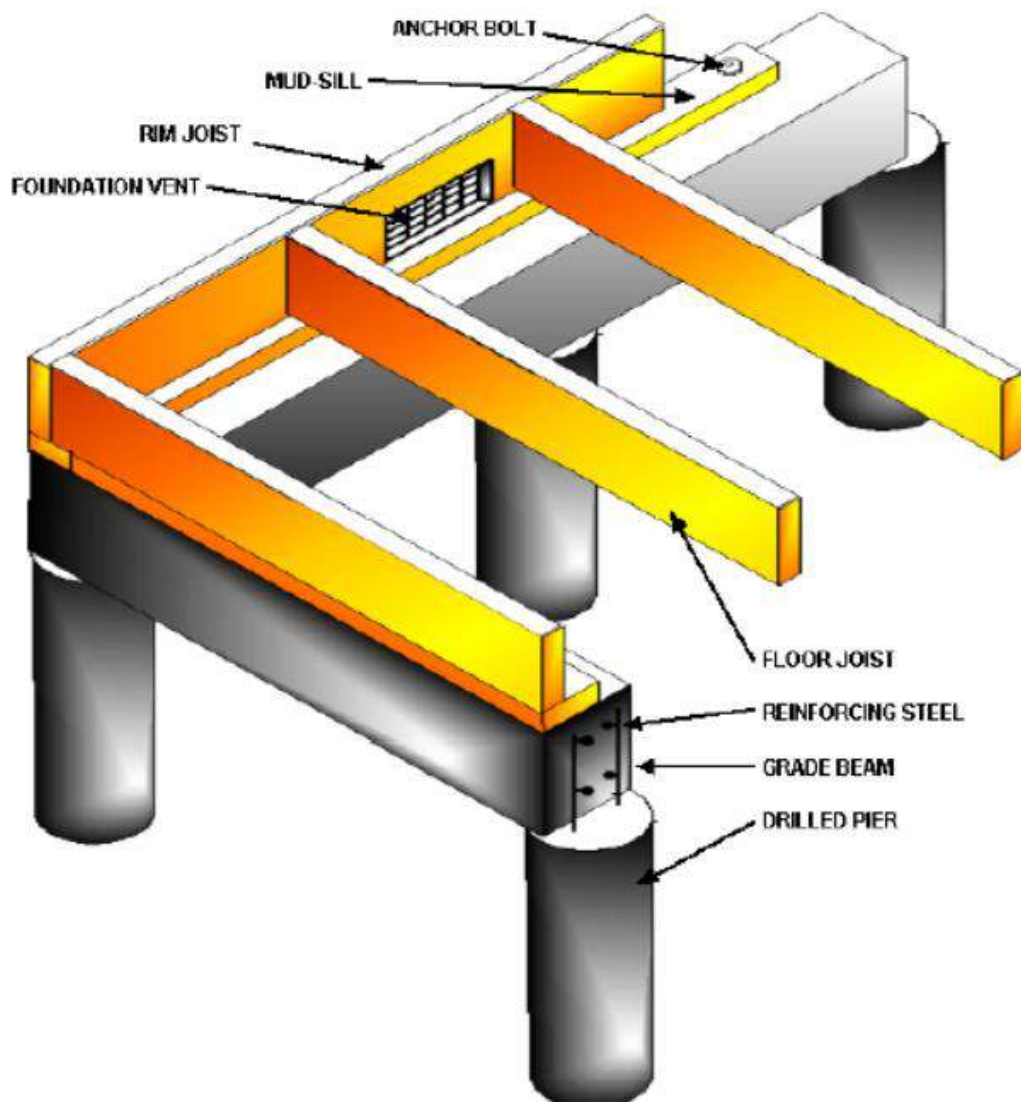
**PIER AND GRADE BEAM FOUNDATION:** Drilled piers are typically employed when fill is encountered, slopes are involved, or the near surface soil's bearing capacity is limited. Under these conditions, firm support is obtained by drilling to the depth necessary to provide both vertical and lateral restraint, filling the resulting hole with reinforced concrete. Each individual pier is then interconnected with reinforced concrete tie beams (grade beams). Please see illustration below.

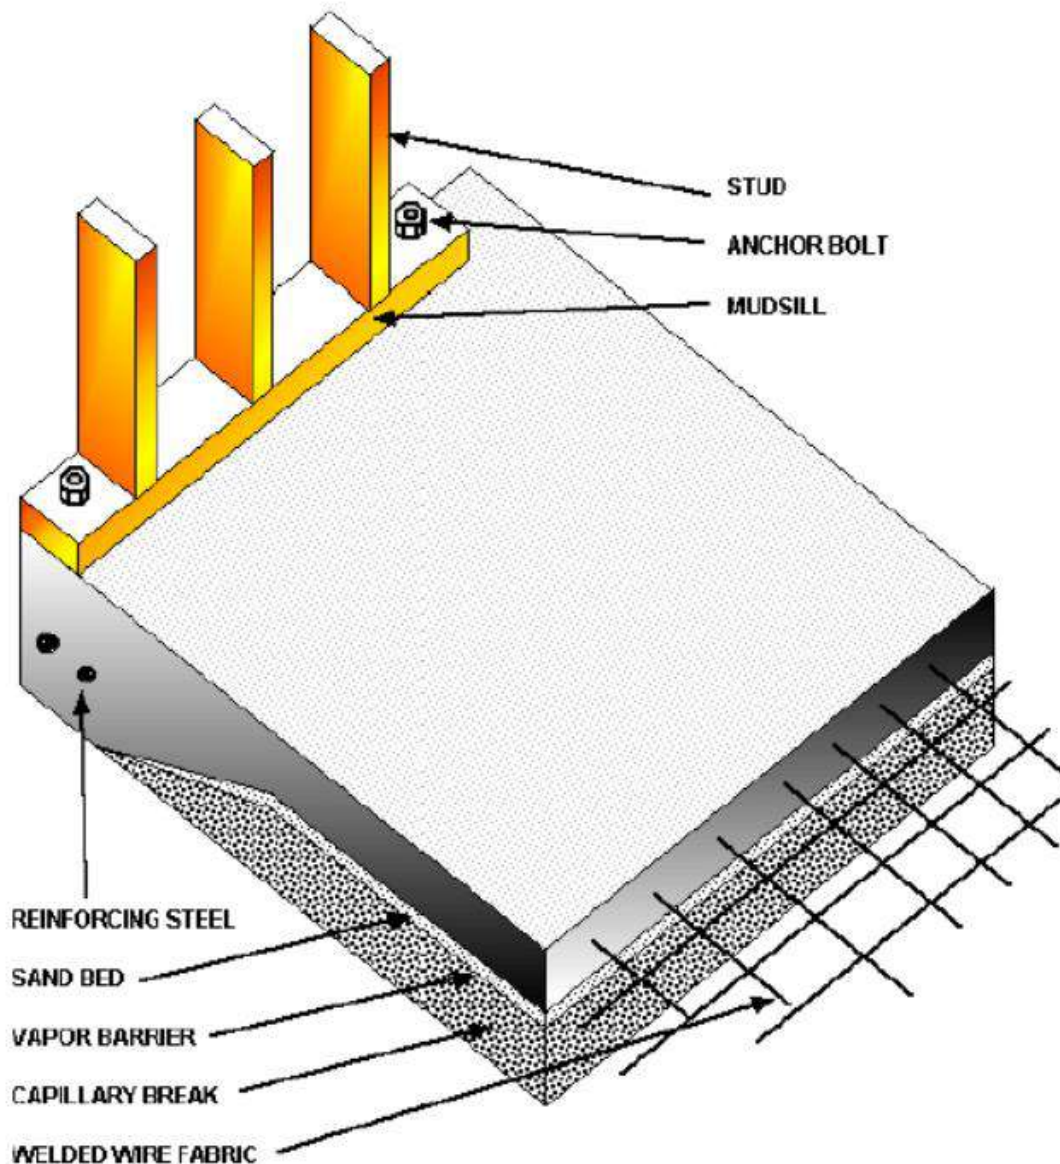
**SLAB-ON-GRADE FOUNDATION:** A slab-on-grade foundation is normally constructed over an engineered base incorporating a moisture barrier (polyethylene membrane) and sand bed. Like spread footing, a slab-on-grade is designed to distribute the structure's load over a wide area of supporting soil.

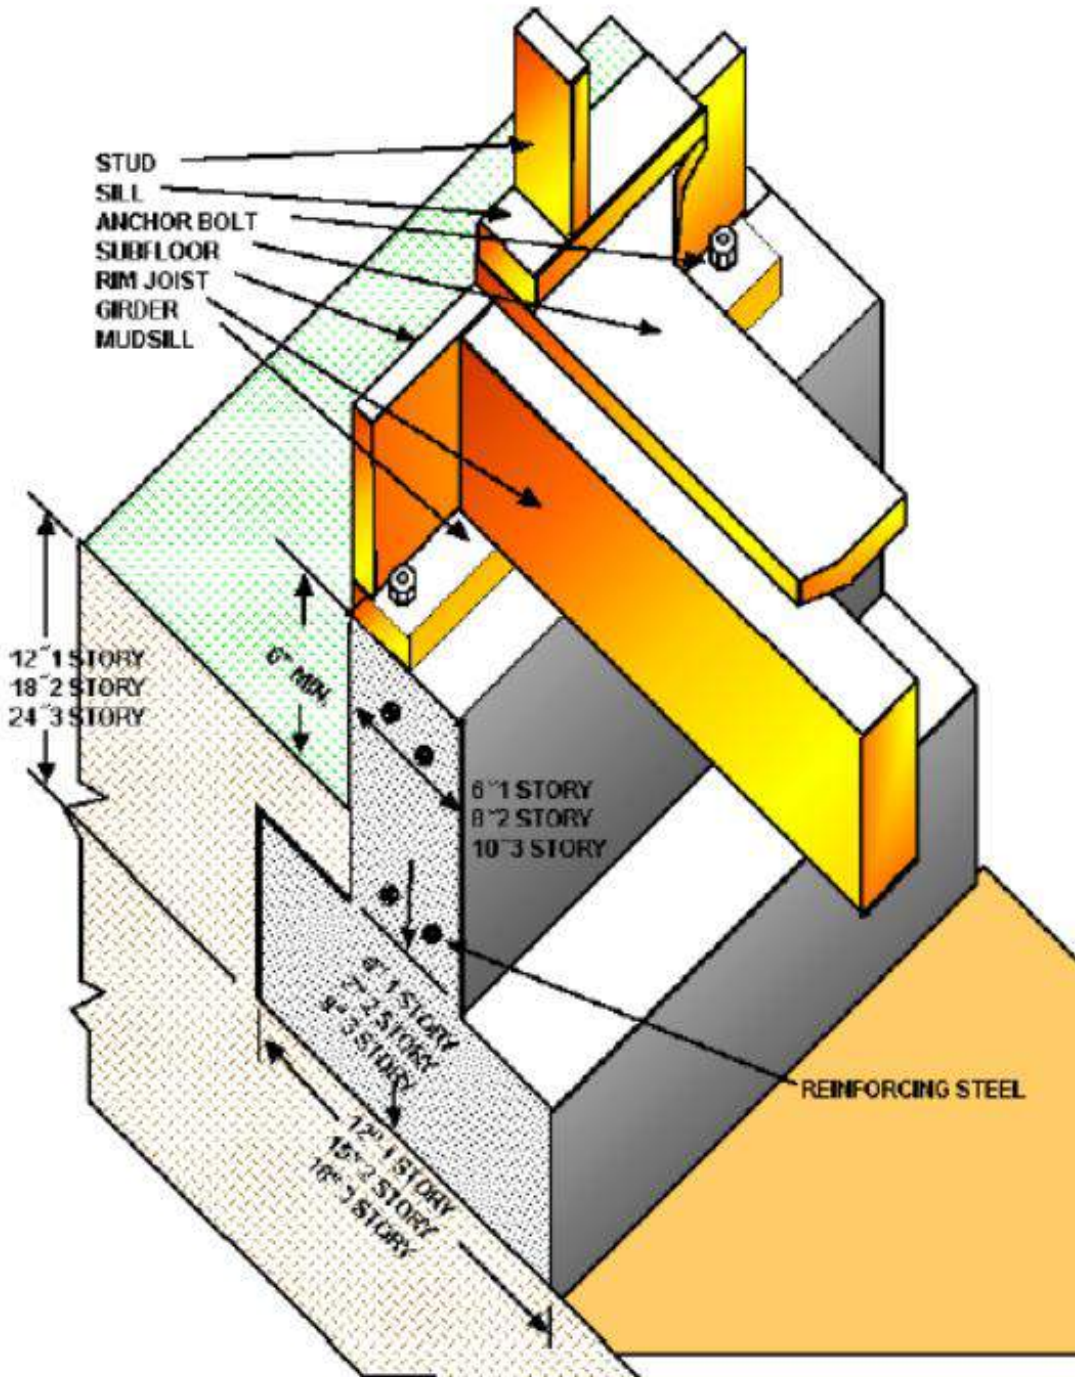
**MINIMUM "UBC" UNIFORM BUILDING CODE REQUIREMENTS  
FOR CONCRETE SPREAD FOOTING FOUNDATIONS**

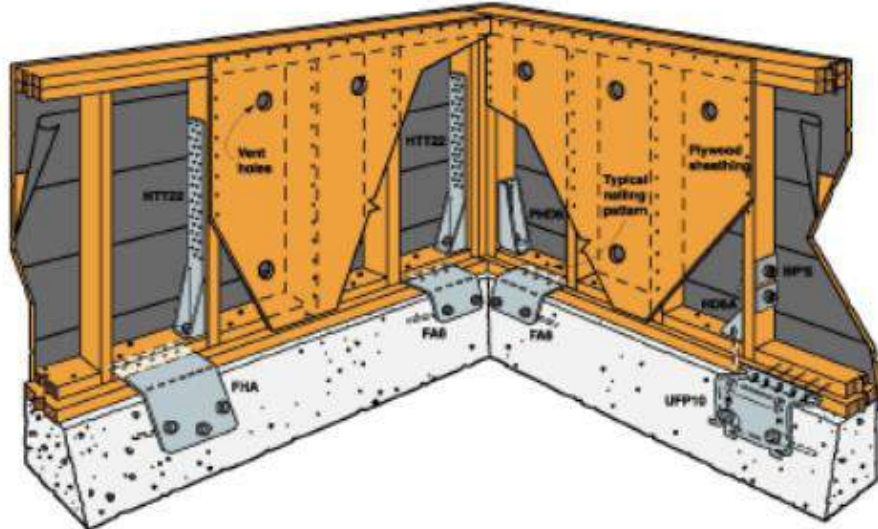
**SPECIAL HARDWARE FOR SEISMIC UPGRADE AND FOUNDATION REPAIR**

This illustration shows shearwall strengthening of a cripple wall (pony wall) area constructed between the mudsill and the floor framing system. Generally, the recommended structural panel is 1/2" 5-ply plywood or 7/16" OSB panels. The width of the panels required depends on the space between studs; the greater the distance between studs, the wider the panels should be. We recommend having vent holes drilled in the sheathing to eliminate moisture build-up which can lead to wood deterioration. Accurate and complete nailing of the structural panel to the stud, mudsill, and top plates is important to ensure that it performs adequately as a shearwall. Minimum nailing requirements is 8d nails nailed every 4" around the edges of the panel, and every 6" on center field nailing (along the studs).

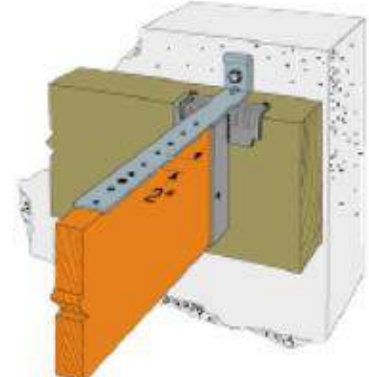
The steel strap assembly shown allows for a direct connection between the foundation and the subfloor joists.

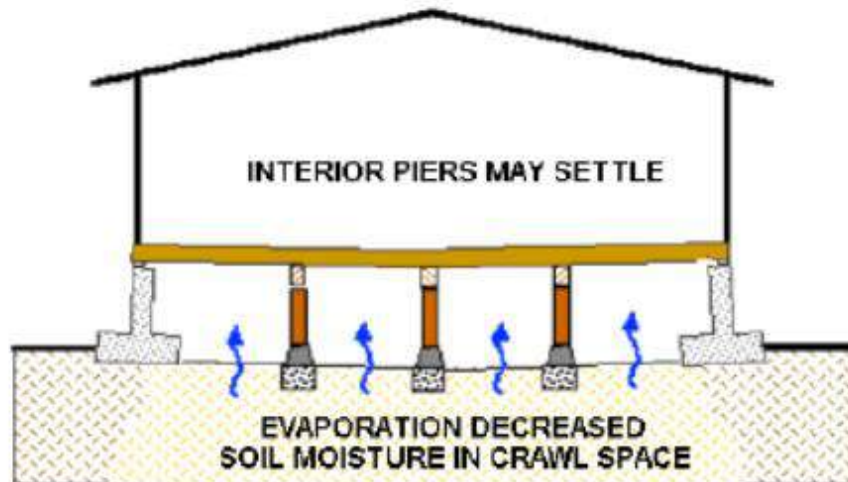
FOOTINGS OFTEN SETTLE WHEN SUPPORTED ON EXPANSIVE SOIL

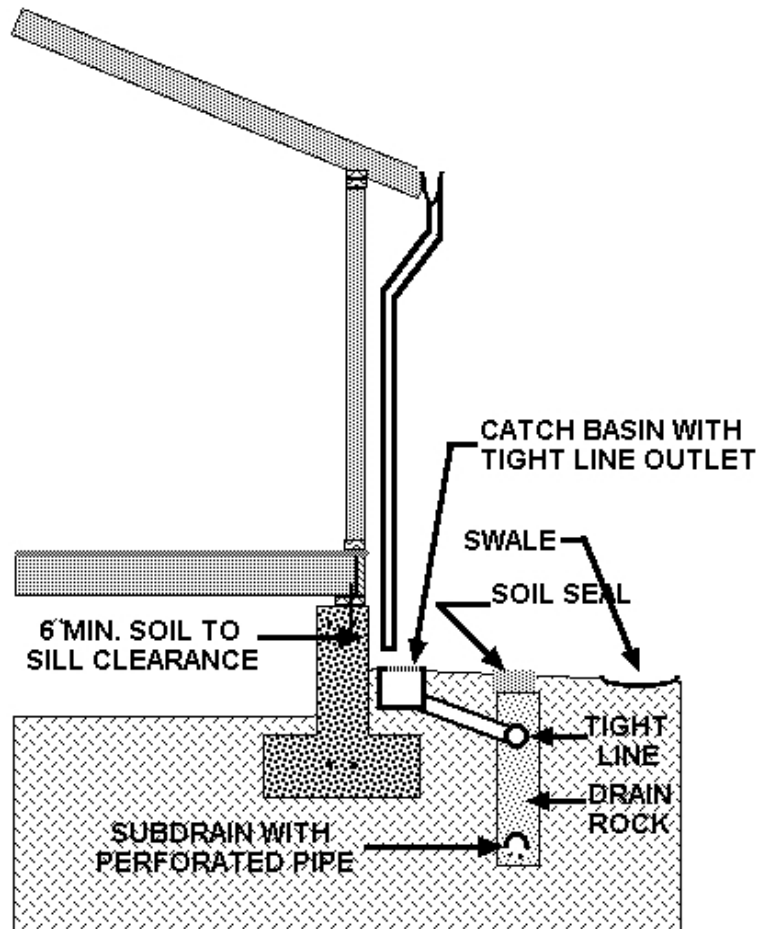
As an alternate to, or in addition to a sub-drain, it may be found cost effective to install a finger drain in the sub-area. A finger drain is constructed much like the perimeter sub-drain, but is typically positioned in the sub-area, just inside the perimeter foundation. A finger drain typically varies in depth from 6" to 15" and often outlets to an 18" diameter, 30" deep, cased sump that is provided with a float-switch activated pump.

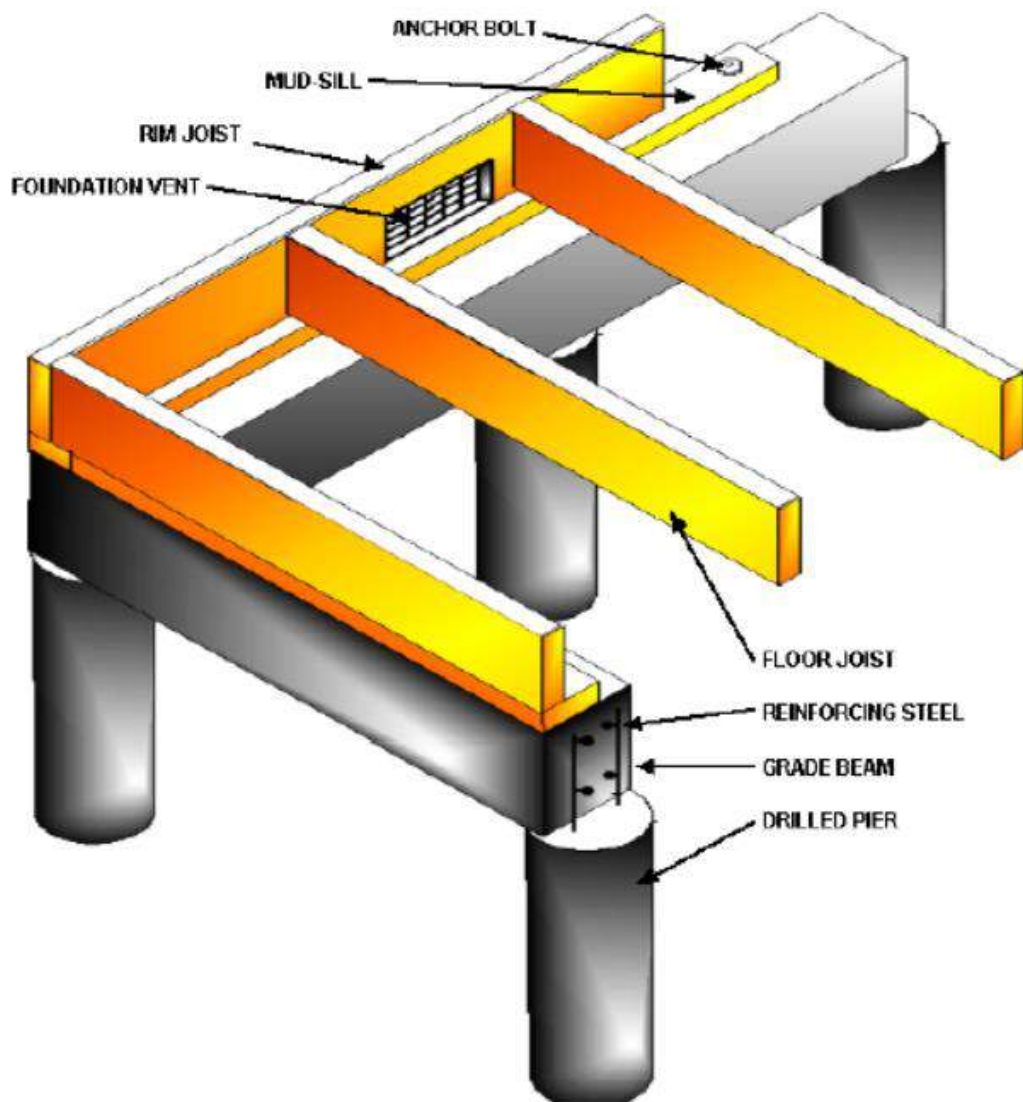
**PIER AND GRADE BEAM FOUNDATION:** Drilled piers are typically employed when fill is encountered, slopes are involved, or the near surface soil's bearing capacity is limited. Under these conditions, firm support is obtained by drilling to the depth necessary to provide both vertical and lateral restraint, filling the resulting hole with reinforced concrete. Each individual pier is then interconnected with reinforced concrete tie beams (grade beams). Please see illustration below.

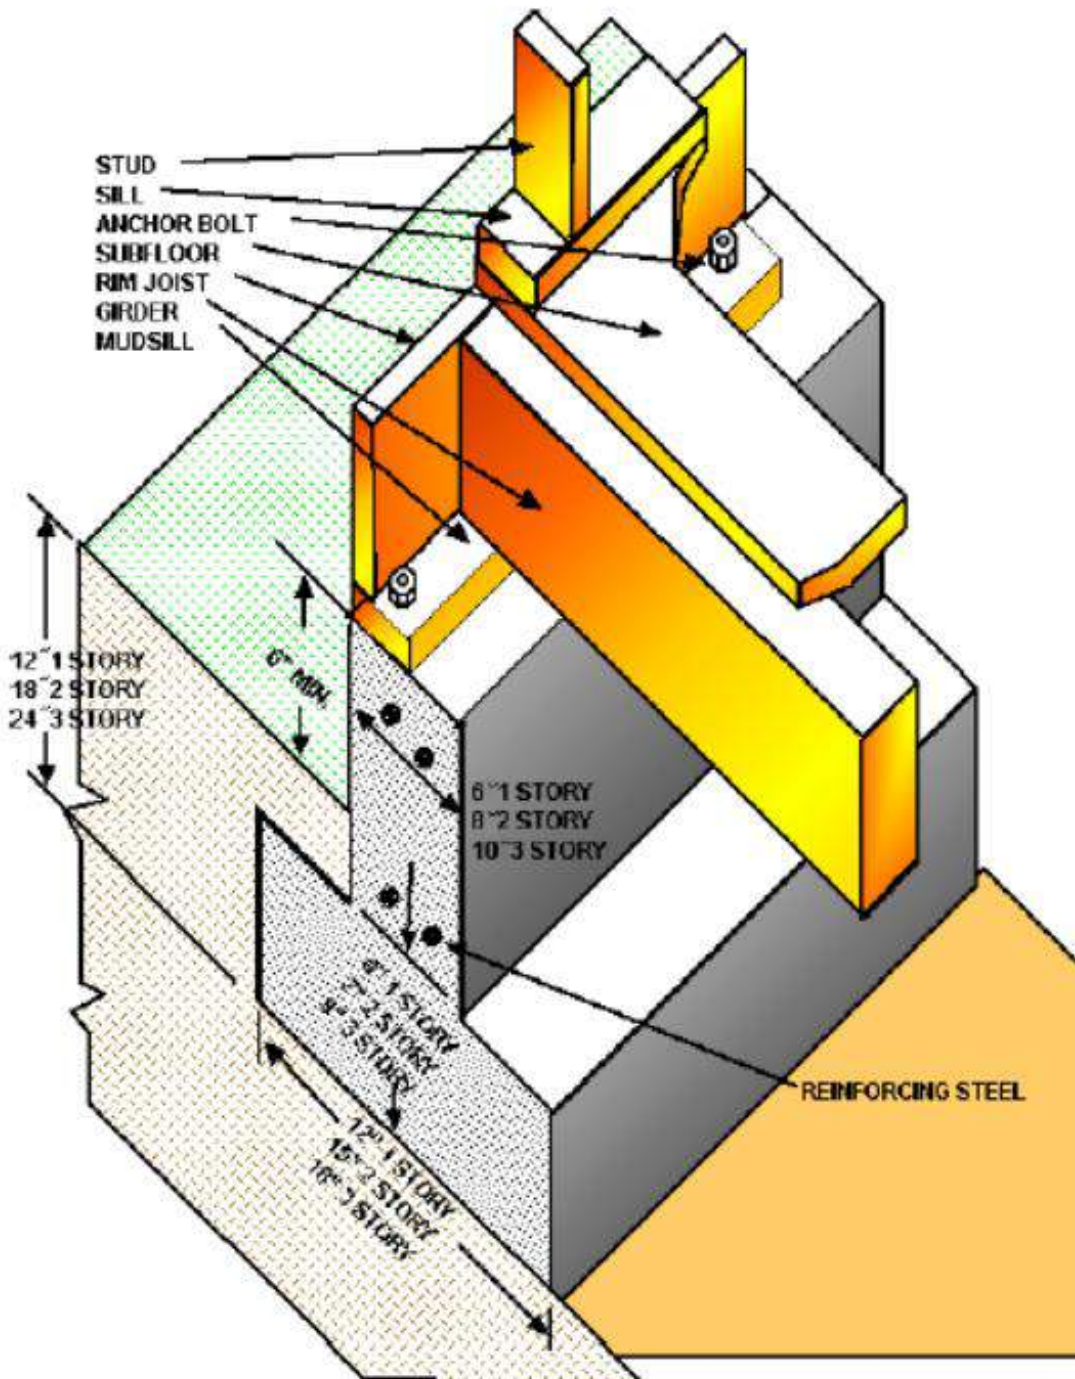
**MINIMUM "UBC" UNIFORM BUILDING CODE REQUIREMENTS  
FOR CONCRETE SPREAD FOOTING FOUNDATIONS**

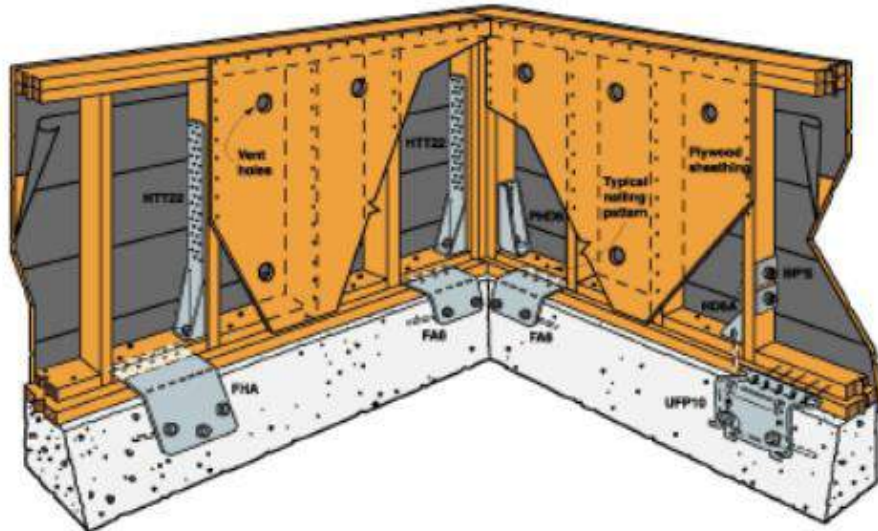
### SPECIAL HARDWARE FOR SEISMIC UPGRADE AND FOUNDATION REPAIR

This illustration shows shearwall strengthening of a cripple wall (pony wall) area constructed between the mudsill and the floor framing system. Generally, the recommended structural panel is 1/2" 5-ply plywood or 7/16" OSB panels. The width of the panels required depends on the space between studs; the greater the distance between studs, the wider the panels should be. We recommend having vent holes drilled in the sheathing to eliminate moisture build-up which can lead to wood deterioration. Accurate and complete nailing of the structural panel to the stud, mudsill, and top plates is important to ensure that it performs adequately as a shearwall. Minimum nailing requirements is 8d nails nailed every 4" around the edges of the panel, and every 6" on center field nailing (along the studs).

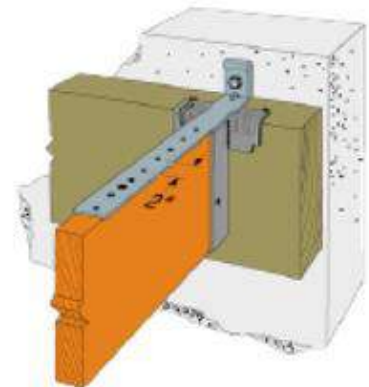
The steel strap assembly shown allows for a direct connection between the foundation and the subfloor joists.

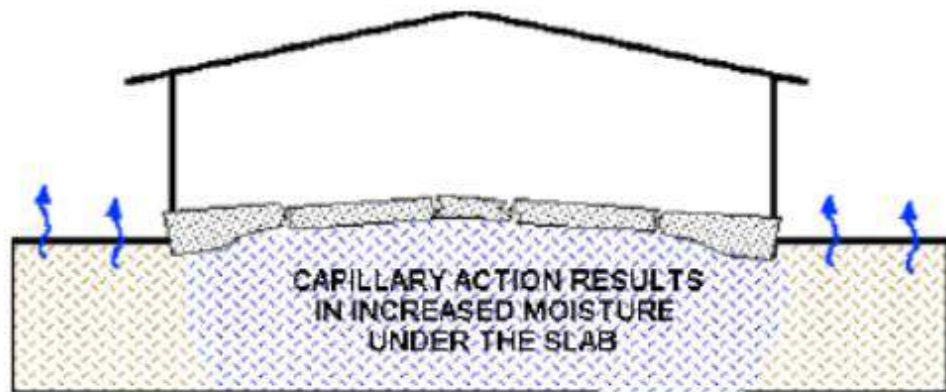
Many Bay Area homes are subject to distress and differential foundation movement as their foundations respond to the annual swell/shrink cycles of the supporting highly expansive soils. Seasonal changes in soil moisture can also result in the down-slope creep of near surface soils.

EVAPORATION DECREASES MOISTURE AT PERIMETER  
SLABS OFTEN HEAVE WHEN SUPPORTED ON EXPANSIVE SOIL

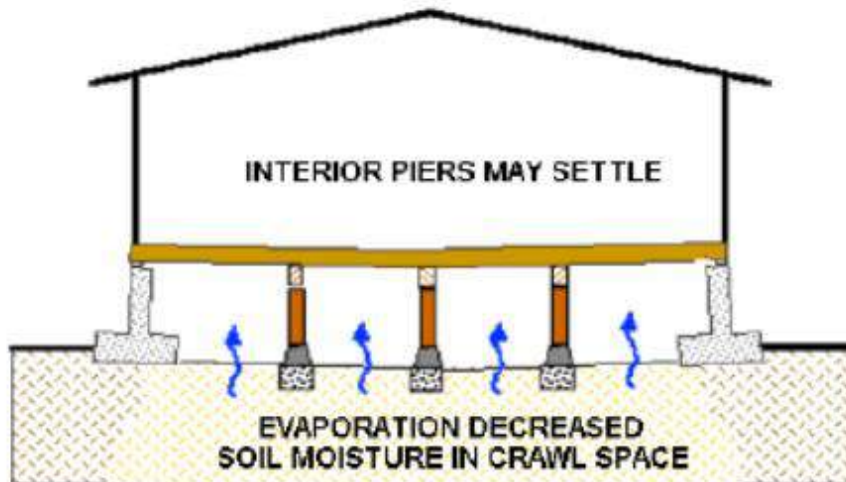
FOOTINGS OFTEN SETTLE WHEN SUPPORTED ON EXPANSIVE SOIL

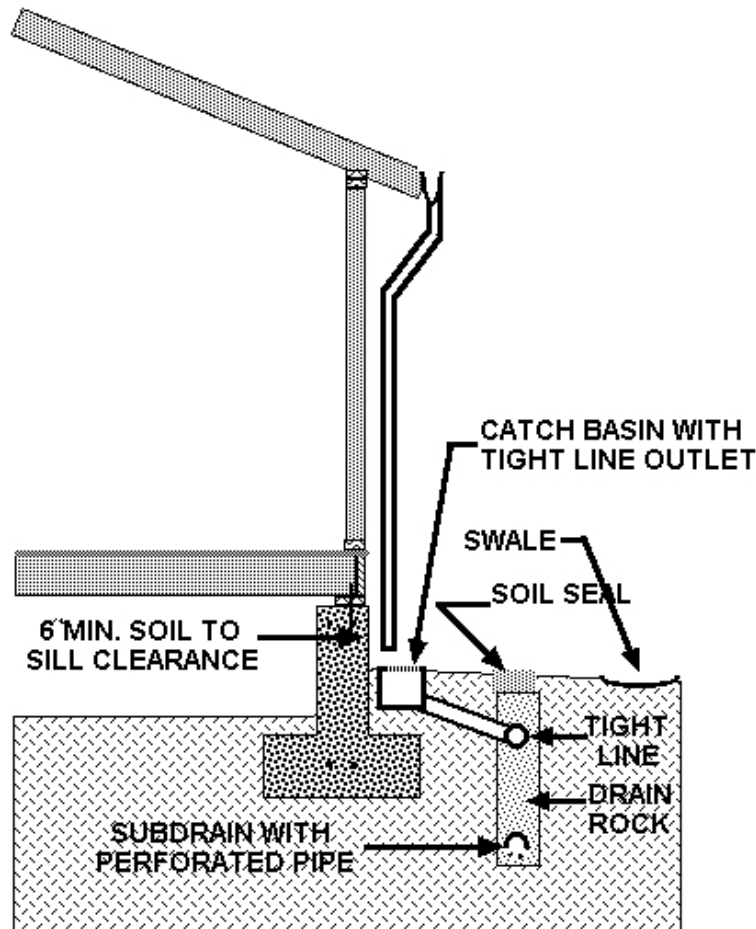
As an alternate to, or in addition to a sub-drain, it may be found cost effective to install a finger drain in the sub-area. A finger drain is constructed much like the perimeter sub-drain, but is typically positioned in the sub-area, just inside the perimeter foundation. A finger drain typically varies in depth from 6" to 15" and often outlets to an 18" diameter, 30" deep, cased sump that is provided with a float-switch activated pump.

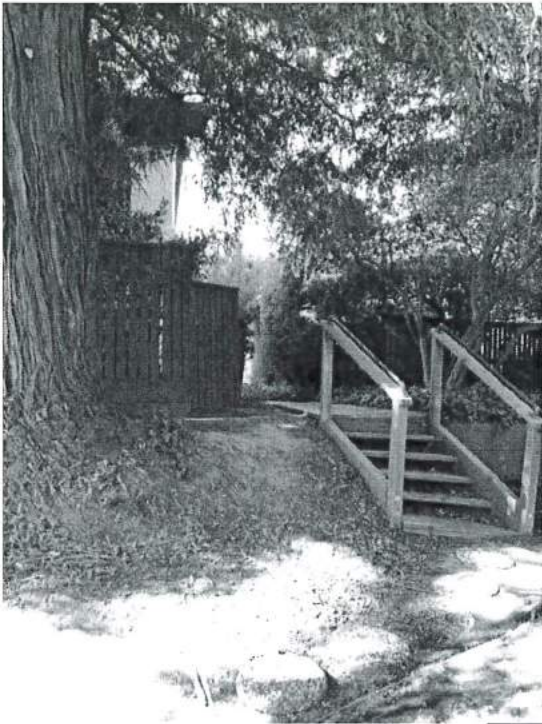
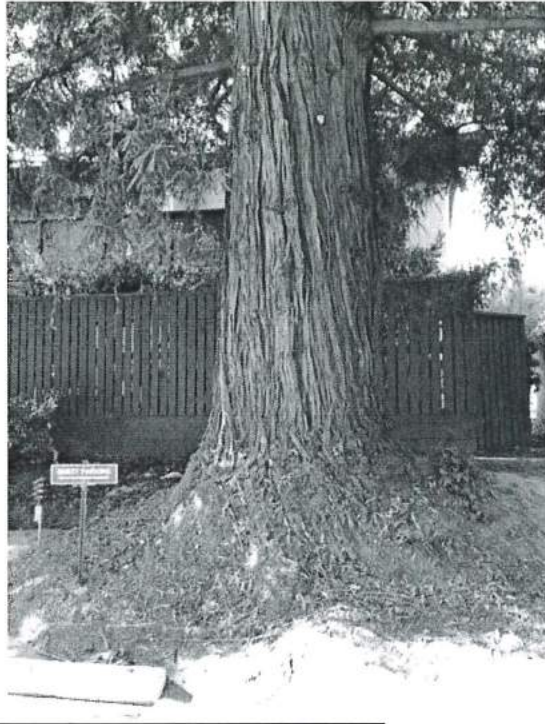
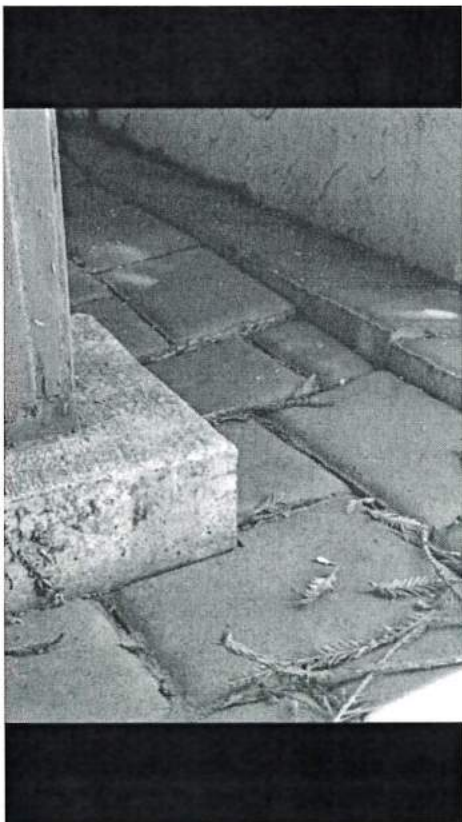
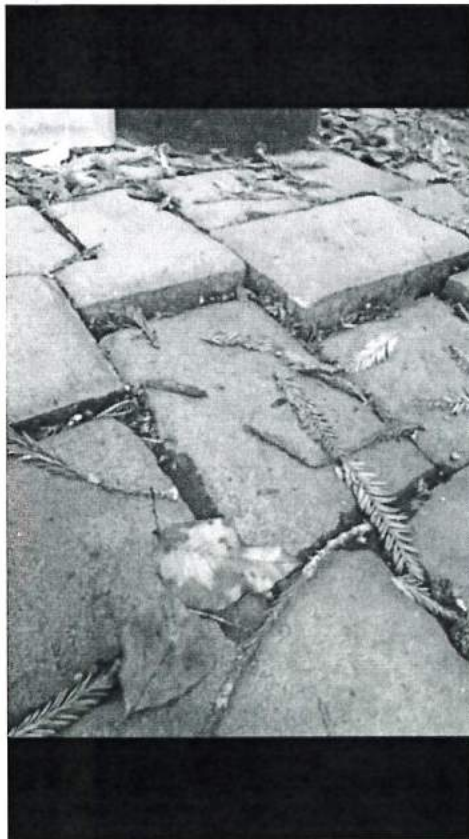
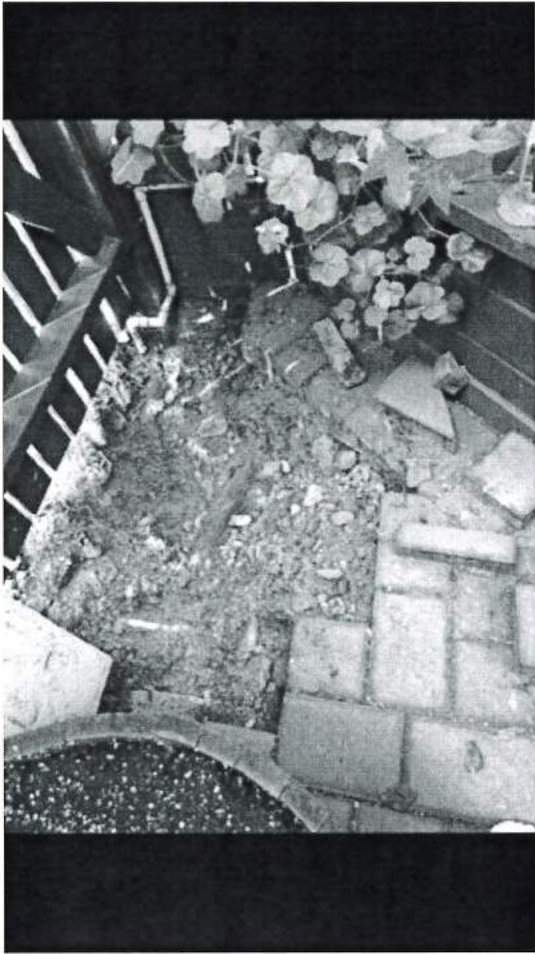
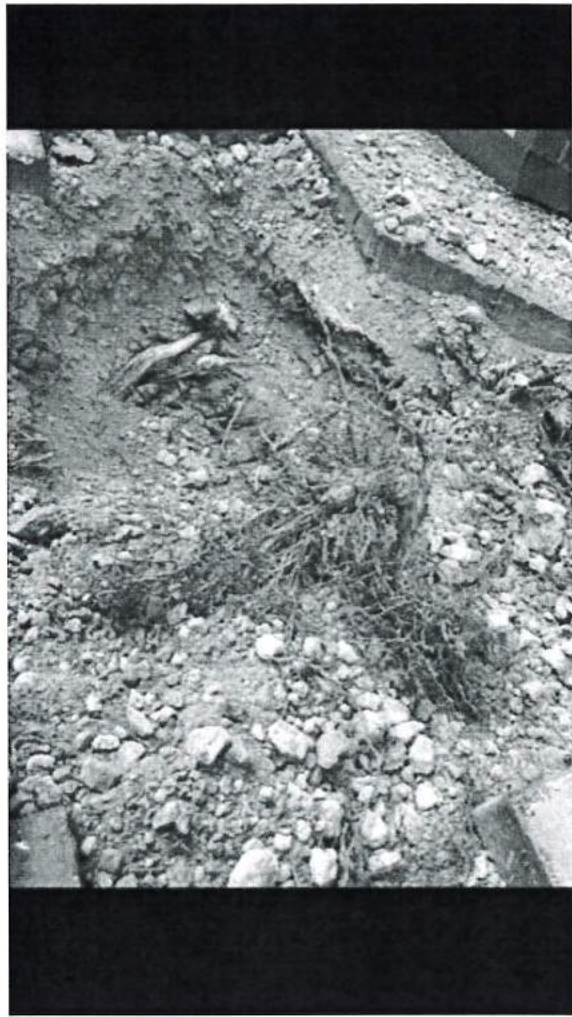
Photos –

**Observations** – The Redwood tree is a large tree and with a large root system. The tree is in close proximity to the unit, thus the invasive root system has caused damage to the fence, gate, pavers, and structure (please see photos below). Root pruning and installing root barriers is not an option as it would be in the CRZ (critical root zone) of the tree and would compromise the integrity of the tree. Therefore, I am recommending the removal of the tree to prevent further damage to persons and/or properties.

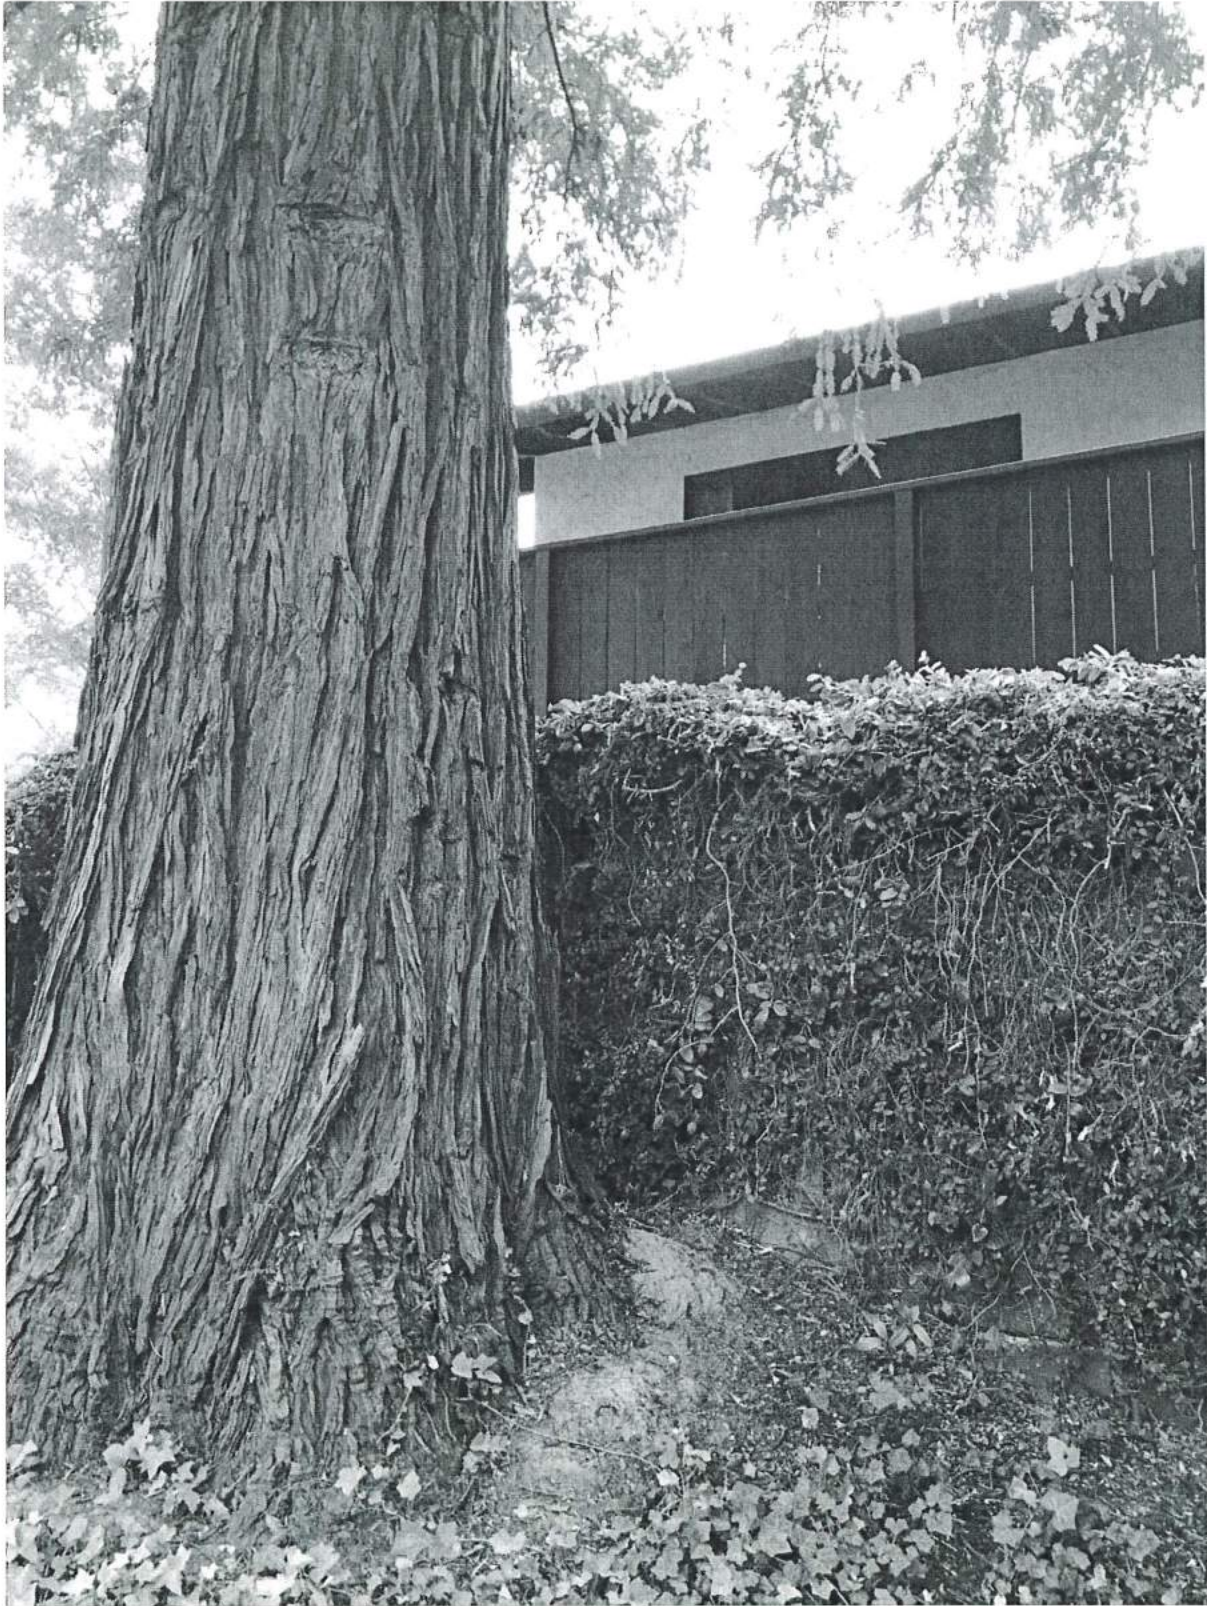
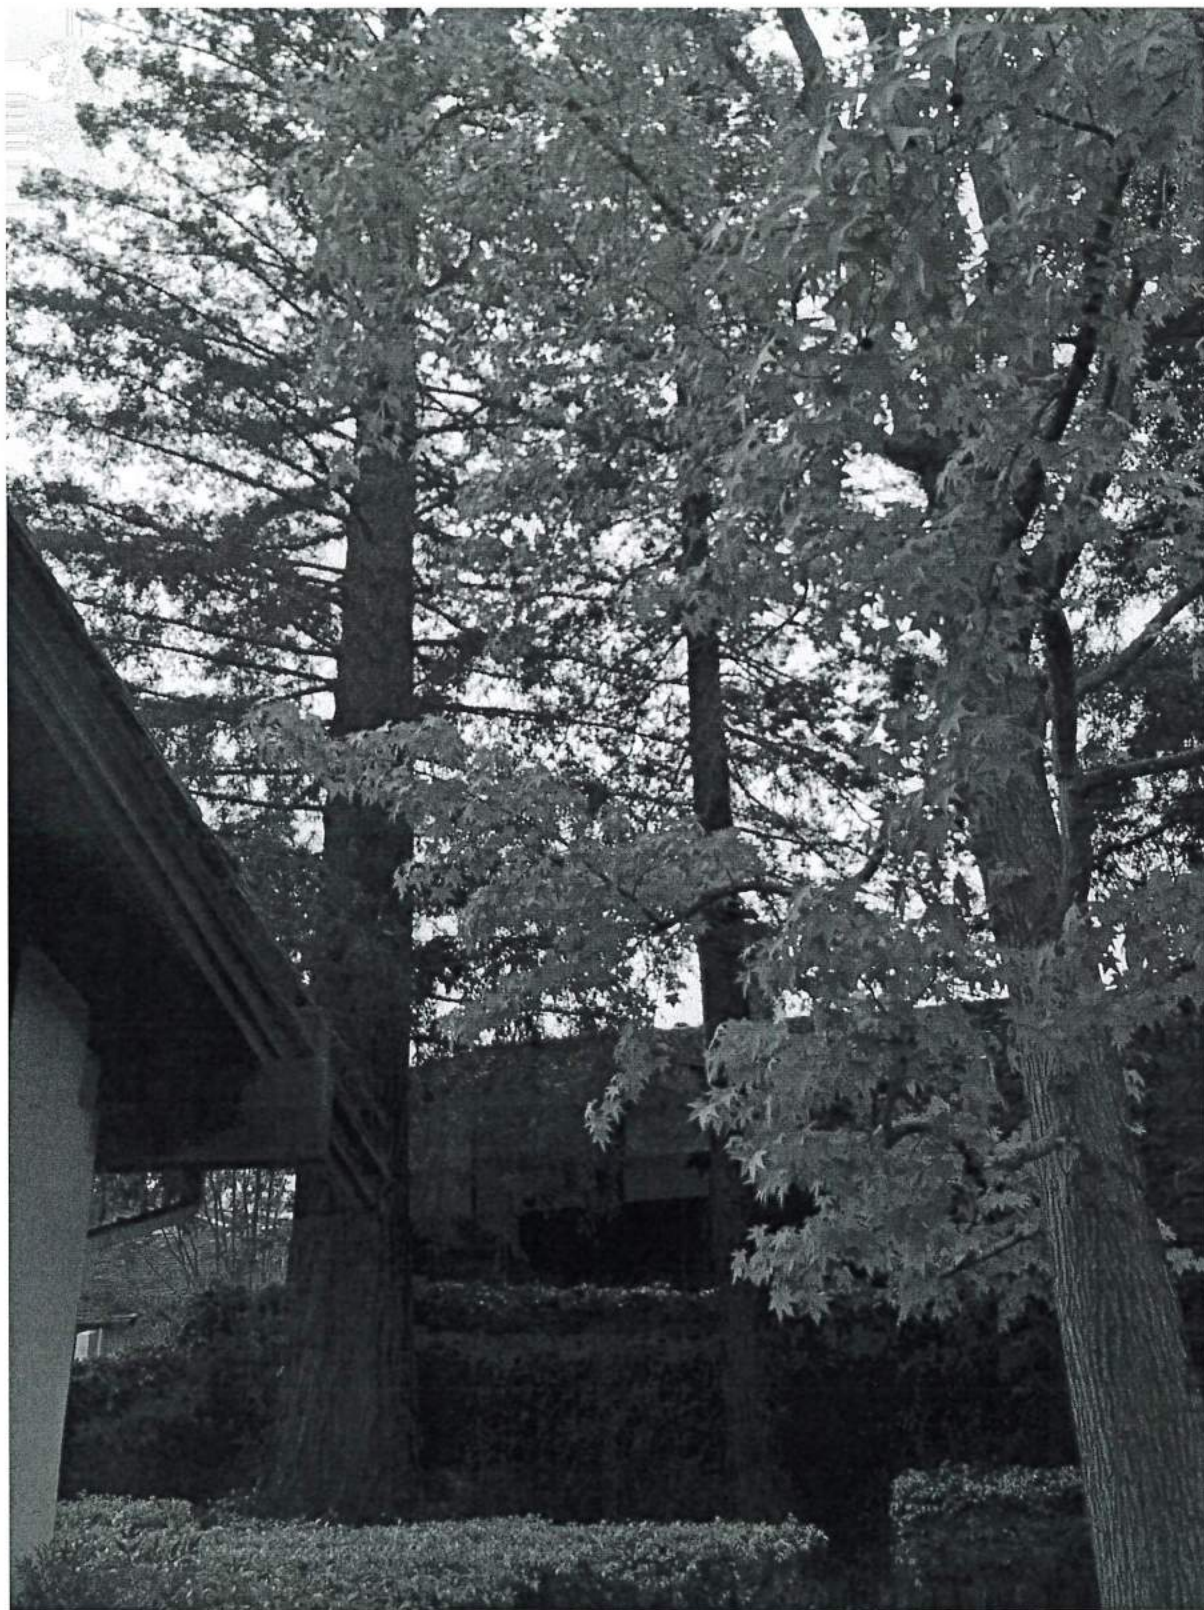
Photos –

Despite the fact that tree roots grow very slowly, they exert tremendous amounts of pressure on whatever they are growing through or near. As they move through the ground in their eternal search for water and nutrients, they displace the soil around them. Clay soils compact more tightly, while loose, dry soil in arid climates shifts and becomes inefficient at supporting a structural load. While the roots themselves aren't capable of causing direct damage to buildings and foundations, increasingly greater soil displacement can compromise the integrity of the soil the building sits on as well as its supporting structure. If soil moves, whatever is sitting on it moves, too. Older building materials that have deteriorated over time can rise or settle as the soil displaced by extensive tree root systems moves, and the structures may develop cracks that smaller tree roots may be able to penetrate.
